MEMORANDUM

SUBJECT: Stevens Creek Fish Passage
Remediation

STEVENS CREEK FISH PASSAGE ANALYSIS

CONCEPTUAL APPROACHES TO REMEDY FISH PASSAGE IMPEDIMENTS IN STEVENS CREEK

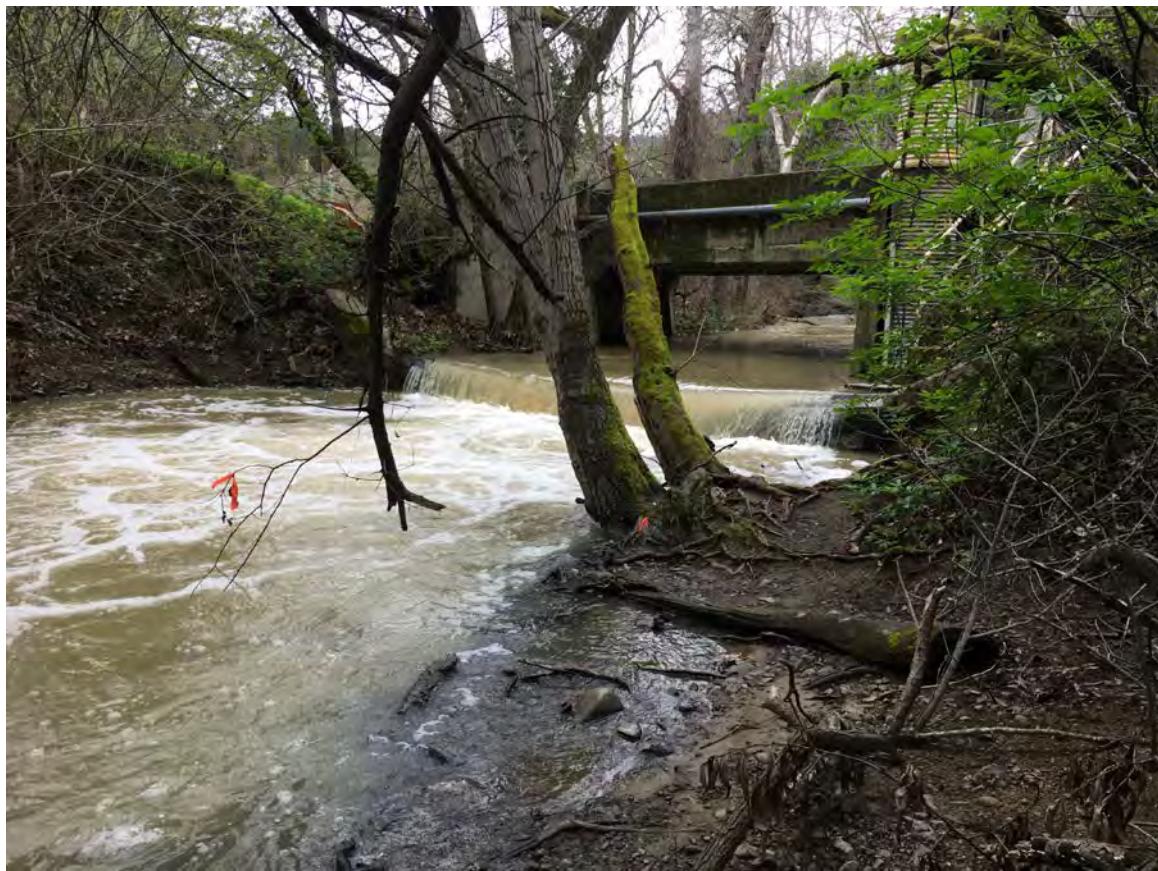
No new potential fish passage impediments were noted. The gauging weir at Stevens Creek Park (44), a previously identified potential impediment, is still present and was confirmed as a potential impediment (see photograph 1).

Photograph 1: Potential fish passage impediment at gauge weir at Stevens Creek Park

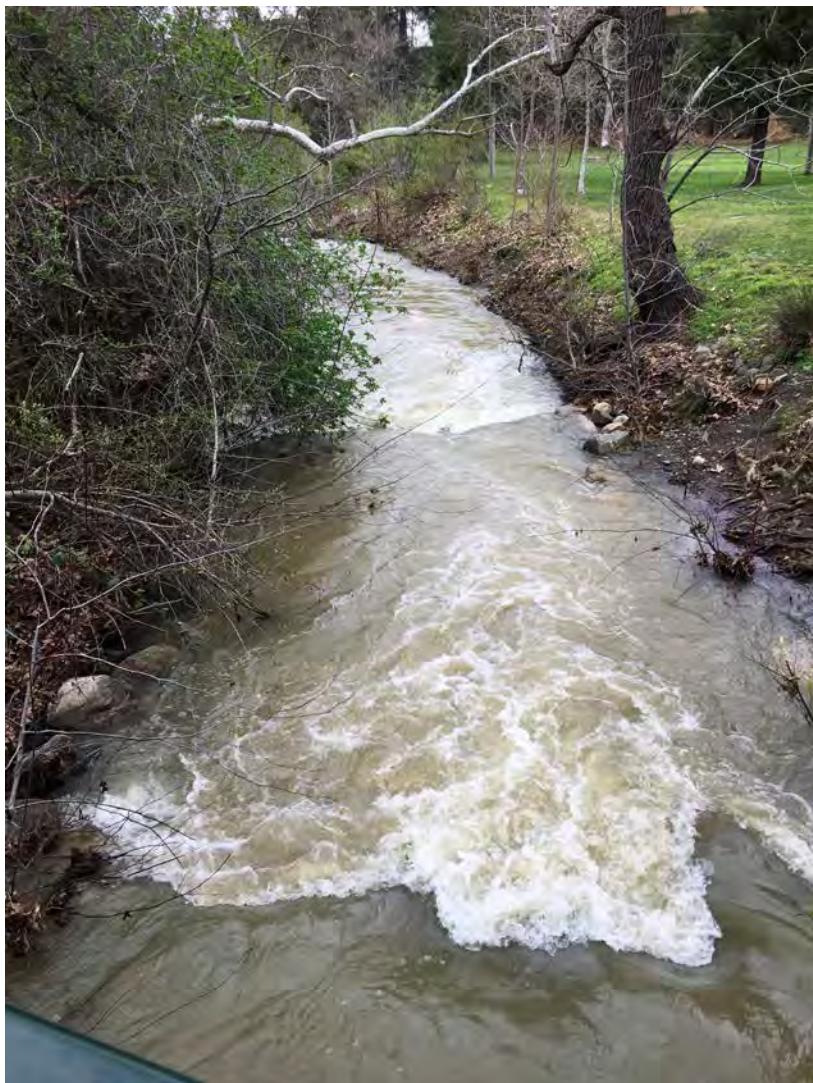
One potential fish passage impediment was noted. Water clarity (i.e. turbidity) made viewing the stream bed during the reconnaissance survey challenging therefore, it was difficult to ascertain what type of structure (i.e. concrete weir, bridge footings) was creating the turbulent condition noted in Photograph 2. The potential passage impediment is located directly downstream of a pedestrian bridge crossing on the creek and therefore it was presumed to be infrastructure related to the bridge crossing. The spatial coordinates for this suspected barrier are as follows; latitude 37.32, longitude -122.06.

Photograph 2. Potential fish passage impediment downstream of footbridge.

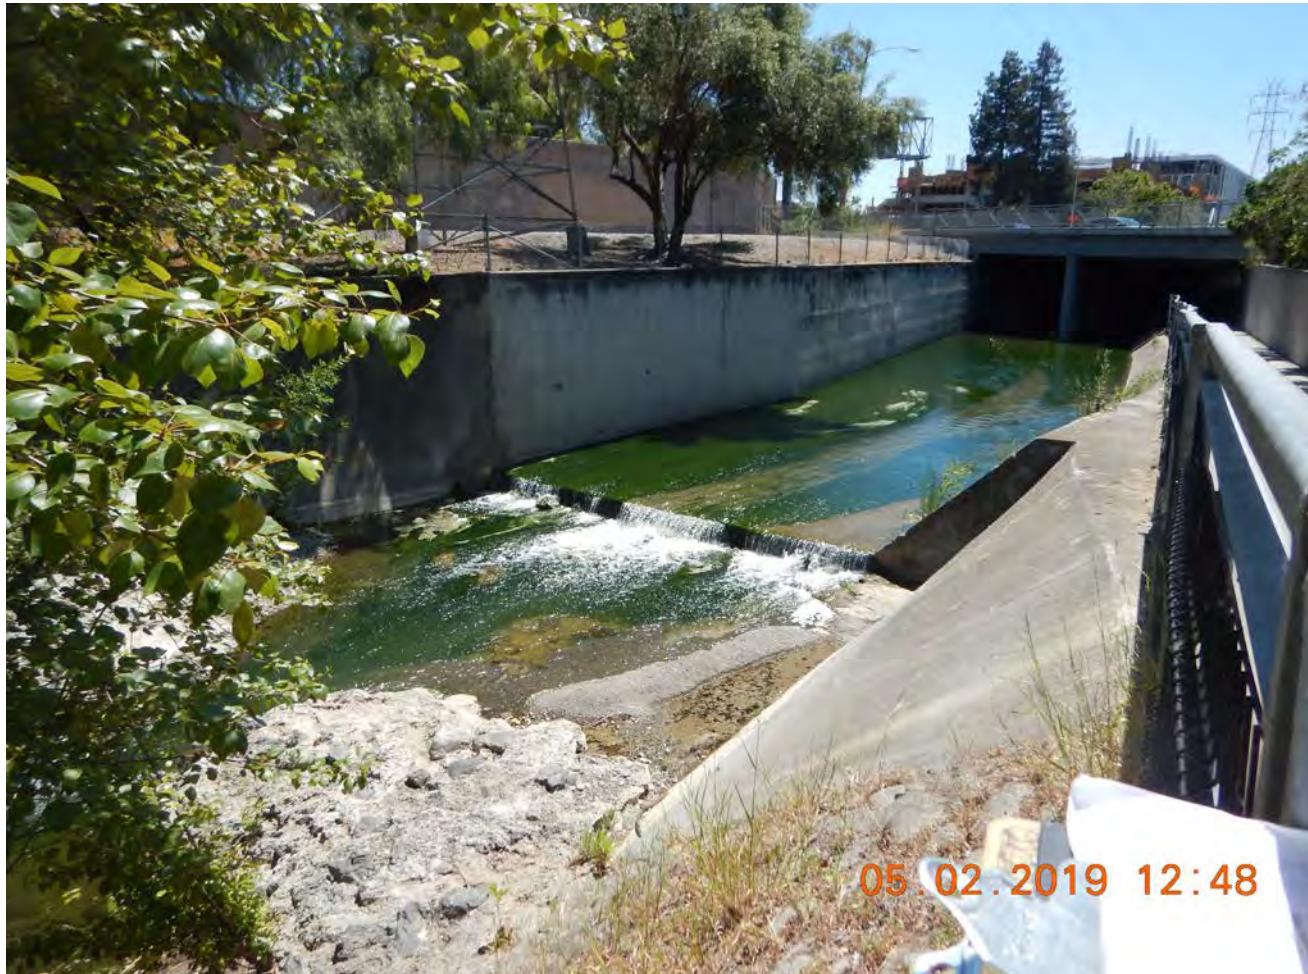
Results: Two previously recorded potential fish passage impediments were confirmed in Study Area 6: Highway 101 culvert (see Photograph 3) and chute and the grade control structure at Vernon Avenue (see Photograph 4). No other potential fish passage impediments were noted in Study Area 6.

Photograph 3: Highway 101 culvert and chute

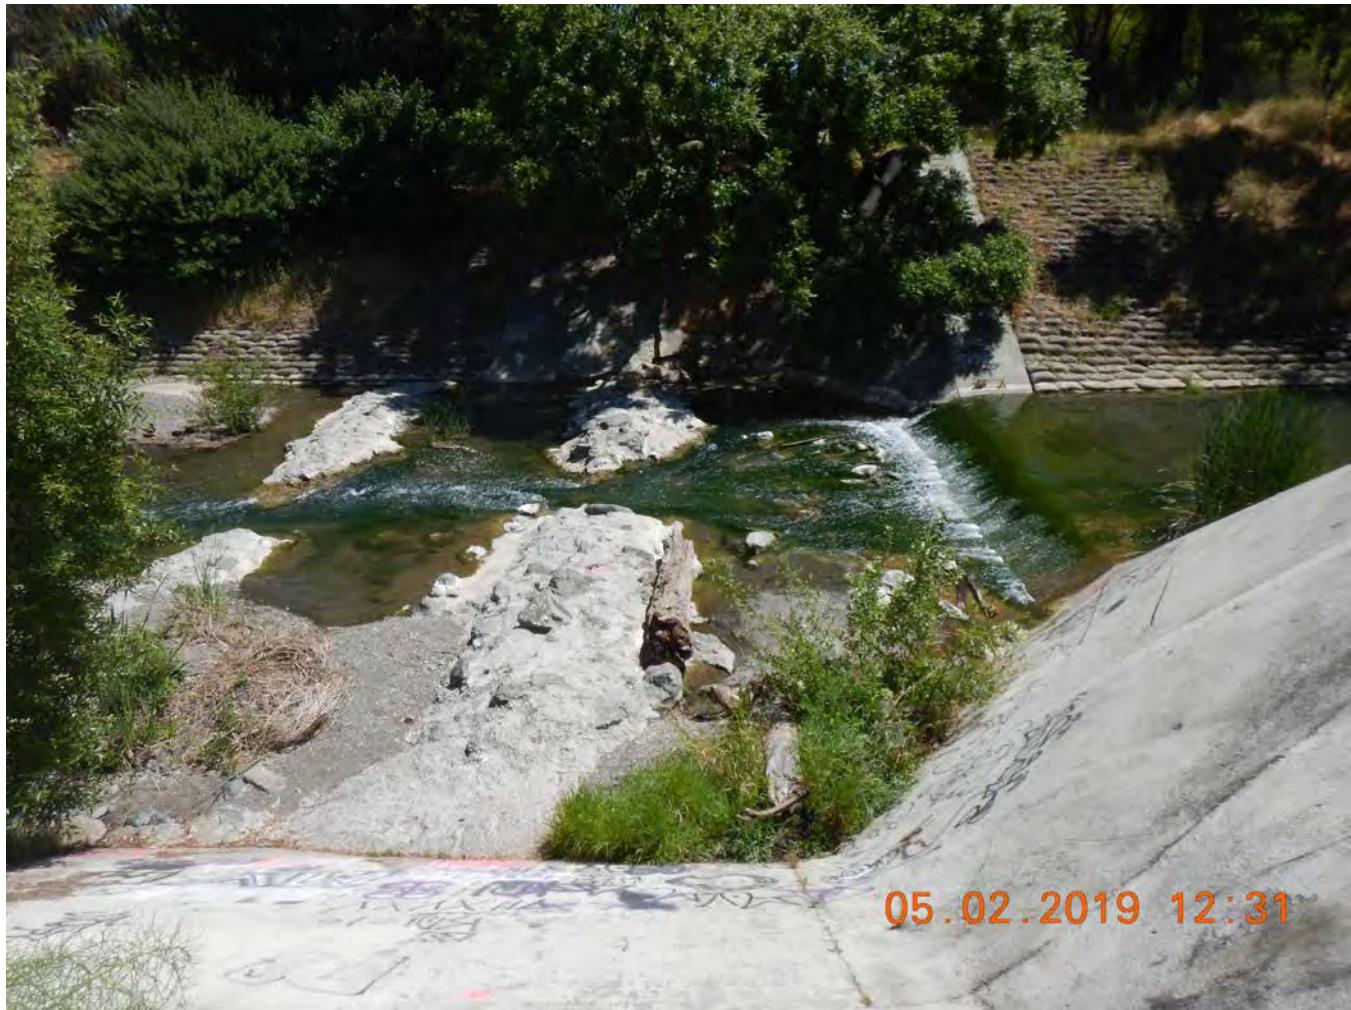
Photograph 4: Grade control structure at Vernon Avenue

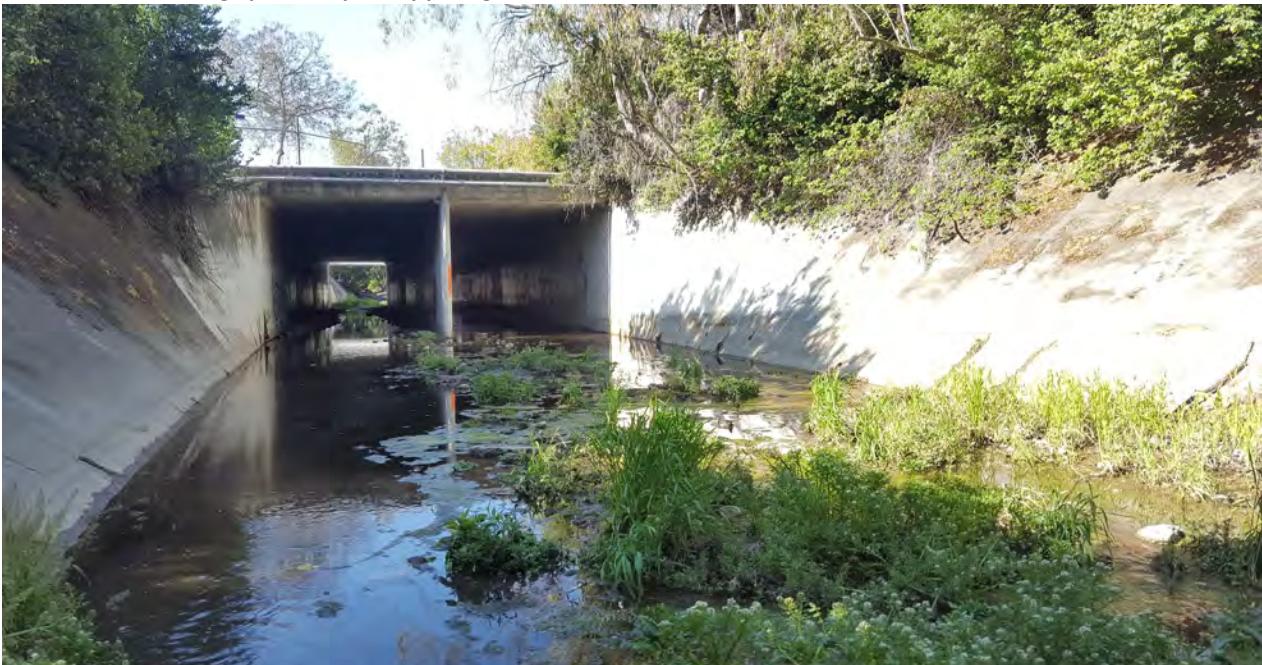
Culvert outlets looking upstream, primary passage culvert on left

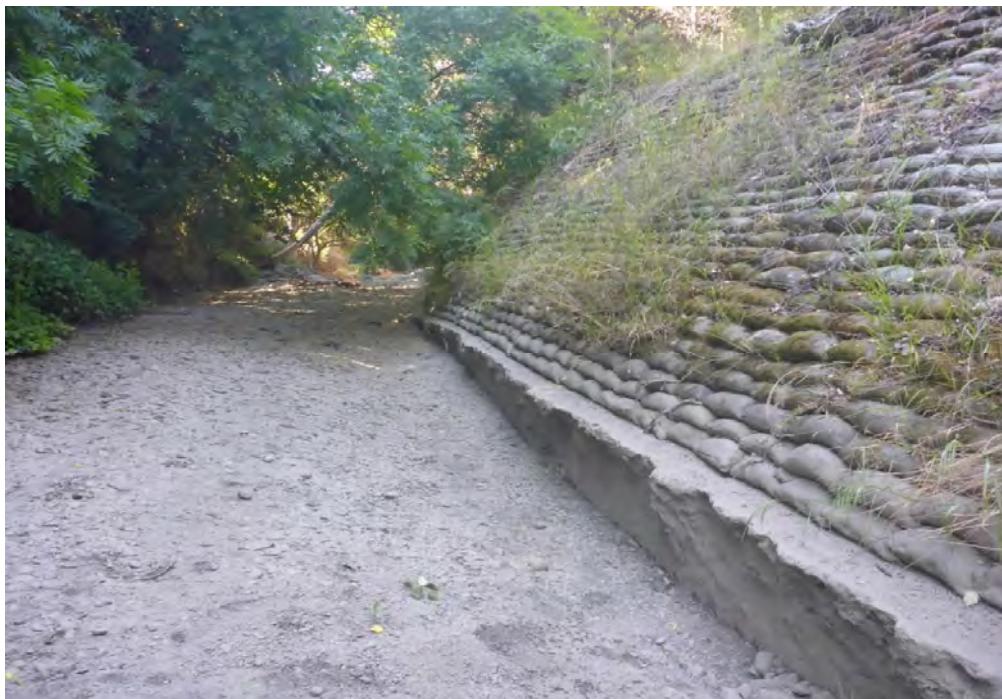
Right bank sacrete revetment with undermined toe, looking downstream from grouted boulders

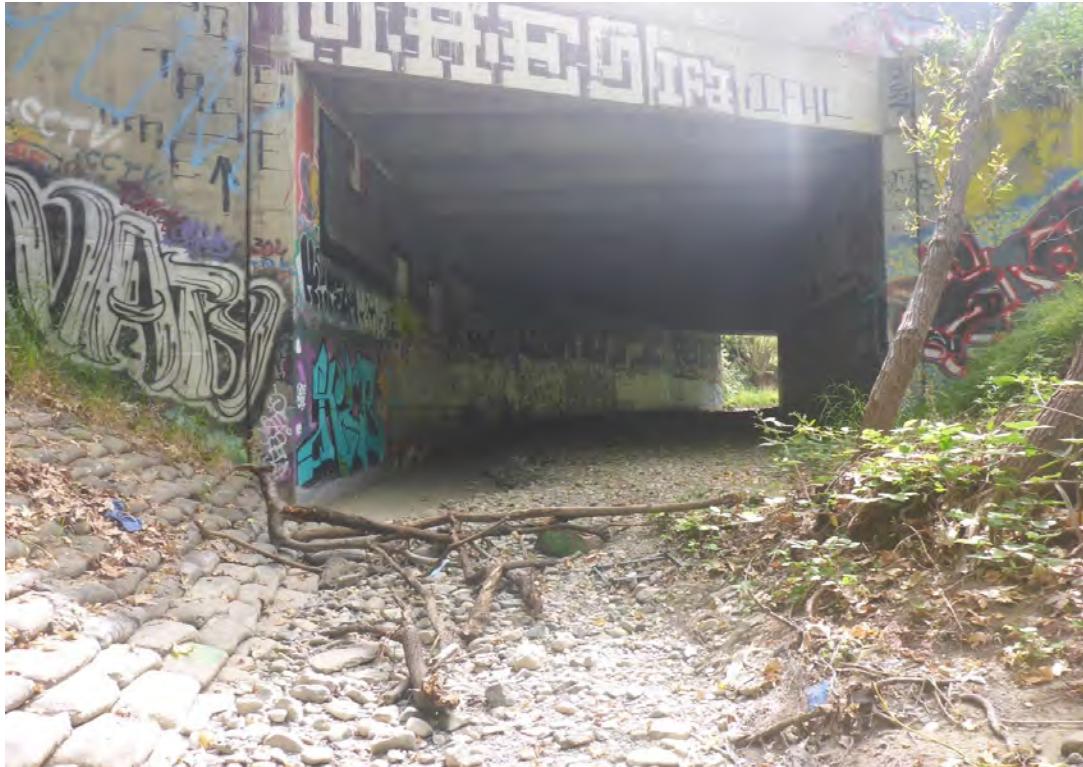
Culvert outlet, looking upstream with some concrete exposure on outside of bend

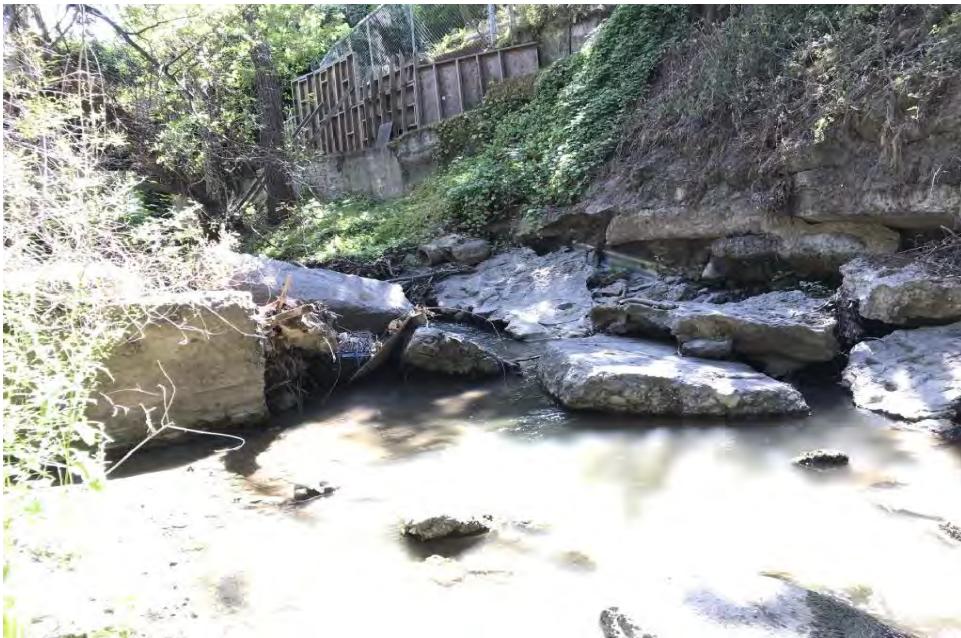
Looking upstream at concrete rubble across channel located downstream of the crossing

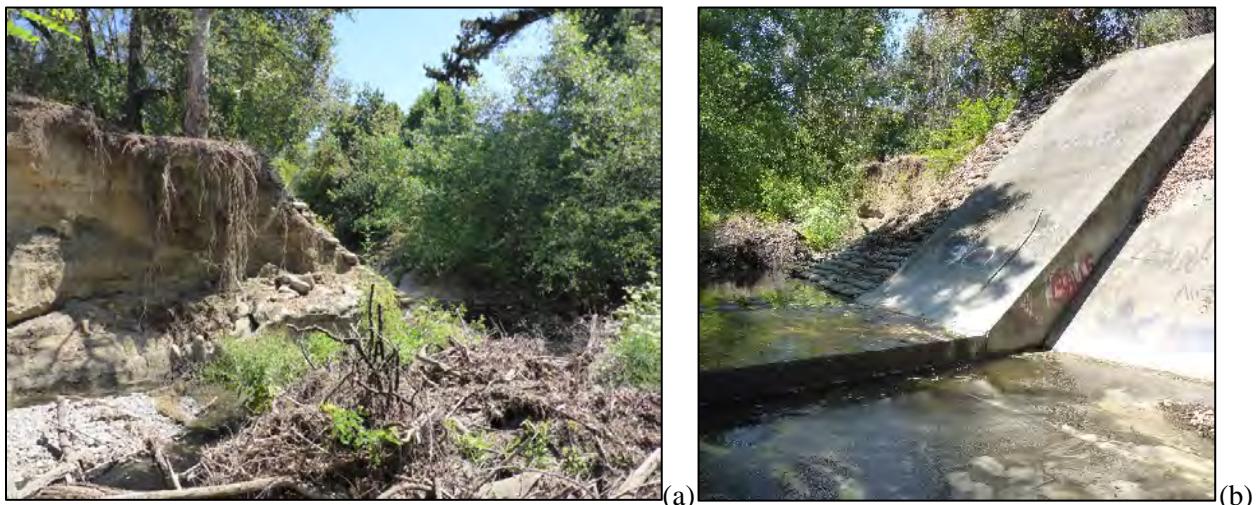
Assessment Site 9, the drop structure upstream of Middlefield Road, is at RM 3.53. The invert of the drop structure is backwatered by the downstream riffle crest, providing sufficient depth for adult fish to swim over it at flows above 49 cfs. As a result, the site is 77 percent passable for adult steelhead but zero percent passable for juveniles, due primarily to excessive water velocities. Immediately upstream of the structure, the channel has dramatically shifted laterally to the left (looking downstream) and is now flowing into a vertical earthen streambank at nearly a perpendicular angle, causing the bank to actively fail (Figure 3-2a). If allowed to continue, the channel may erode behind the existing concrete revetment at Site 9 (Figure 3-2b). Any action taken at Site 9 will require a larger stream repair project to stabilize this reach. For this reason, fish passage improvements at this site should be in alignment with upstream channel repair. Two passage remedies were considered for the site, including a roughened channel and pool-and-chute fishway.

Figure 3-2 Site 9 – Looking (a) Downstream, Where the Stream Flows Directly into a Failing Bank before Turning Right and Going Over the Site 9 Drop Structure, and (b) Looking Upstream at Site 9, with Failing Banks in Background

9	◆◆	<u>Drop structure upstream of Middlefield Road</u> Remedy would replace concrete drop structure with a roughened channel (2% profile) or pool and chute fishway (10% profile). Either solution would remove the hydraulic drop and improve sediment transport continuity. Bank stability a concern and substantial bank work may be required.
11	◆	<u>Highway 85 crossing, post mile 23.0</u> Remedy would replace concrete drop structure with a roughened channel (2% profile) or pool and chute fishway (10% profile). Either solution would remove the hydraulic drop and improve sediment transport continuity.
12	◆	<u>Vortex Fish Weir fishway at Gage 35</u> Remedy would modify concrete vortex weir fishway to reduce hydraulic drop. No change to geomorphic characteristics would result.
14	◆	<u>Drop structure downstream of pedestrian bridge</u> Remedy would replace concrete drop structure with a roughened channel (1 to 2% profile), which would improve geomorphic characteristics.
