Project F1: Vegetation Control and Sediment Removal for Capacity Approach to Maintaining Creek Capacity

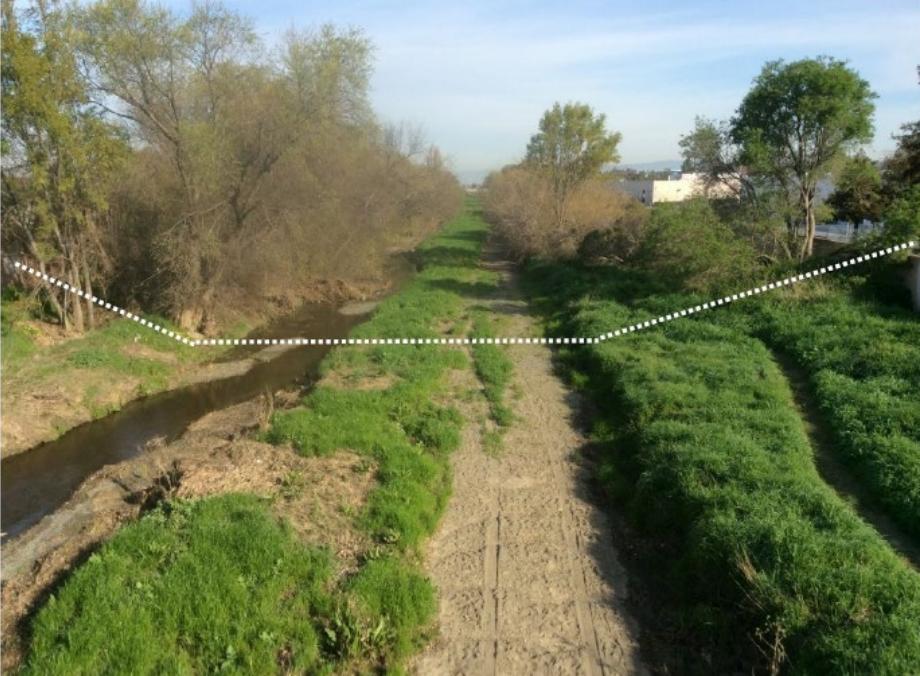
Figure 3: Example Stream Maintenance Guideline Representative Cross-Section Photo (2015) for Calabazas Creek, Reach 1c

Figure 3 is a 2015 photo of the representative cross-section of this reach of Calabazas Creek. Based on staff observations and referencing a roughness/vegetation photo atlas developed for use on county streams, a composite roughness of 0.042 was ascribed for this site.

Calabazas Creek Reach 1c	Composite Roughness: 0.042
Date: Spring, 2015	
Estimated vegetation composition (dotted cross-section): Grasses = 30% Herbaceous = 30% Woody = 20% Bare ground & water = 20%

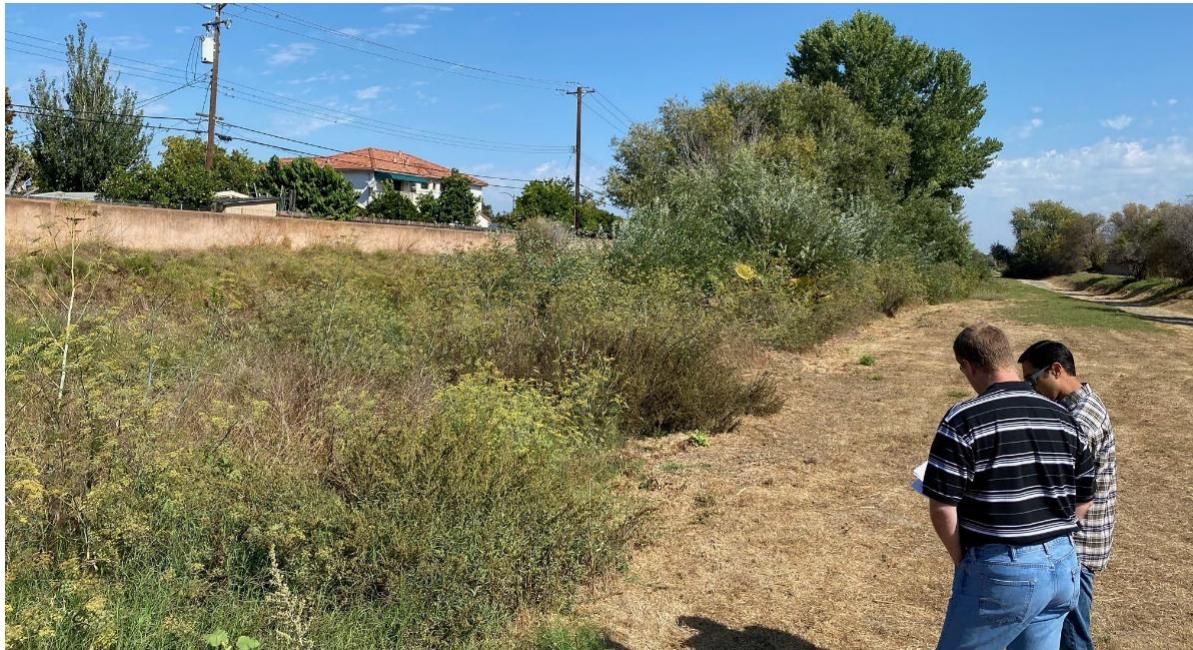
Figure 4: Example Stream Maintenance Guideline Photo (2022) for Calabazas Creek, Reach 1c

Figure 4 is an August 2022 photo from the same reach. As compared to the photo in Figure 3, the Figure 4 photo indicates much more vegetation has grown in this reach, and while it may not be readily apparent, sediment accumulation has occurred as well. Based on staff's observations, a composite hydraulic roughness of 0.05 to 0.055 was estimated.

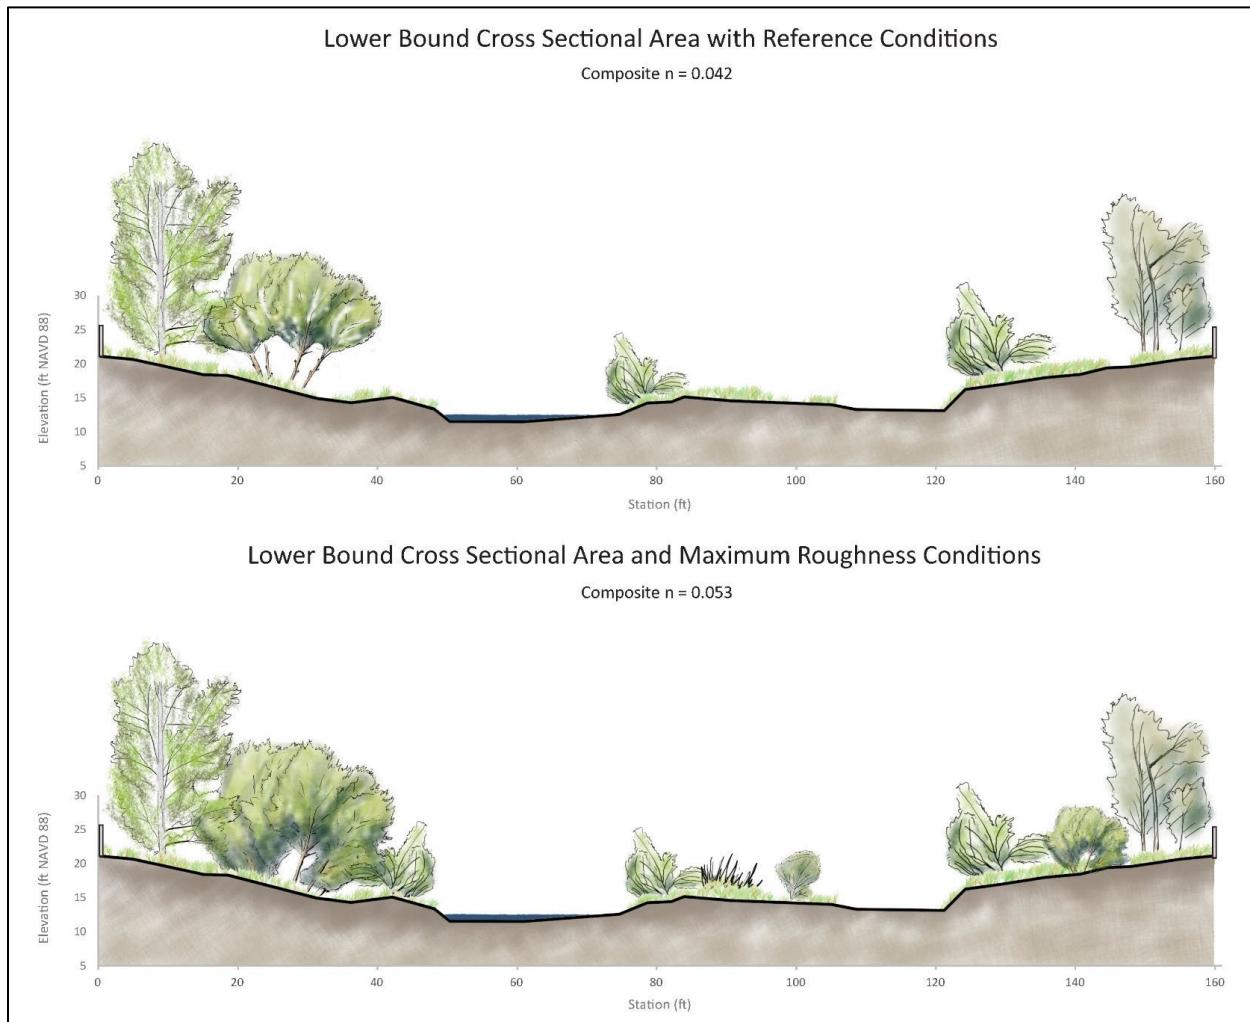
Figure 5: Example Stream Maintenance Guideline, Representative Roughness Cross-Section for Calabazas Creek, Reach 1c

Figure 5 illustrates the representative roughness cross-section for this reach. To provide a visual comparison of conditions, this figure includes two depictions of the representative section:

- The upper cross-section portrays roughness characteristics under observed conditions in 2015.
- The lower cross-section portrays the maximum roughness evaluated as part of the analysis. This lower cross-section more closely resembles what was observed in 2022.

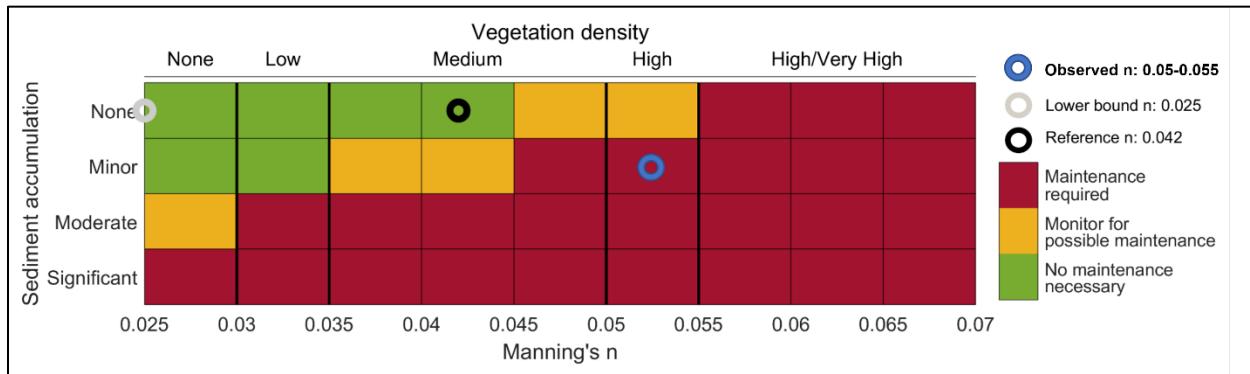
Figure 6: Example Stream Maintenance Guideline Summary Thresholds for Maintenance for Calabazas Creek, Reach 1c with Applied 2022 Observations

Taking the above information into account, with an estimated composite roughness of 0.05 to 0.055 and observed minor sediment accumulation, as depicted by the blue circle in Figure 6, it can be concluded that maintenance is recommended in this reach of Calabazas Creek.
