# Palo Alto Flood Basin Tide Gate Structure Project Seismic Retrofit & Rehabilitation

August 2025

# EXISTING TIDE GATE STRUCTURE BUILT IN 1957

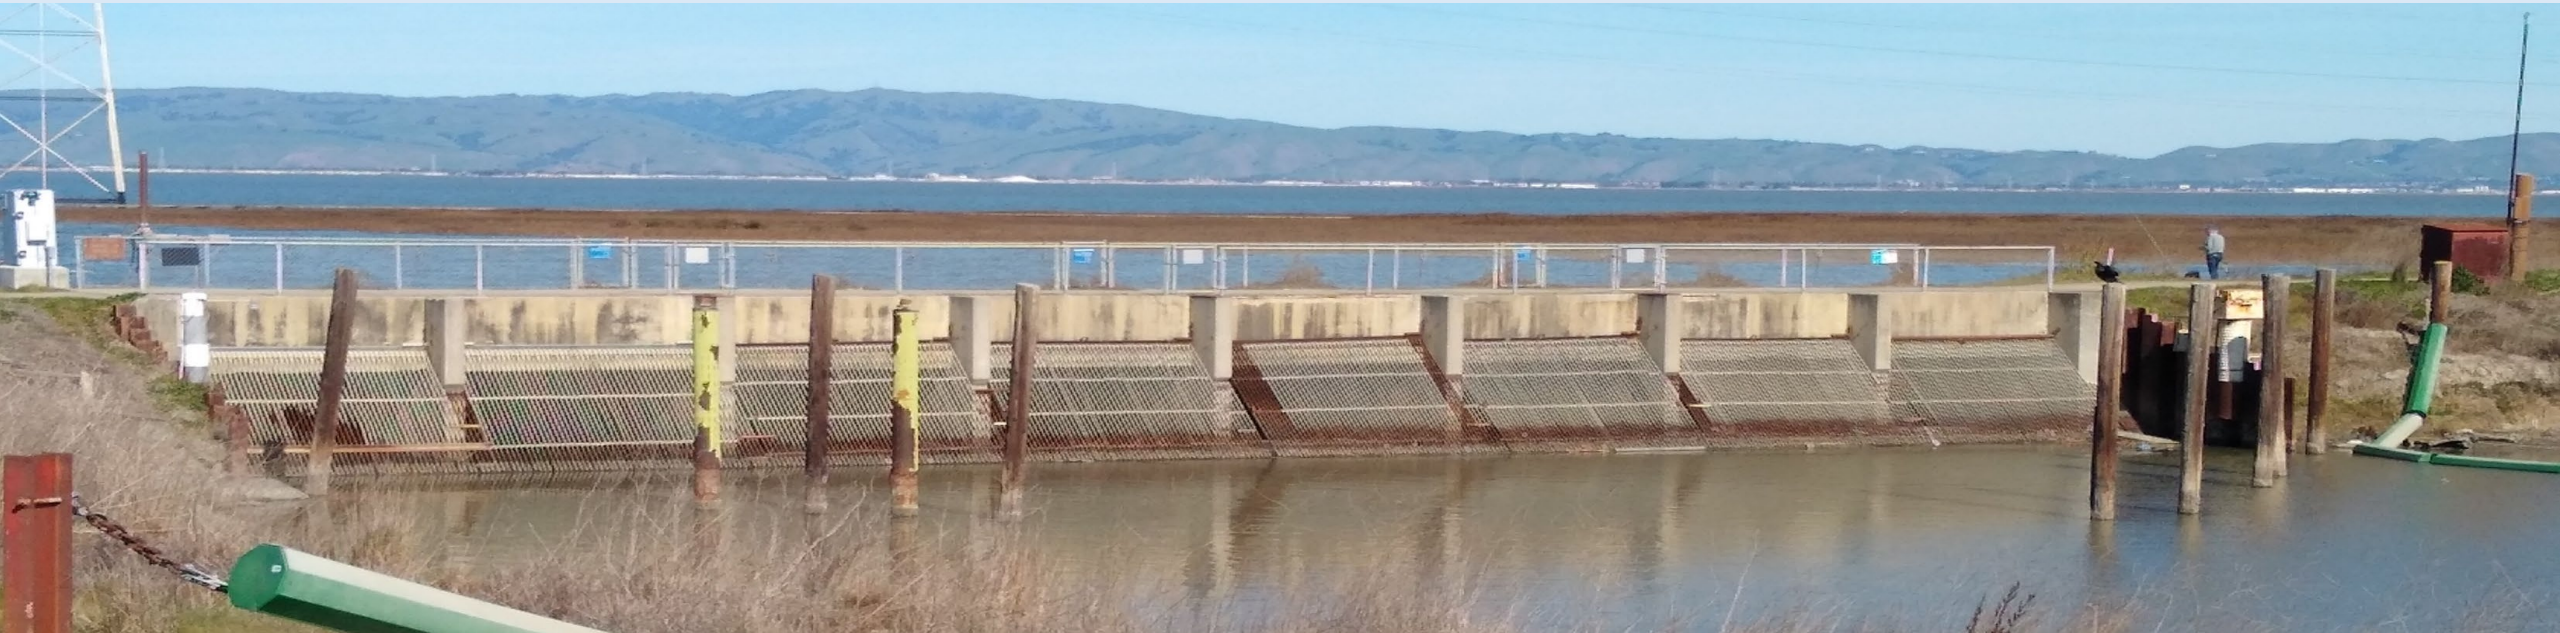
- Palo Alto Flood Basin (PAFB) provides flood protection for Matadero, Barron and Adobe Creeks
- City of Palo Alto operates one of the gates for managing the basin
- Tide gate structure part of the SF Bay Trail
- The gates hold high-tide water out and allow the basin to drain at low-tide

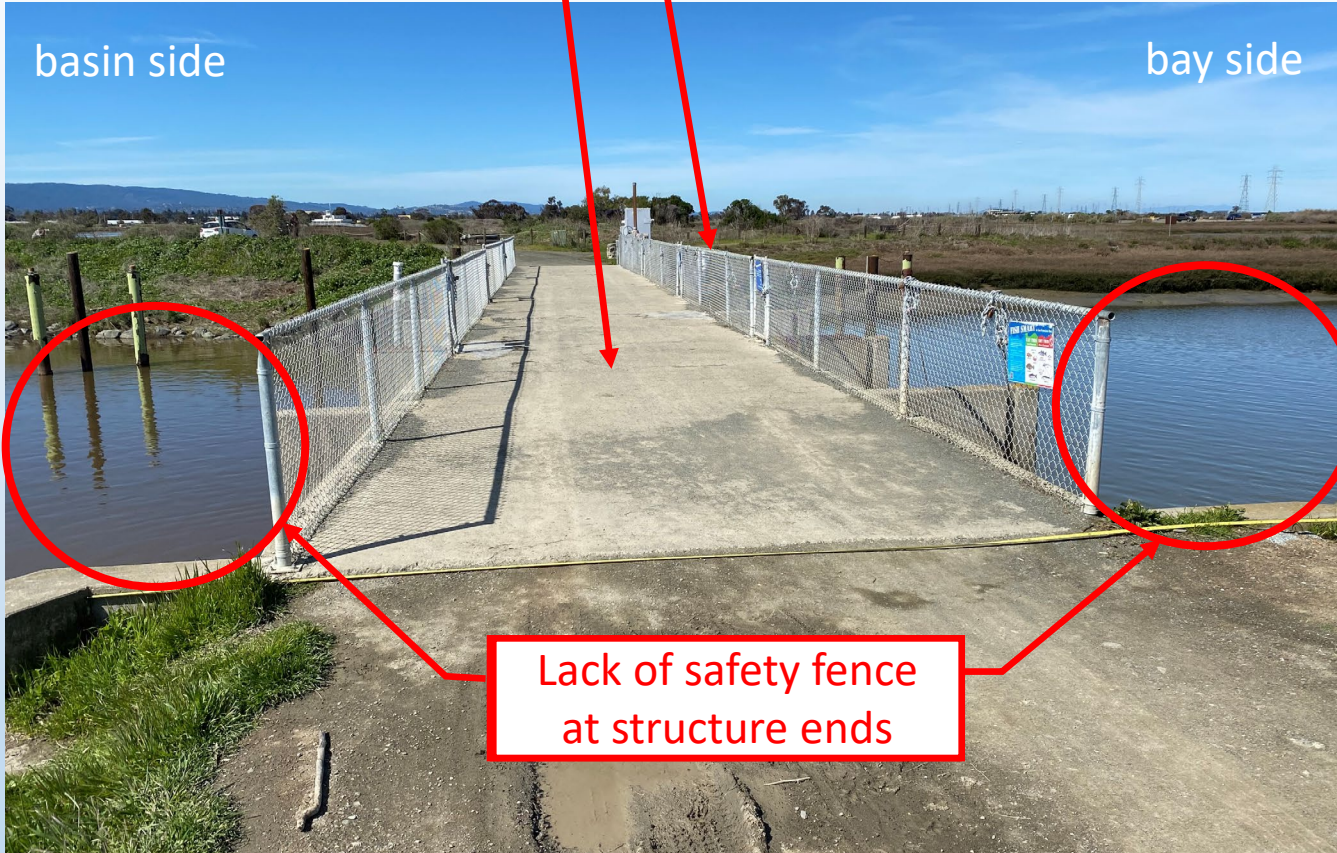
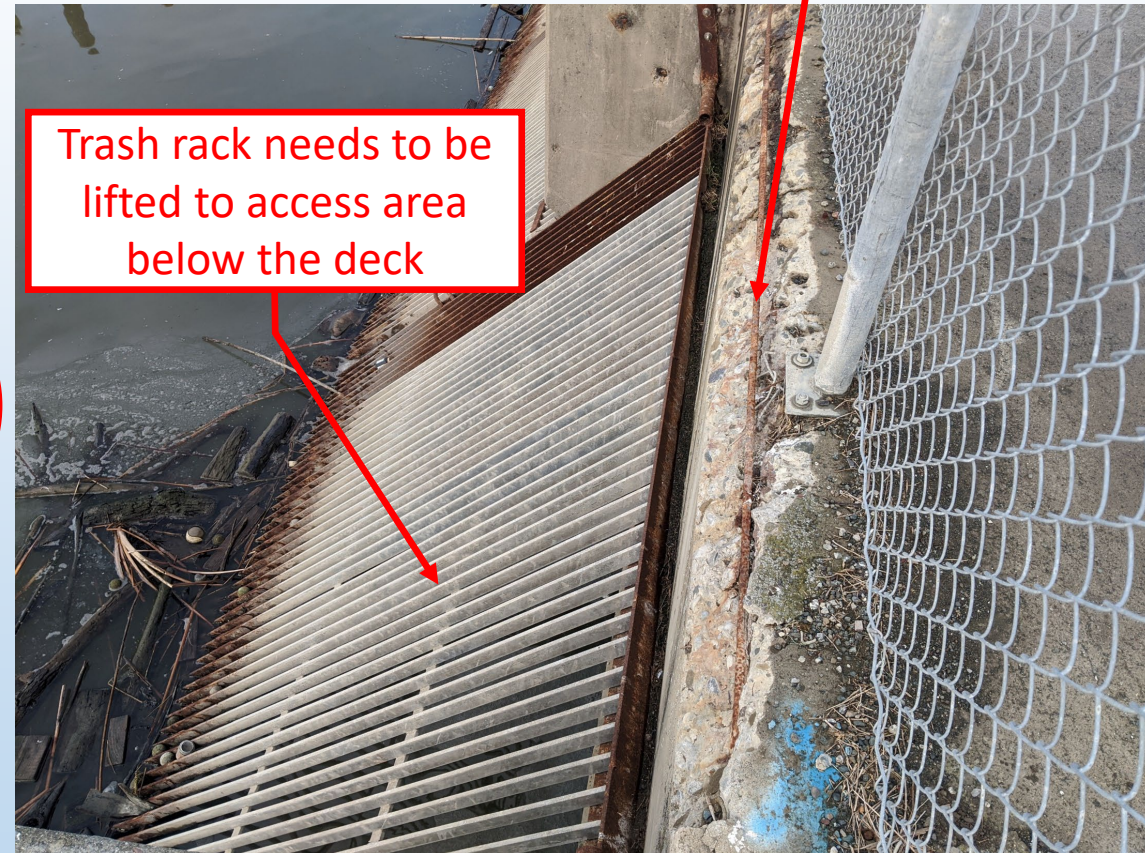
# EXISTING TIDE GATE STRUCTURE CONDITIONS

Spalled concrete spots on deck surface

42" fence height is substandard for bicyclist safety

Spalled concrete and corroded steel reinforcement

Trash rack needs to be lifted to access area below the deck

Lack of safety fence at structure ends

View of the structure from the east.

Trash rack located on the basin side.

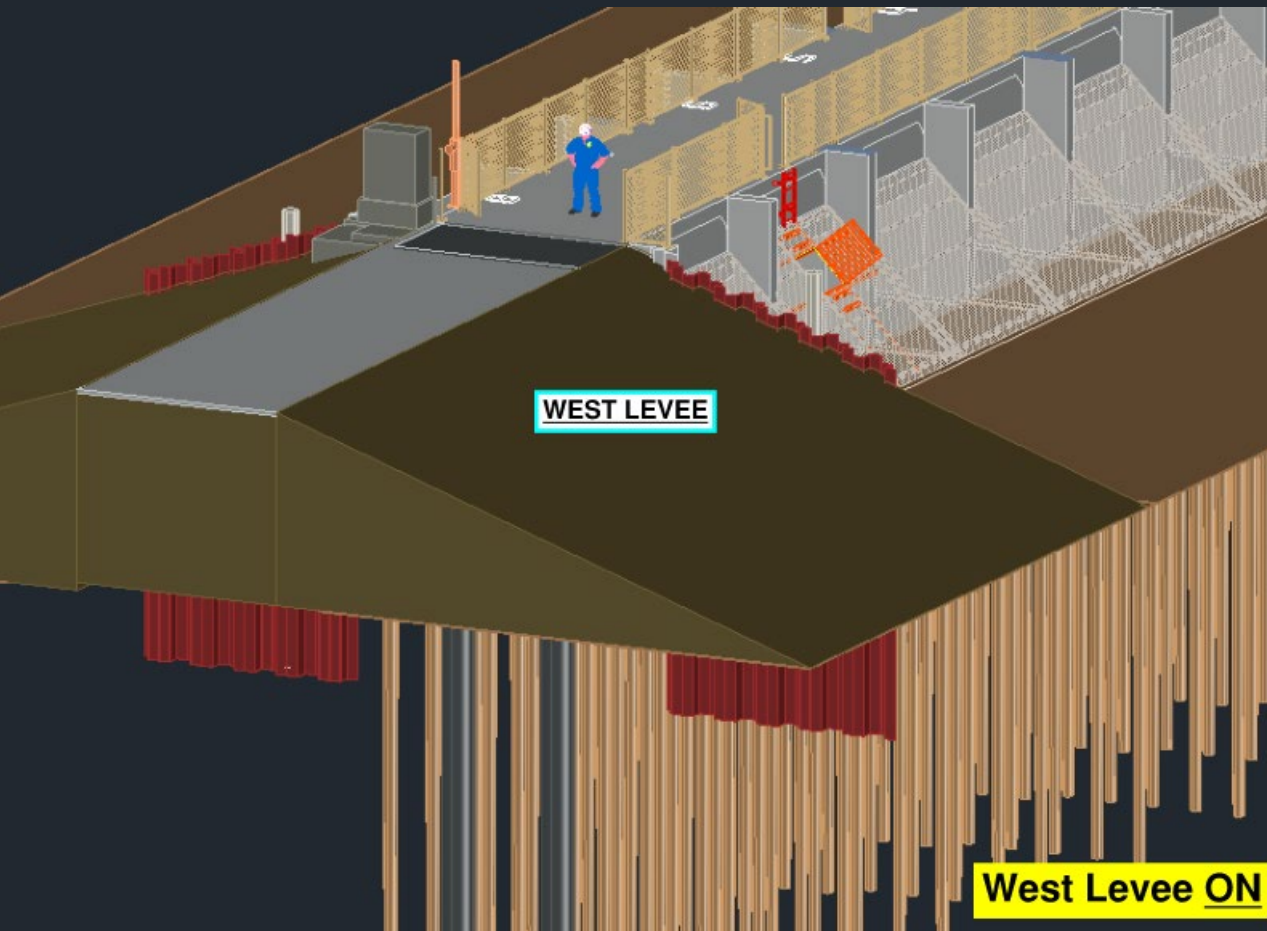
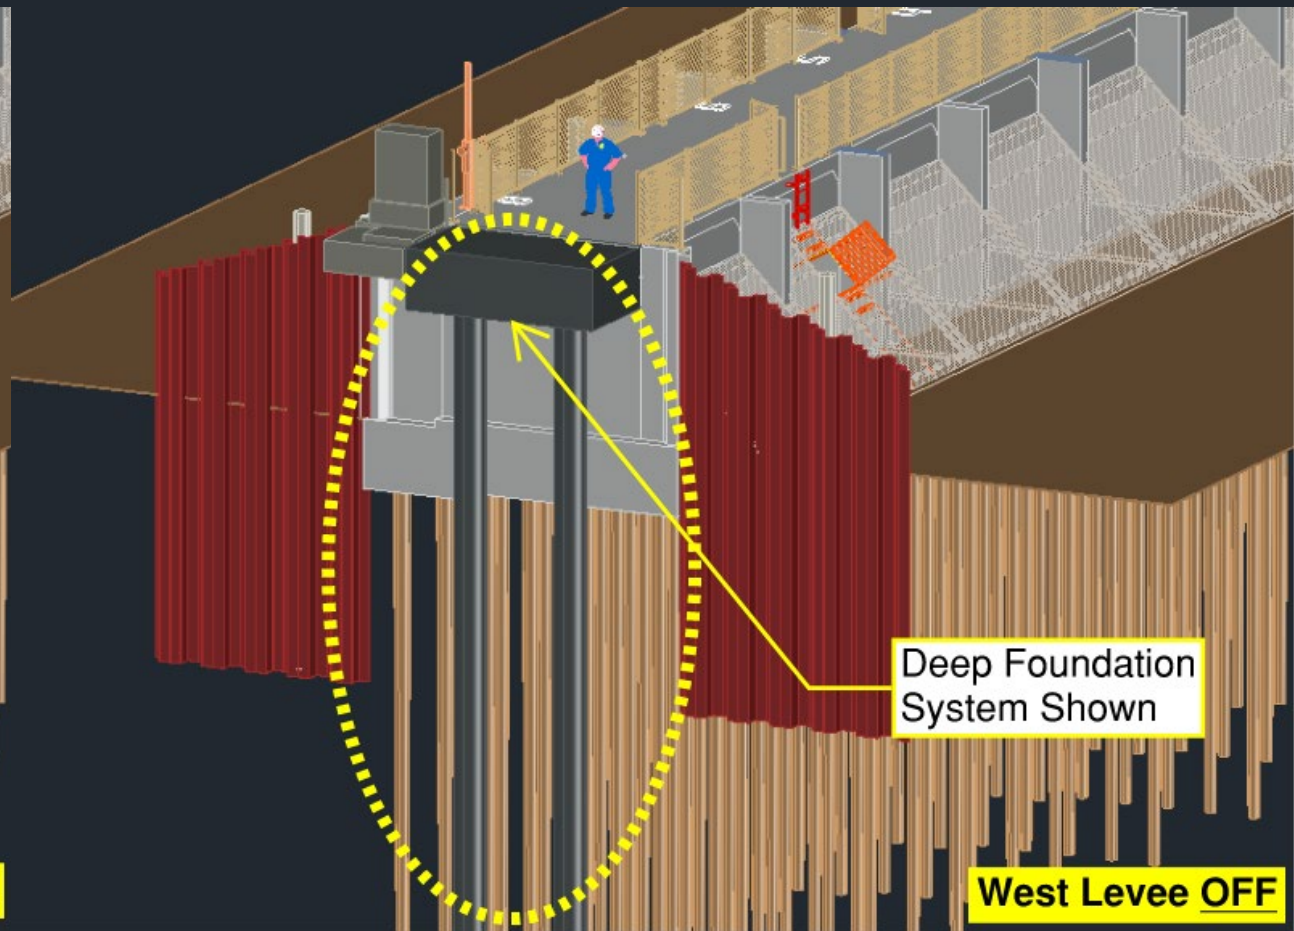
# WORK SCOPE: DEEP FOUNDATION

**CONCEPTUAL DESIGN:** These displays are intended to provide visualization of the design concepts. Final design may not be exactly as shown.

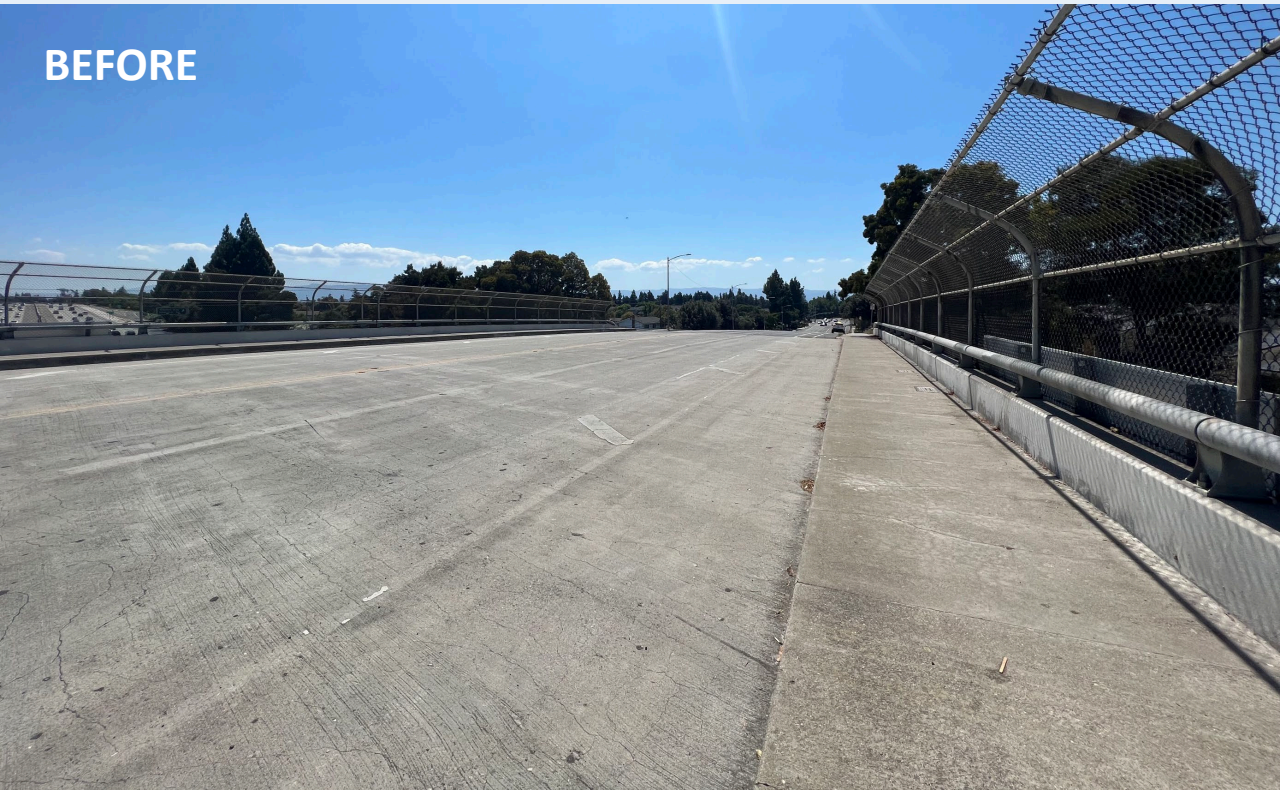
BEFORE

# POLYESTER POLYMER CONCRETE (PPC) OVERLAY

- Paving material, hardened polyester resin and aggregate
- Provide durable and improved surface

*Local example: Cropley Avenue overpass above Interstate 680*

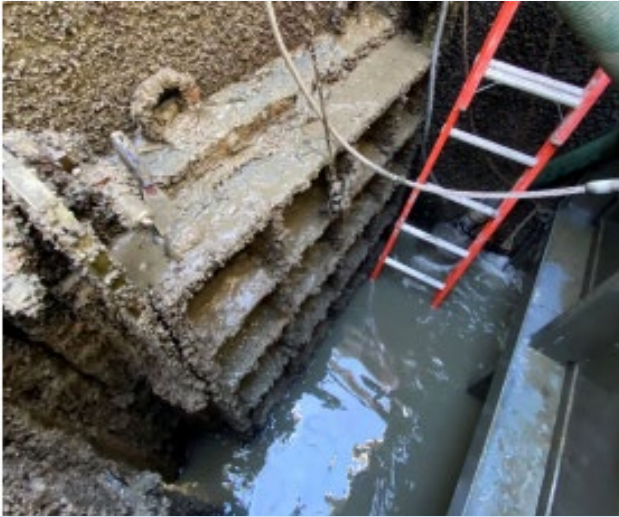
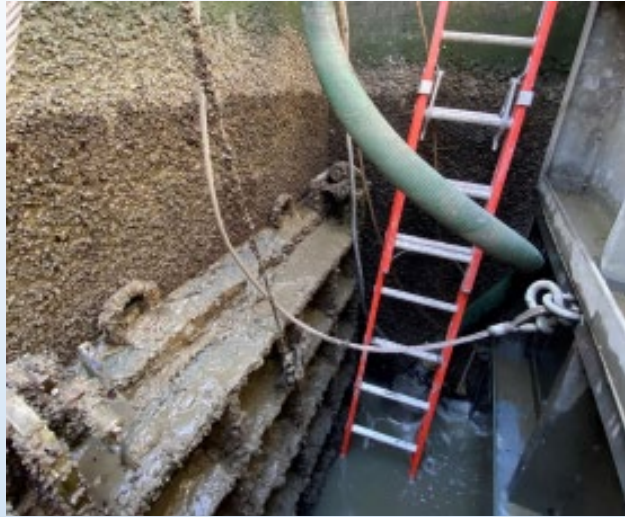
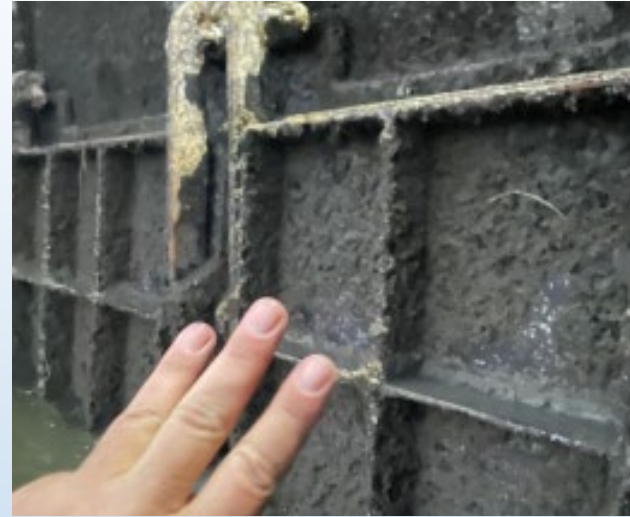
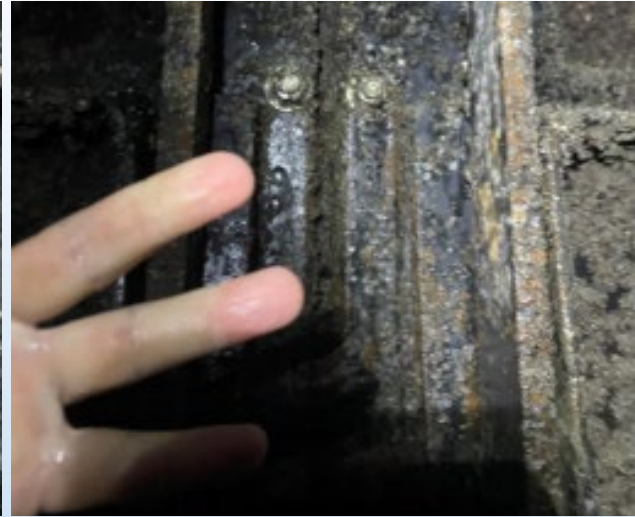
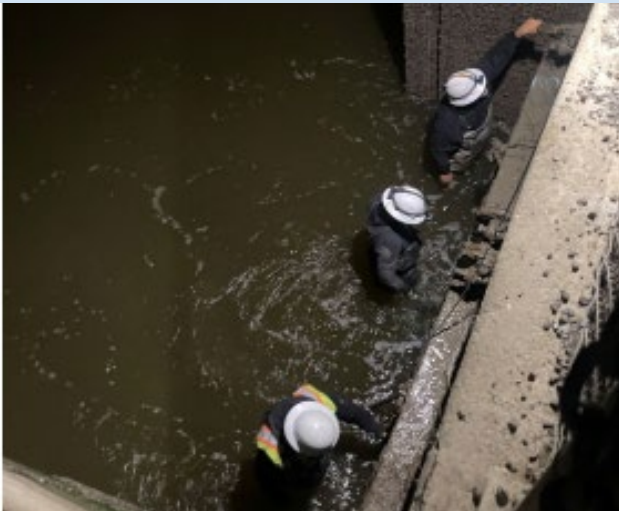
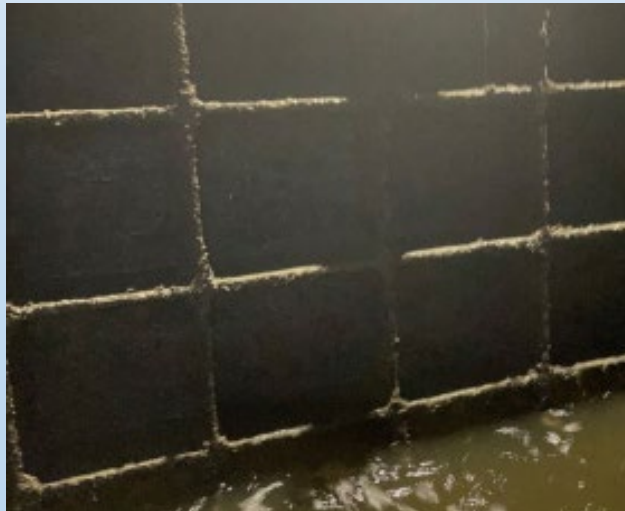
# WORK SCOPE: FLAP GATES REPLACEMENT

Existing conditions:

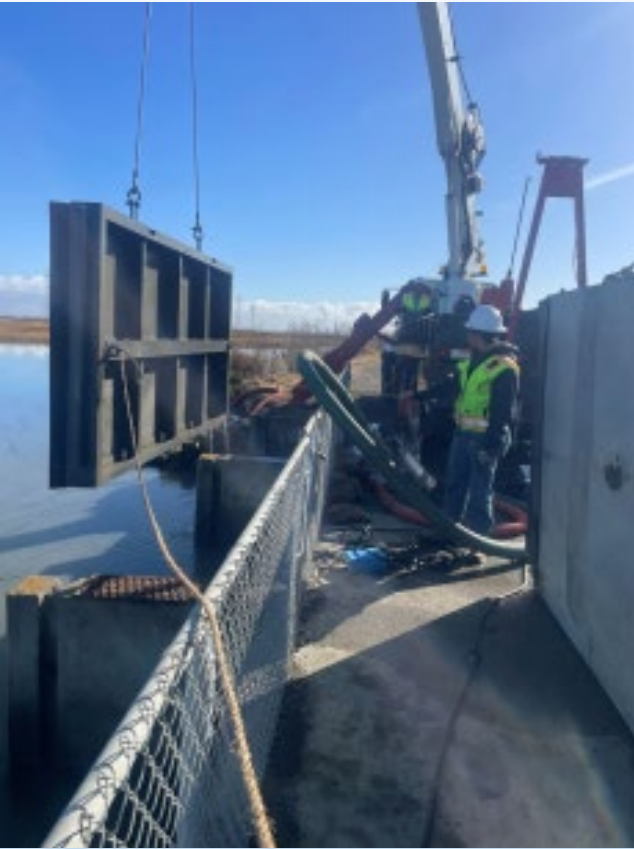
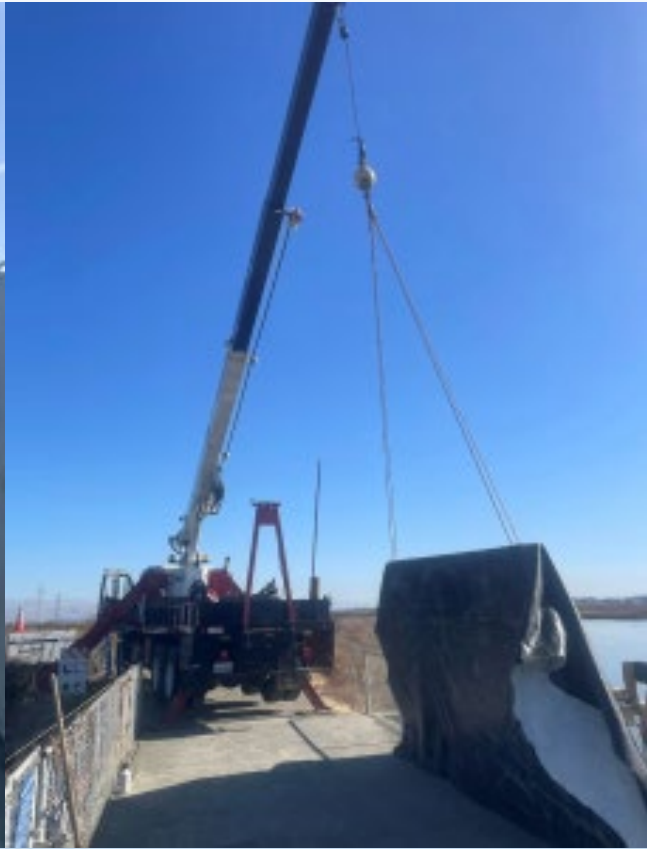
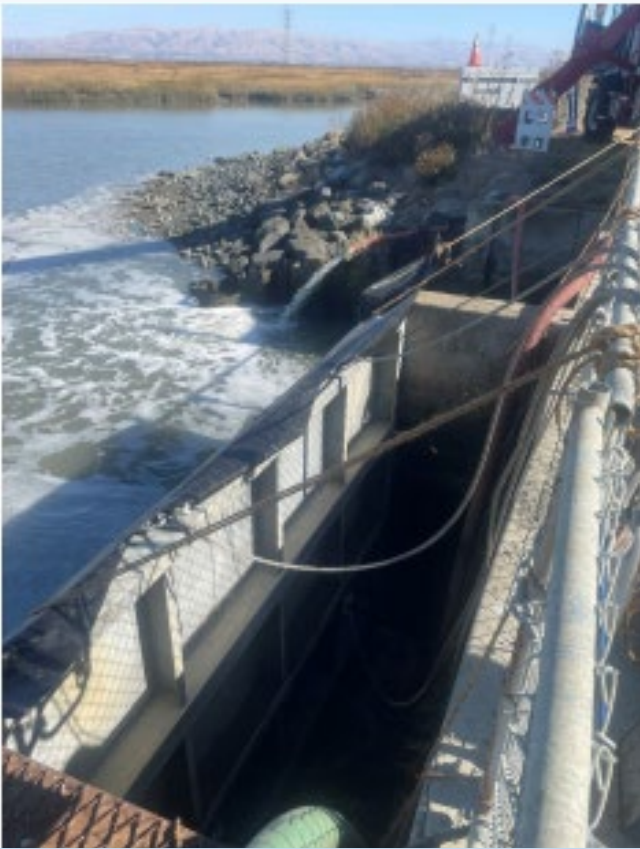
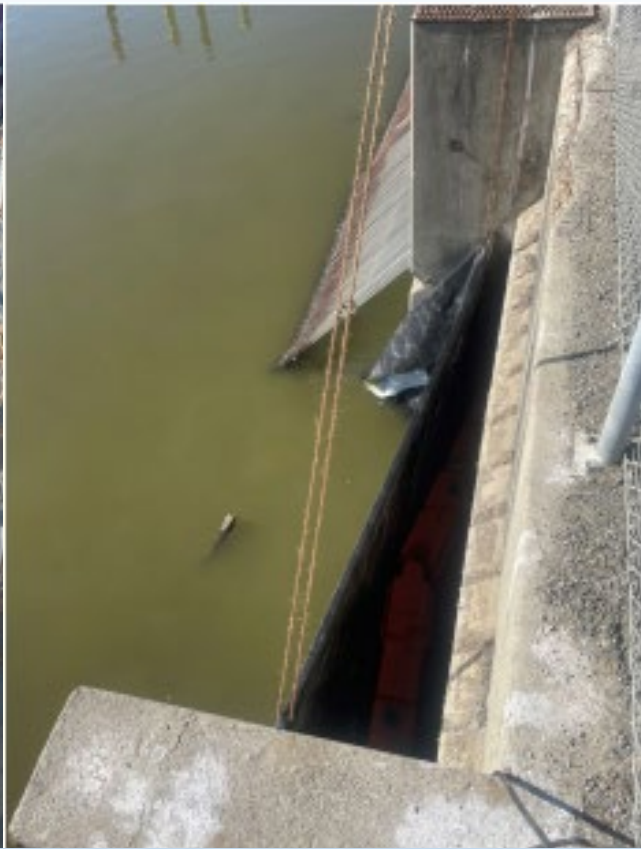
# WORK SCOPE: FLAP GATES REPLACEMENT

Examples:
