# FLOODING REPORT

SANTA CLARA COUNTY

*DECEMBER 2022 – MARCH 2023*

*Prepared by the Hydraulics, Hydrology, and Geomorphology Unit  
October 2023*

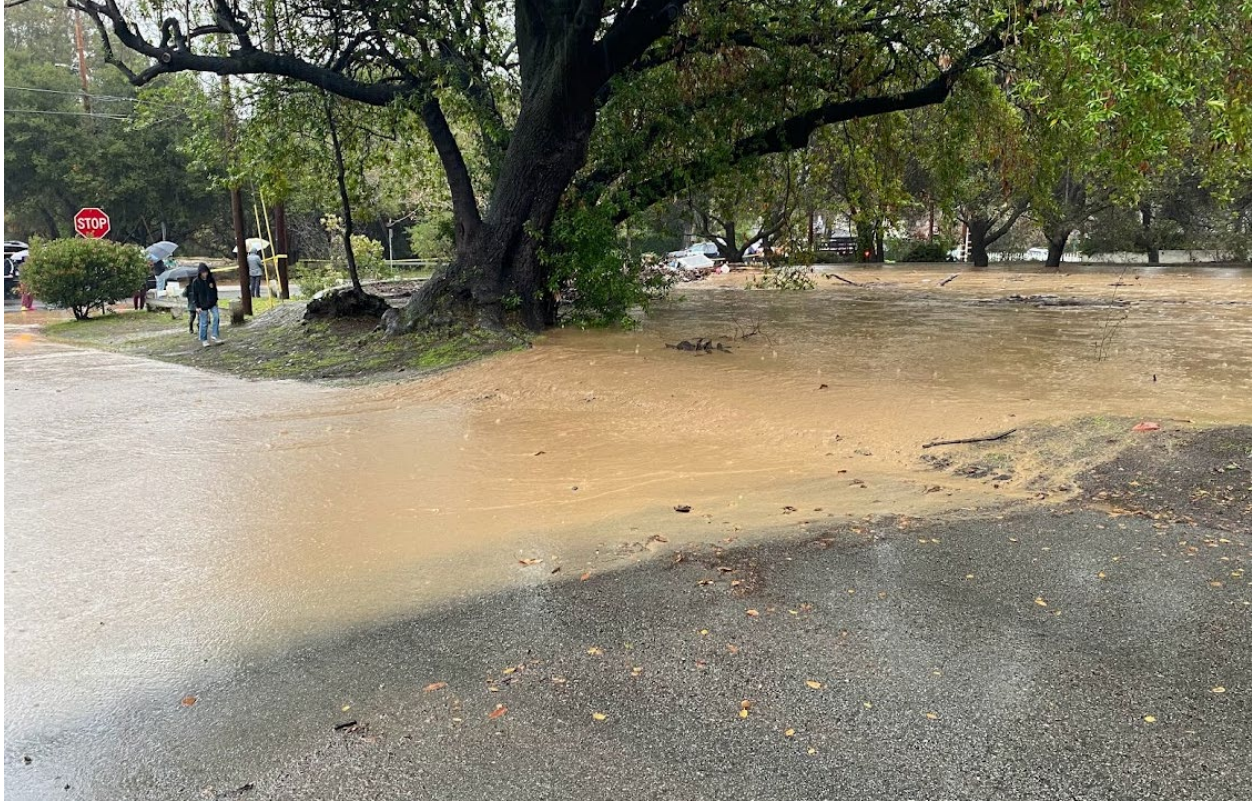
*Figure 6. Creek Overbanking Upstream of Pope Chaucer Bridge in Menlo Park*

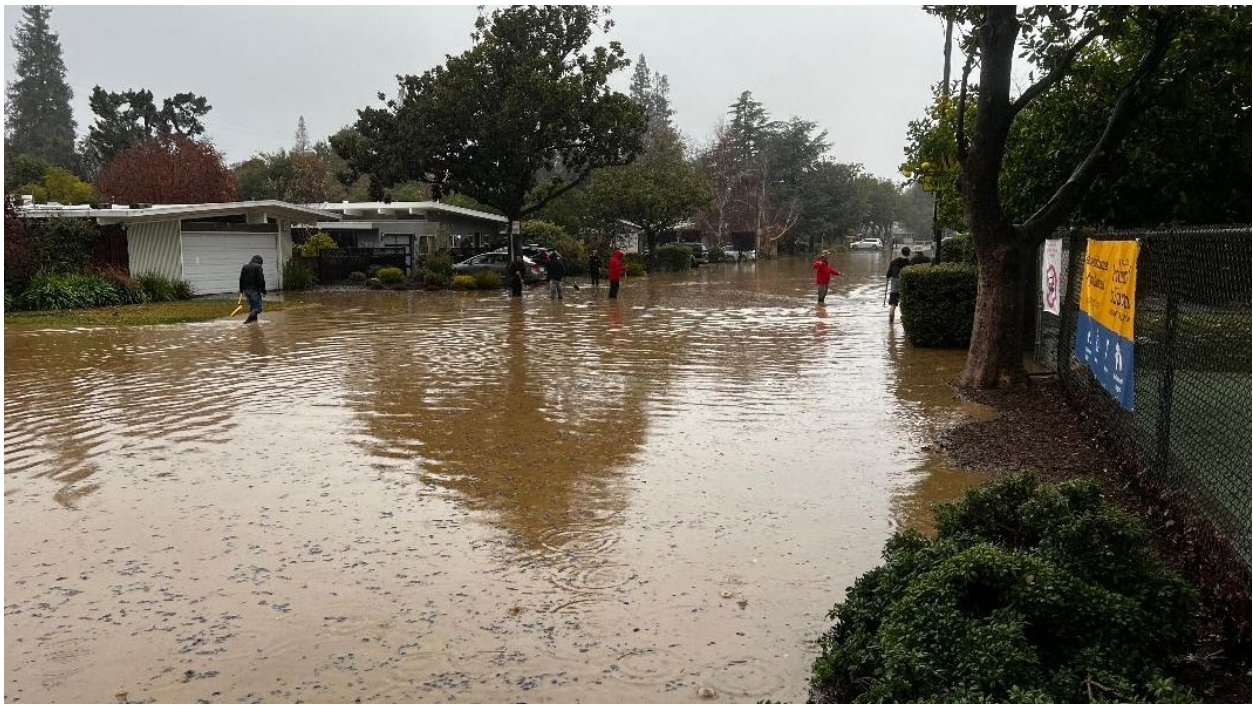
*Figure 7. Street Flooding from Creek Overbank near Duveneck Elementary School in Palo Alto*

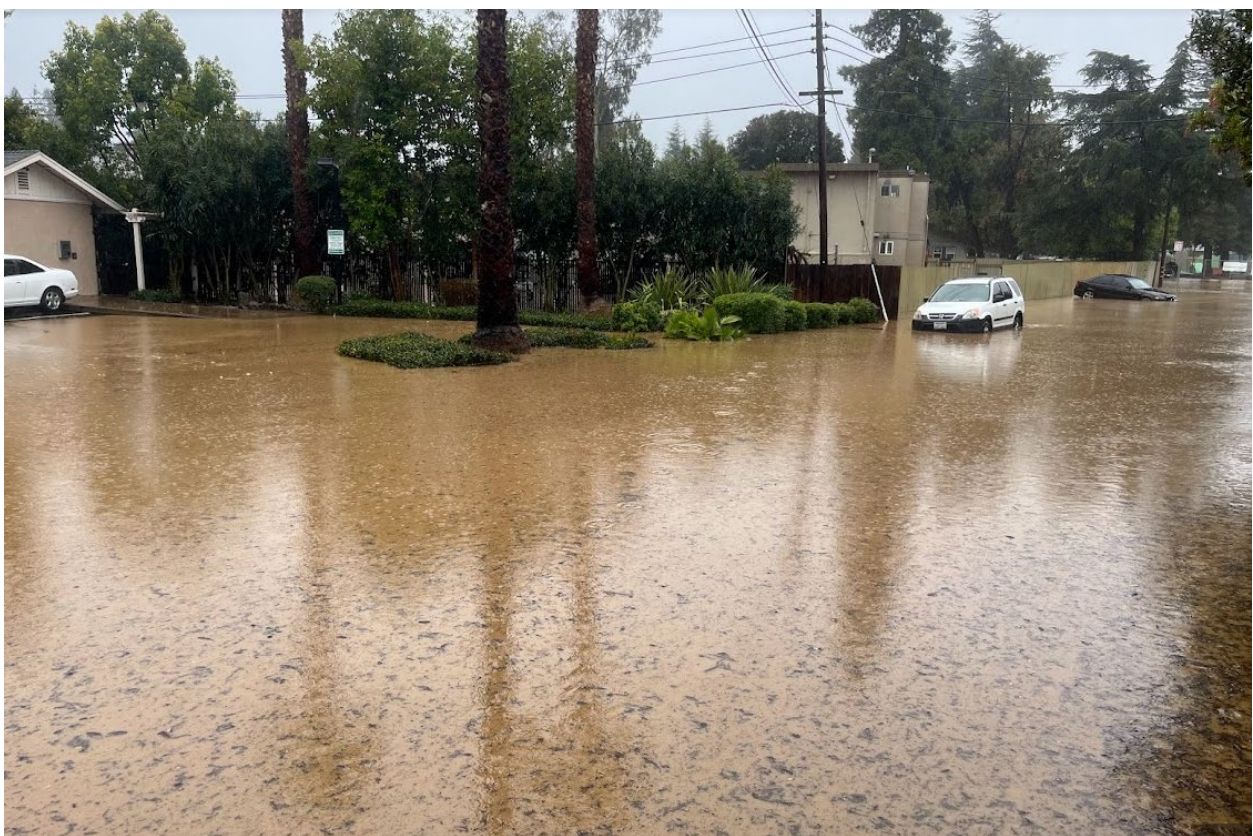
*Figure 8. Street Flooding from Creek Overbank in East Palo Alto*

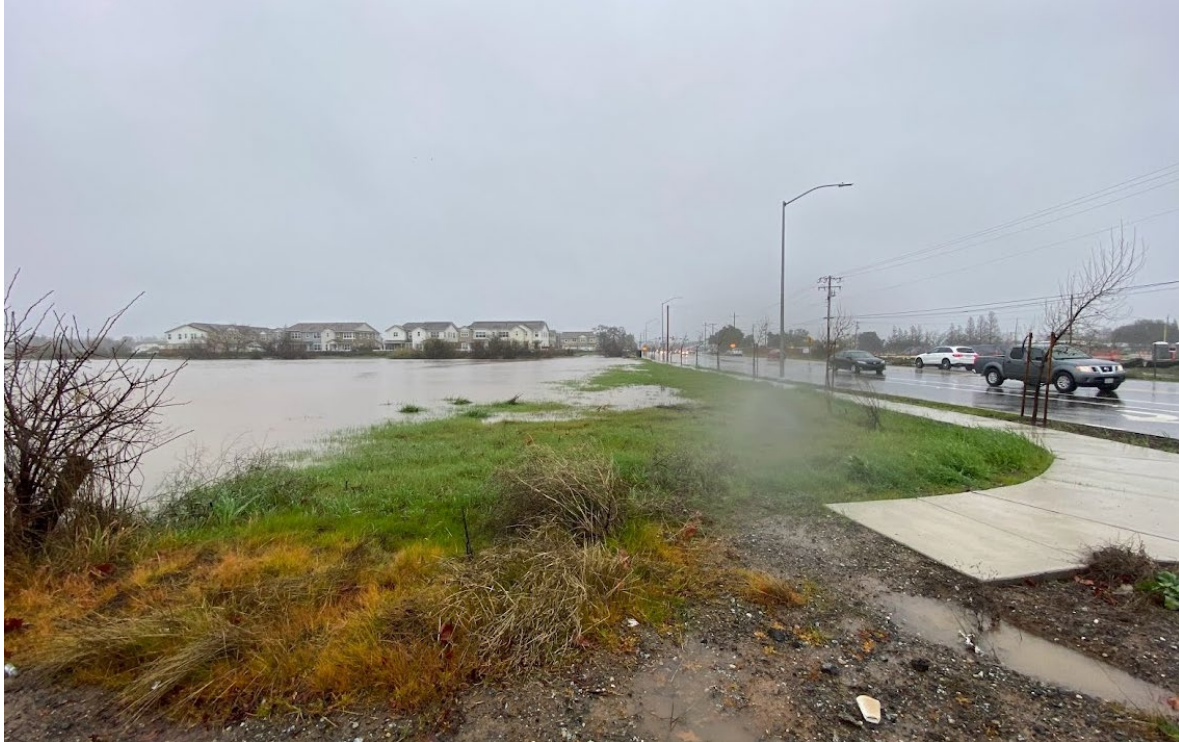
*Figure 11. West Little Llagas Creek Floodplain (12/31/22)*

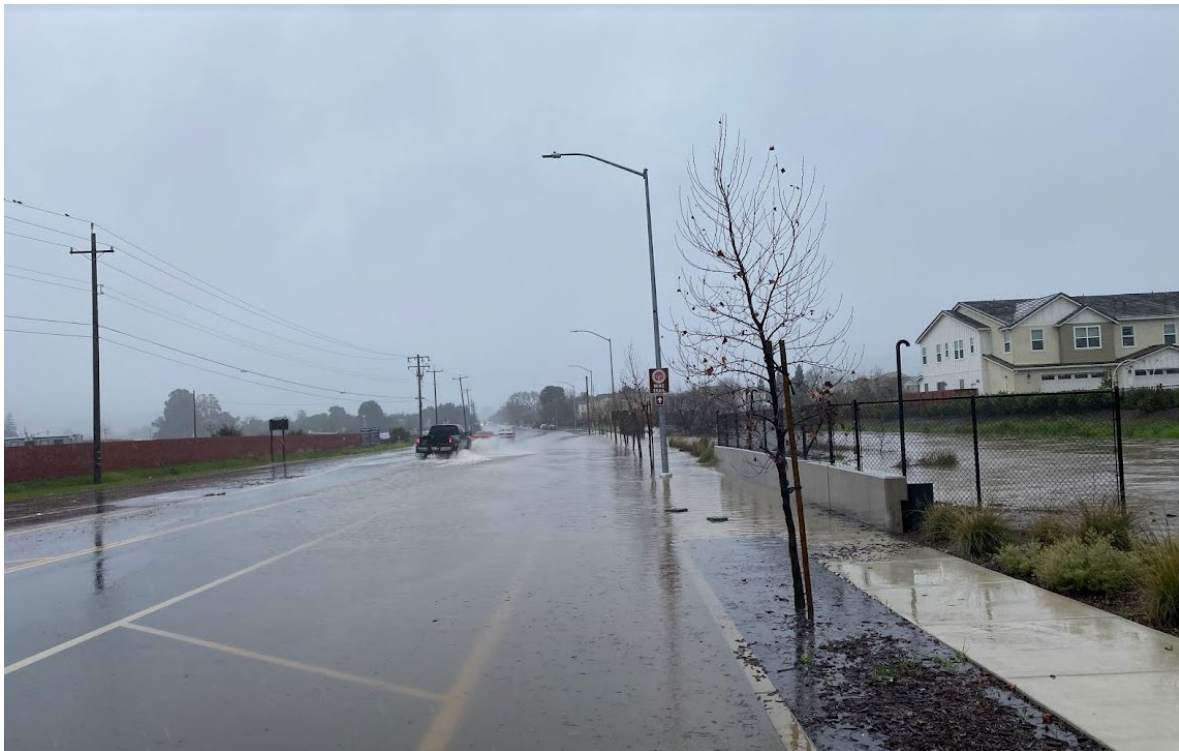
*Figure 12. West Little Llagas Creek Overtopping Watsonville Road (12/31/22)*

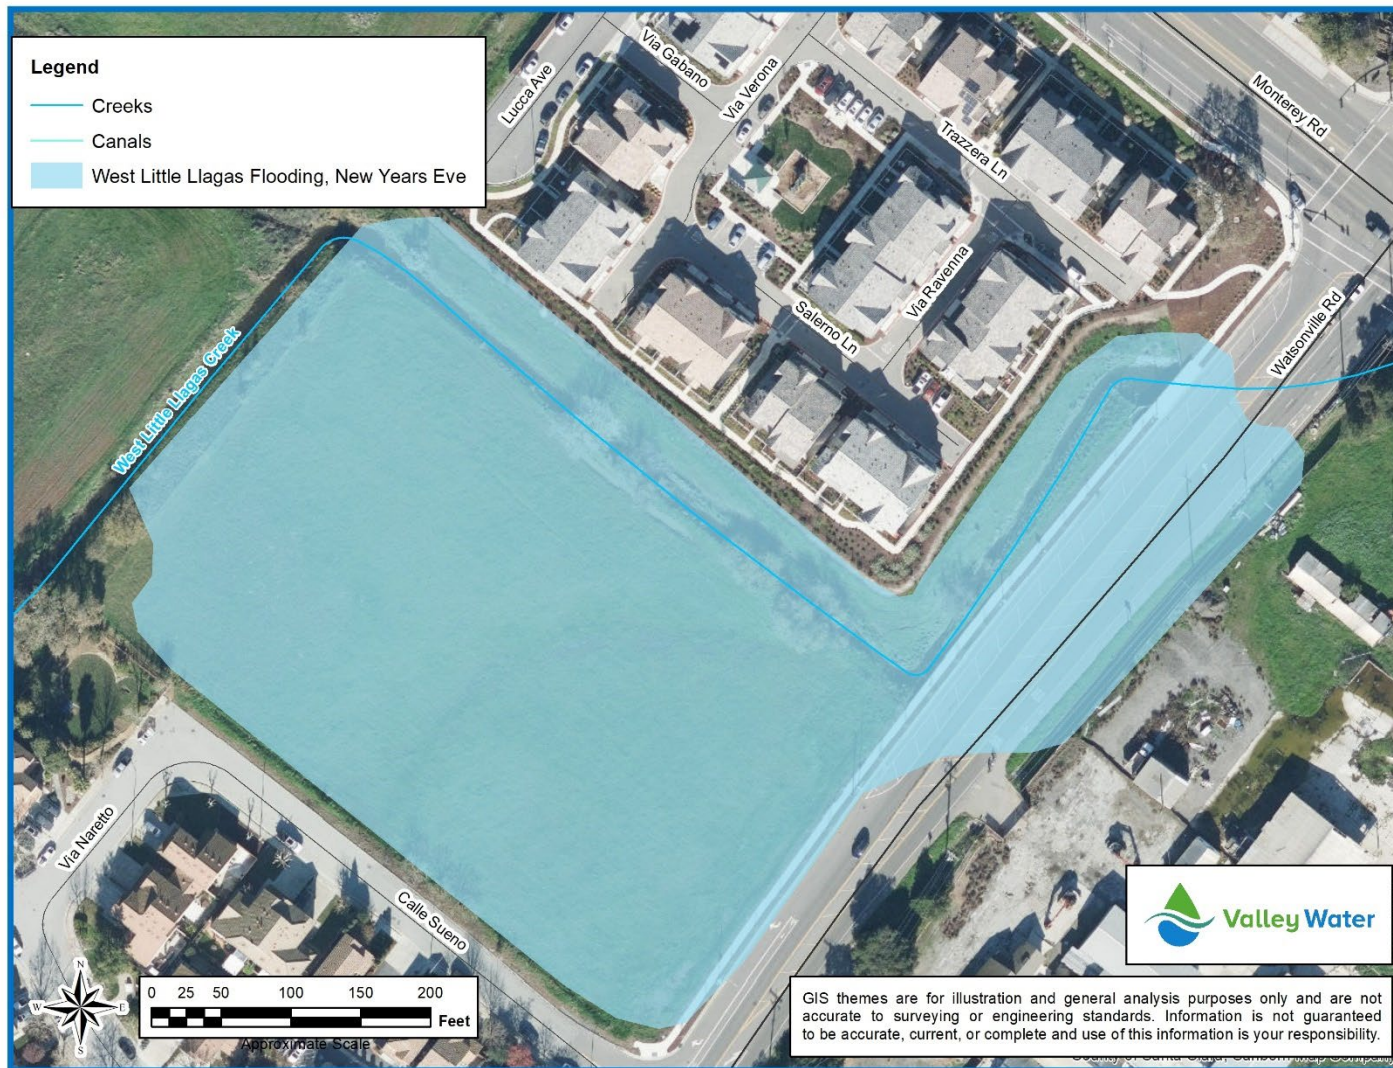
Figure 13. West Little Llagas Creek Flooding Extents (12/31/22-1/1/23)

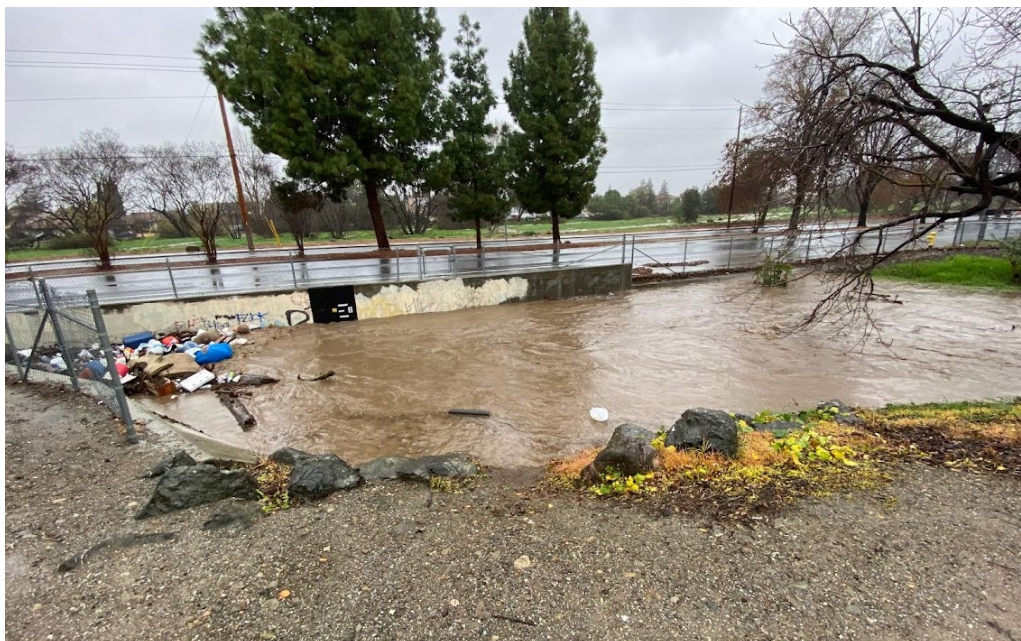
Figure 15. Upper Penitencia Creek at Mabury Road near Pine Hollow Circle (12/31/22)

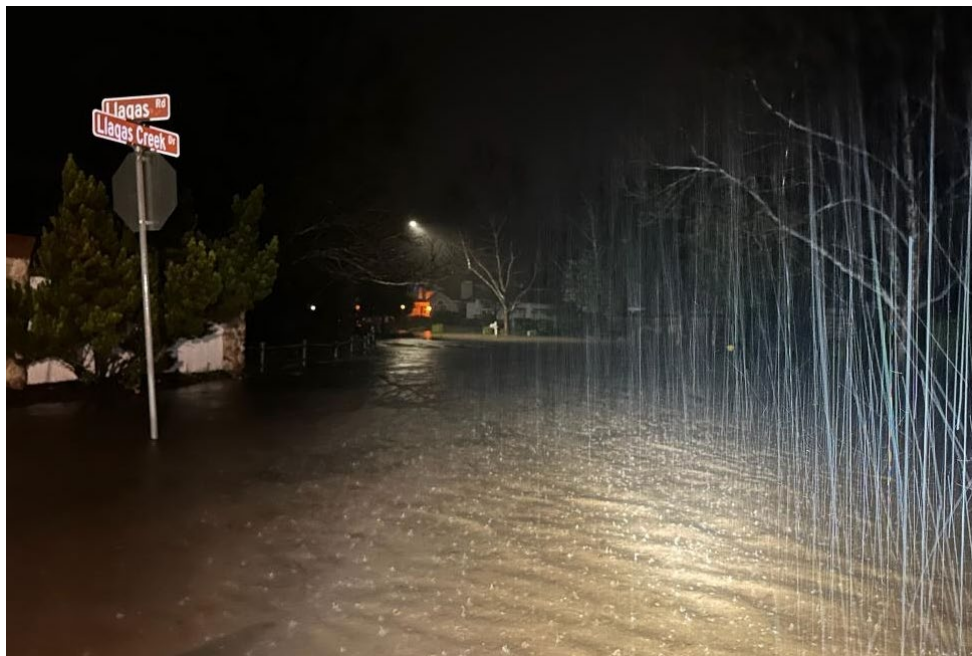
Figure 21. West Little Llagas Creek Overbanking at Llagas Road (1/9/23)

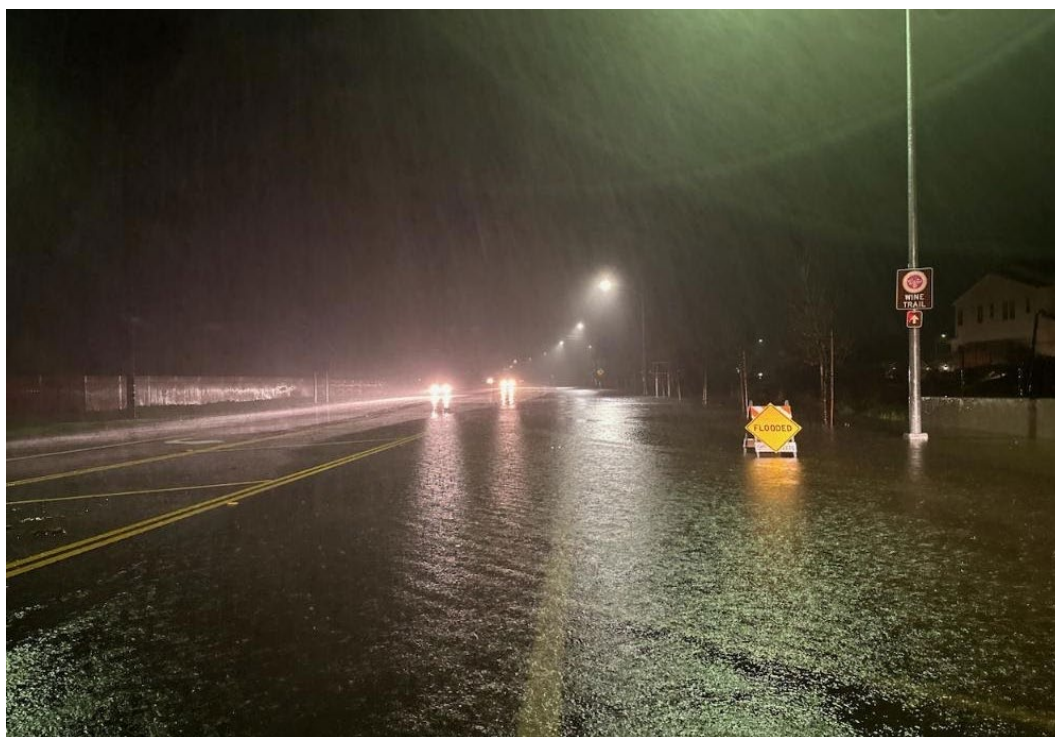
*Figure 23. West Little Llagas Creek Overbanking at Watsonville Road (1/9/23)*

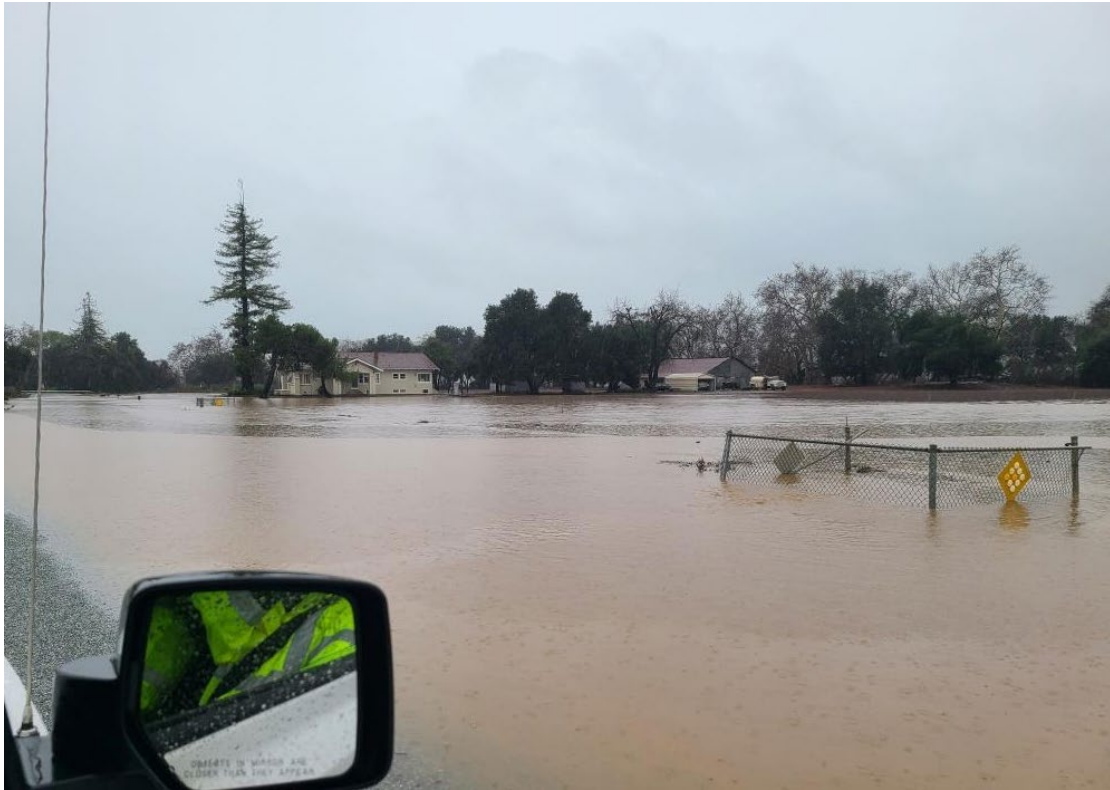
*Figure 28. Uvas Creek Overbanking Floodplain (1/9/23)*

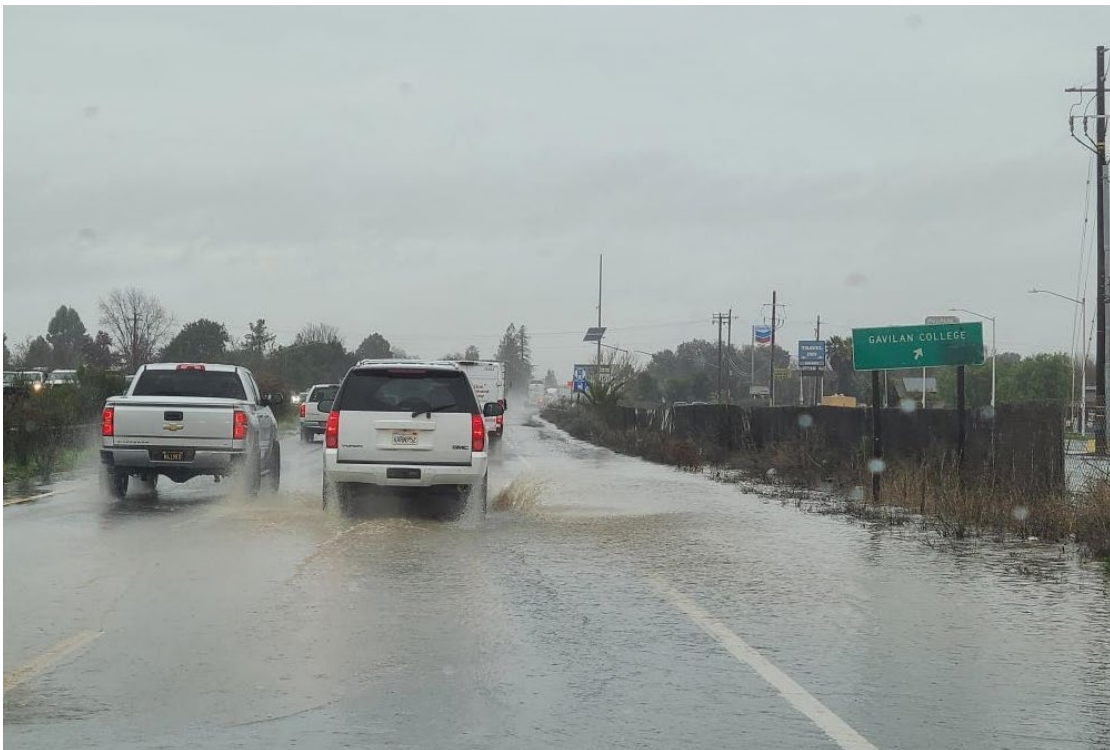
*Figure 29. Uvas Creek Overbanking Flooding US-101 (1/9/23)*

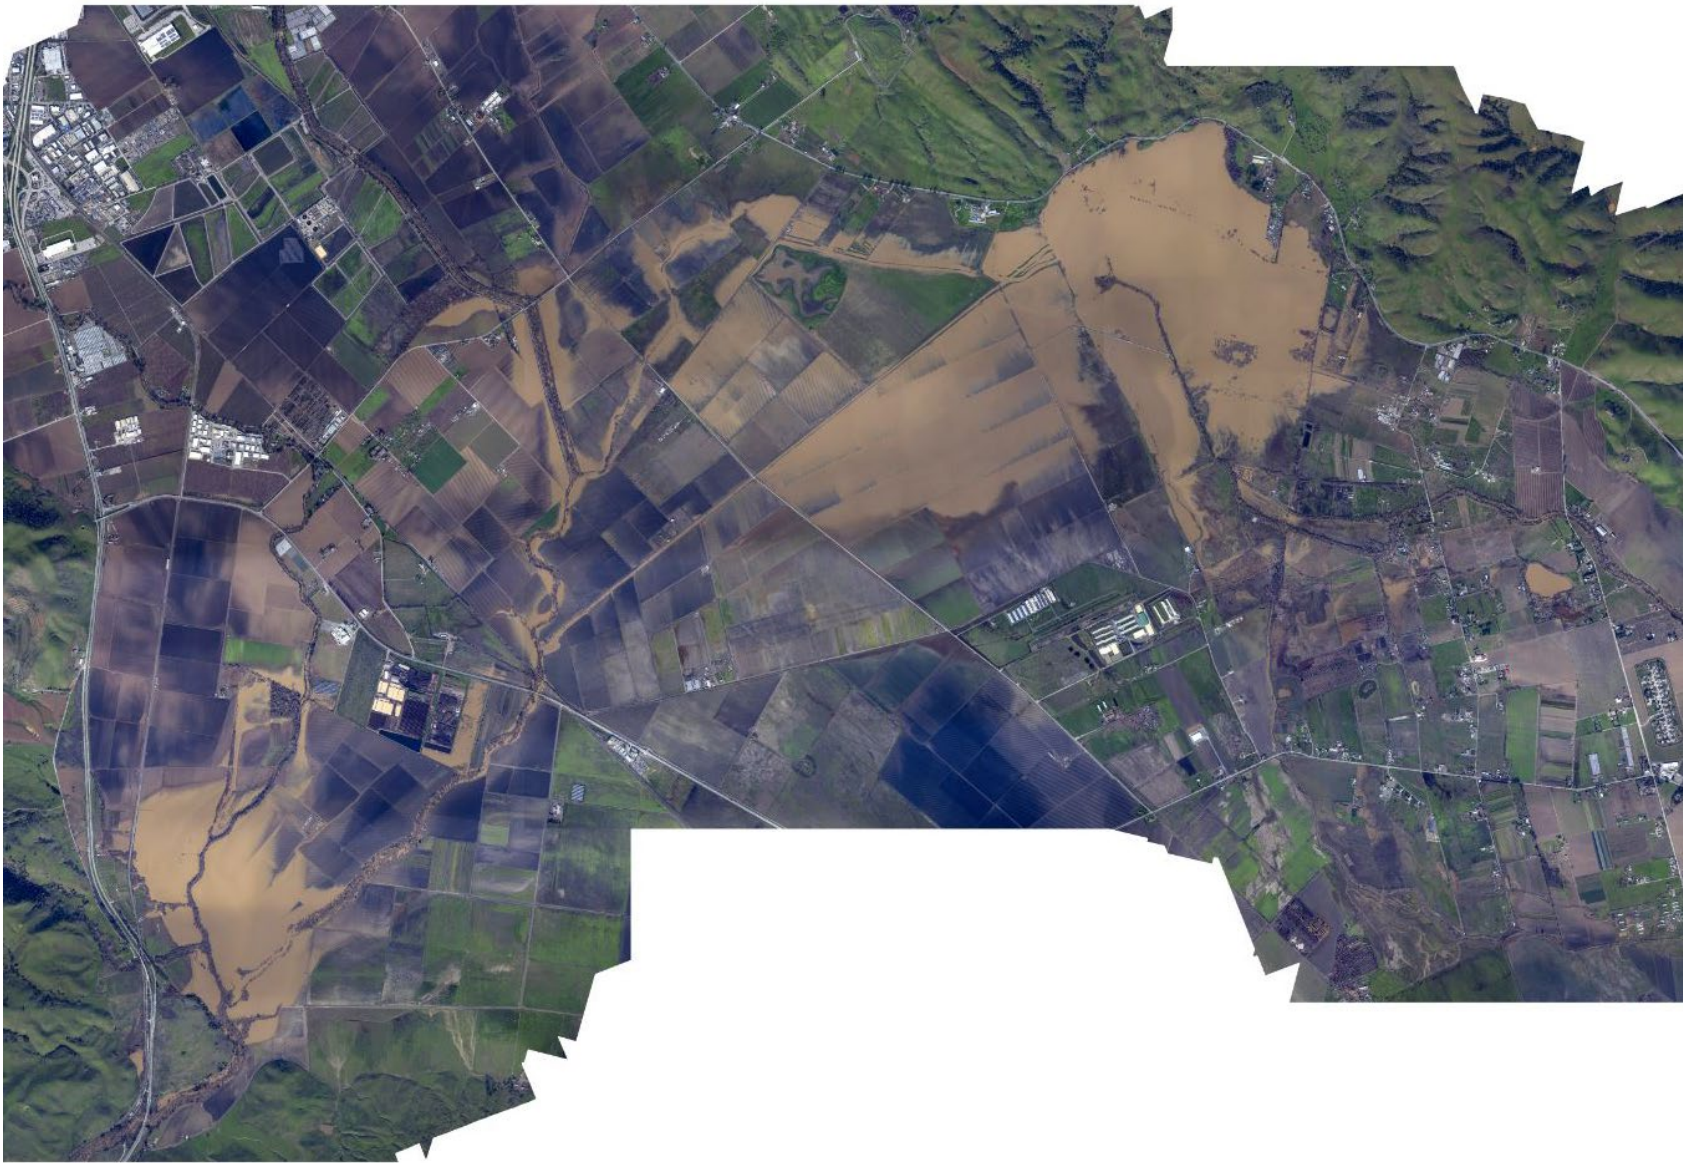
*Figure 30. Soap Lake Floodplain Aerial Photo (1/12/23)*

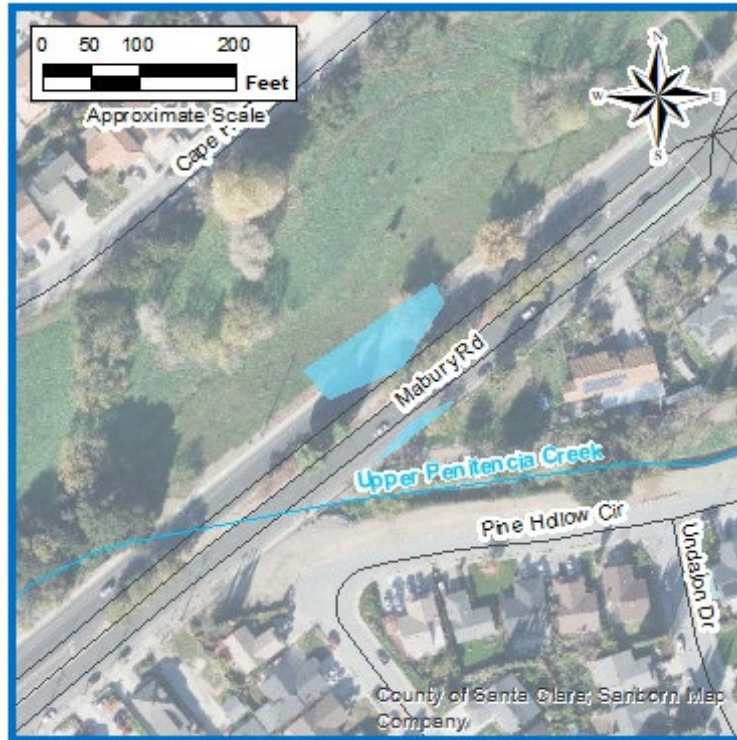
Figure 33. Upper Penitencia Creek Flooding Extents (1/9/23-1/10/23)

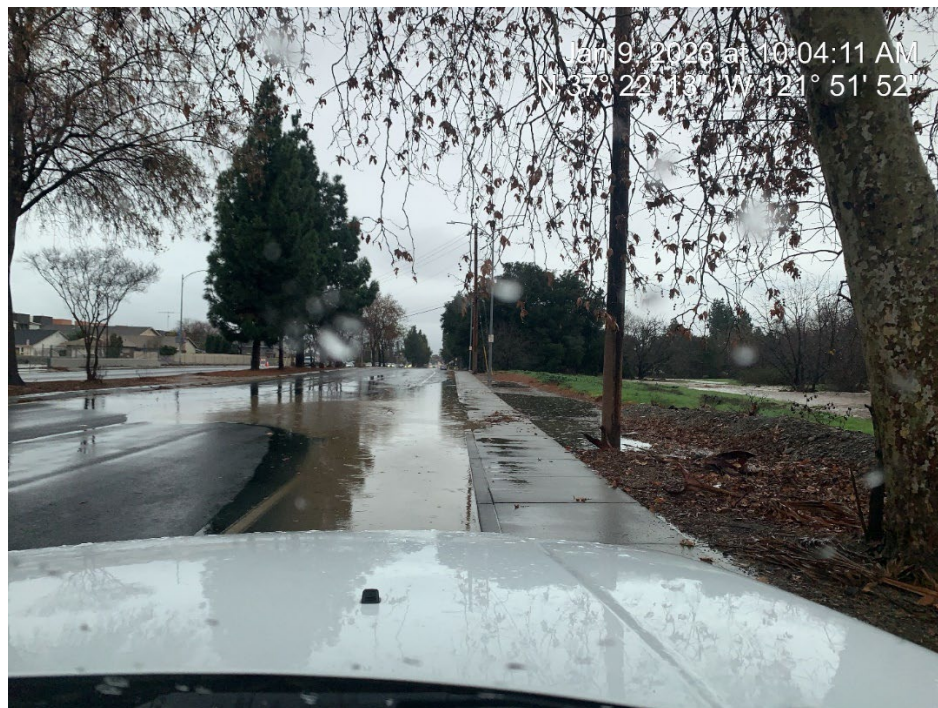
Figure 34. Upper Penitencia Creek flooding on Mabury Road (1/9/23)

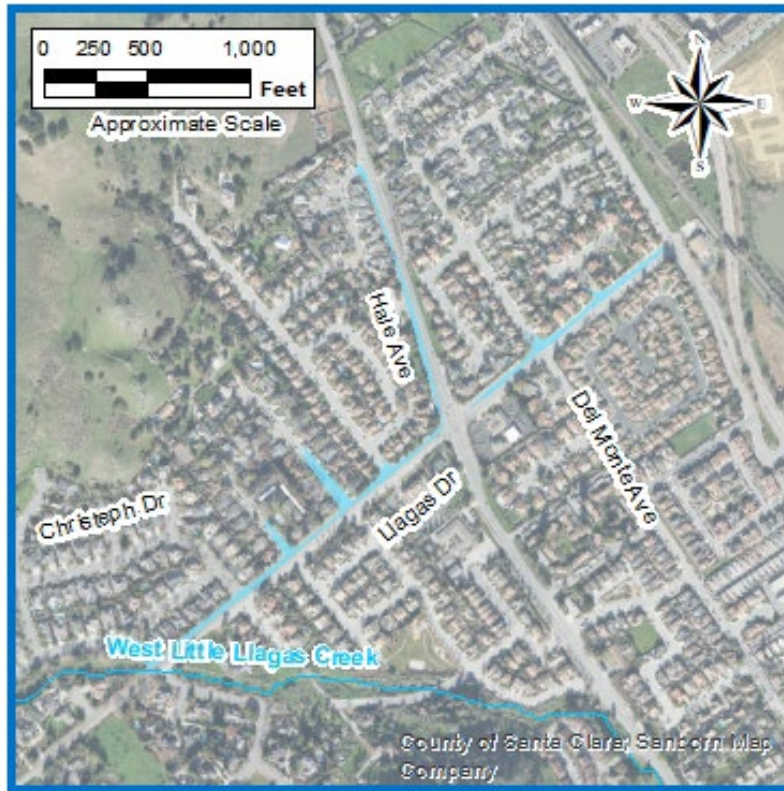
Figure 41. West Little Llagas Creek Flooding Extents near Llagas Dr and Hale Ave (1/14/23)

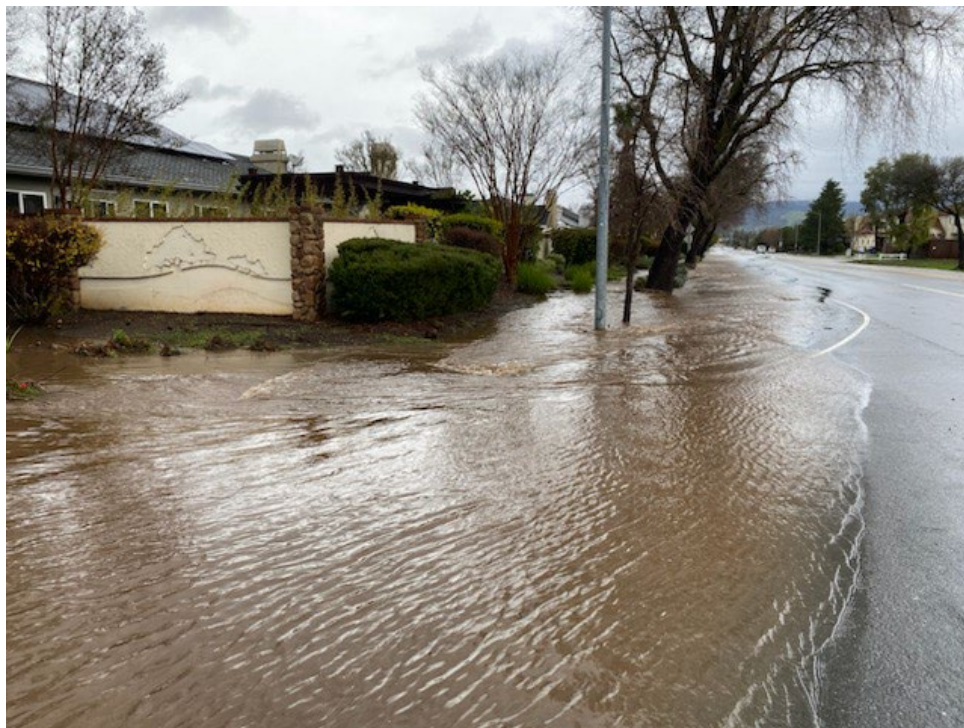
Figure 42. Flooding along Llagas Creek Dr and Llagas Rd, looking northeast along Llagas Rd (1/14/23)

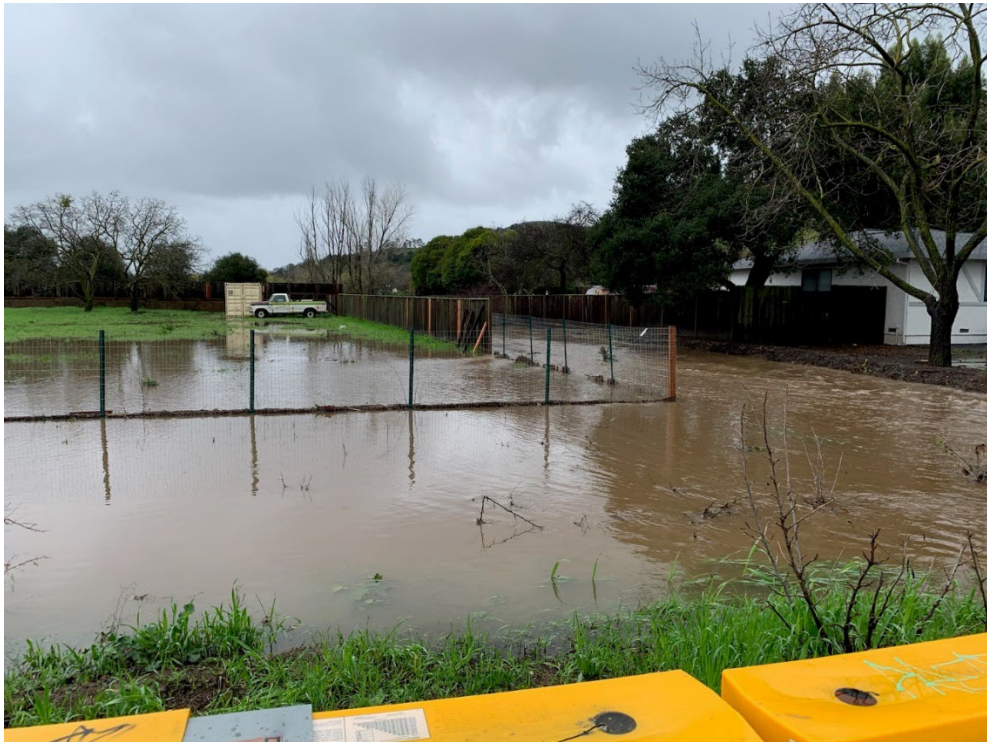
*Figure 44. Flooding at Fisher Creek downstream of Tilton Ave, looking south (1/14/23)*

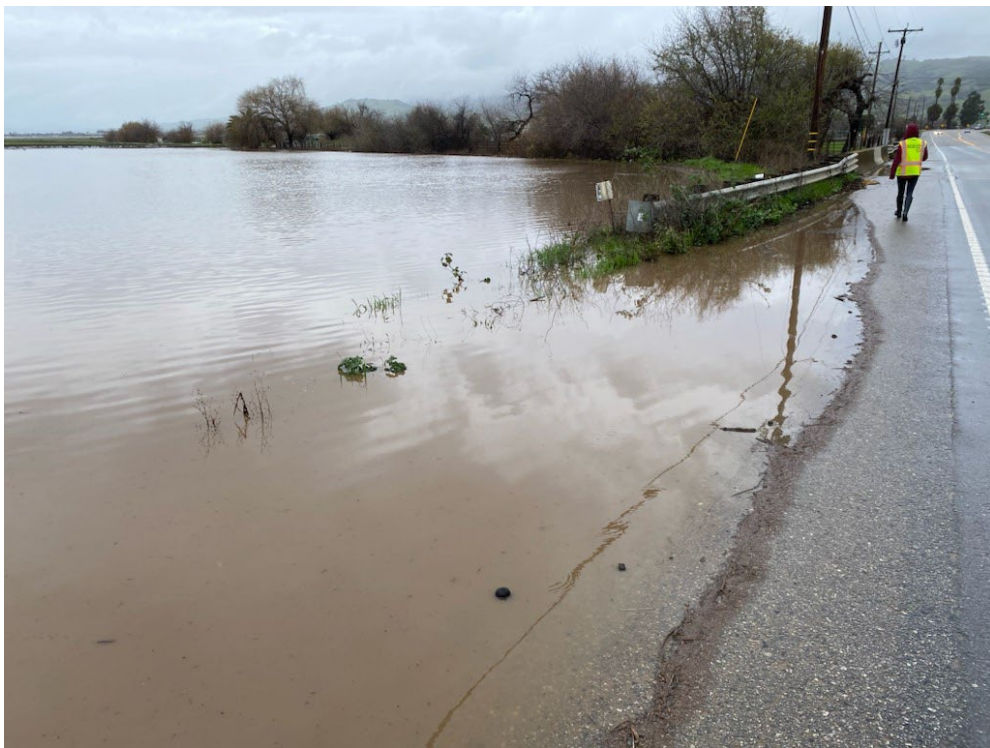
*Figure 45. Flooding from Jones Creek upstream of Pacheco Pass Hwy, looking east (1/14/23)*

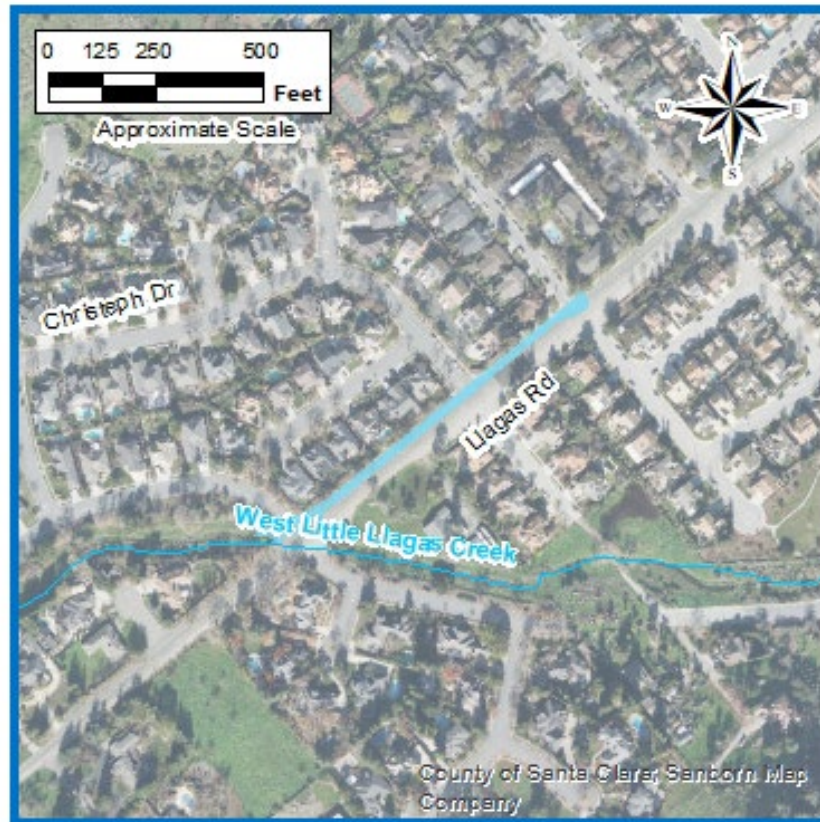
Figure 49. West Little Llagas Creek Flooding Extents near Llagas Rd (3/9/23-3/10/23)

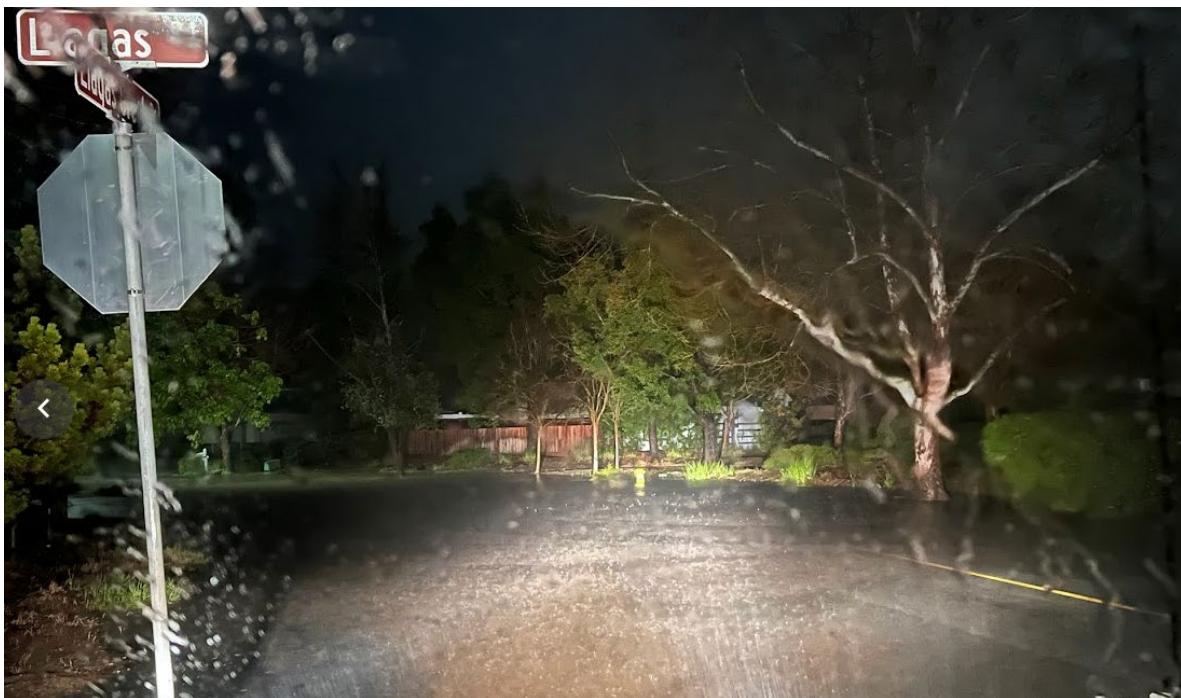
Figure 50. West Little Llagas Creek Flooding at Llagas Road (3/10/23)

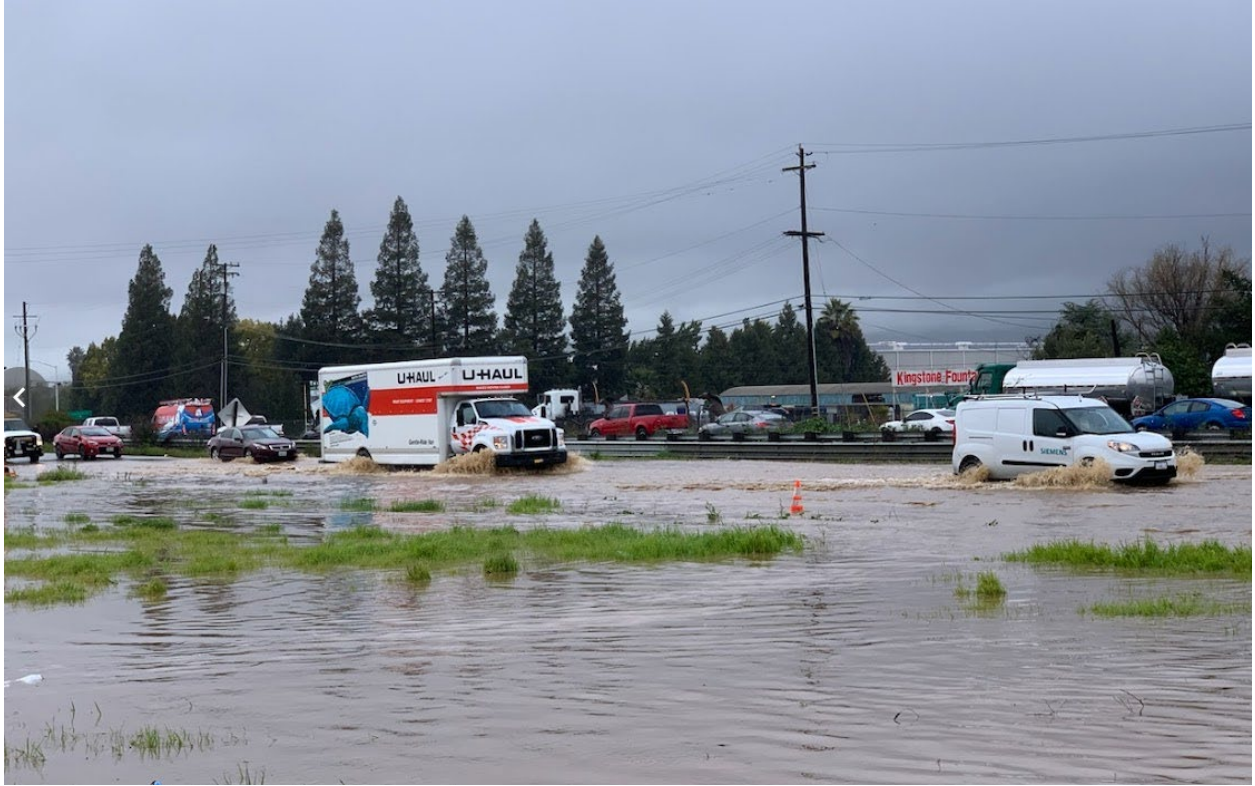
*Figure 53. Uvas Creek Overbanking onto US-101 (3/10/23)*

Flooding was widespread in the Soap Lake floodplain, similar to the January flooding. Uvas Reservoir was full for most of the calendar year and continued to spill through the event on March 9. Spills from Uvas Reservoir peaked around 5 am on March 10 and flows at Luchessa Avenue peaked about three hours later. Based on aerial imagery taken on March 10, Uvas Creek overtopped its banks at several locations and caused closure on US-101 for several hours.

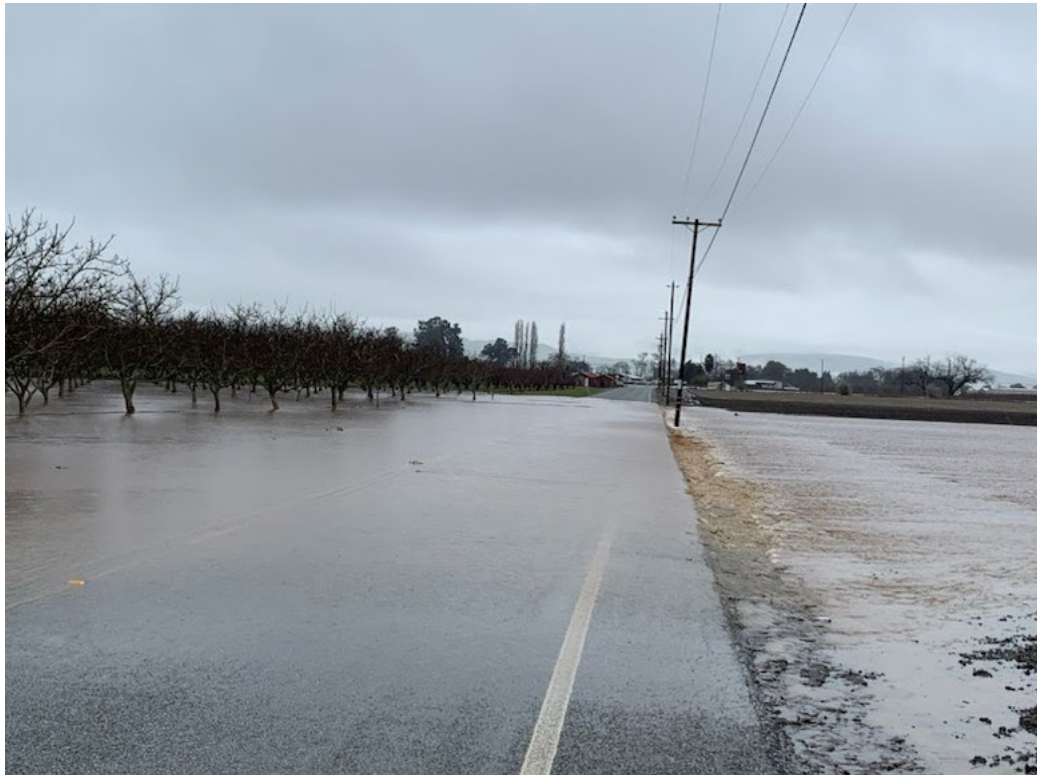
*Figure 54. Uvas Creek Overland Flow over Castro Valley Road (3/10/23)*

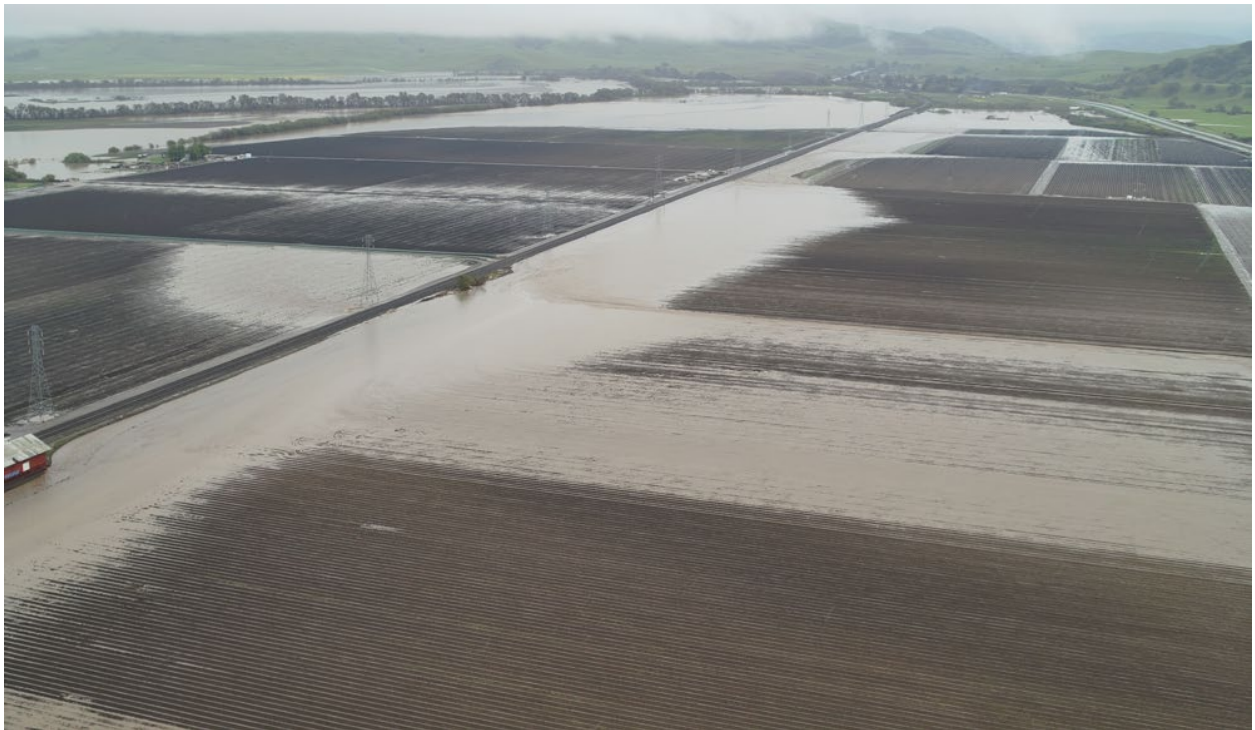
*Figure 56. Widespread Overland Flooding south (3/10/23)*

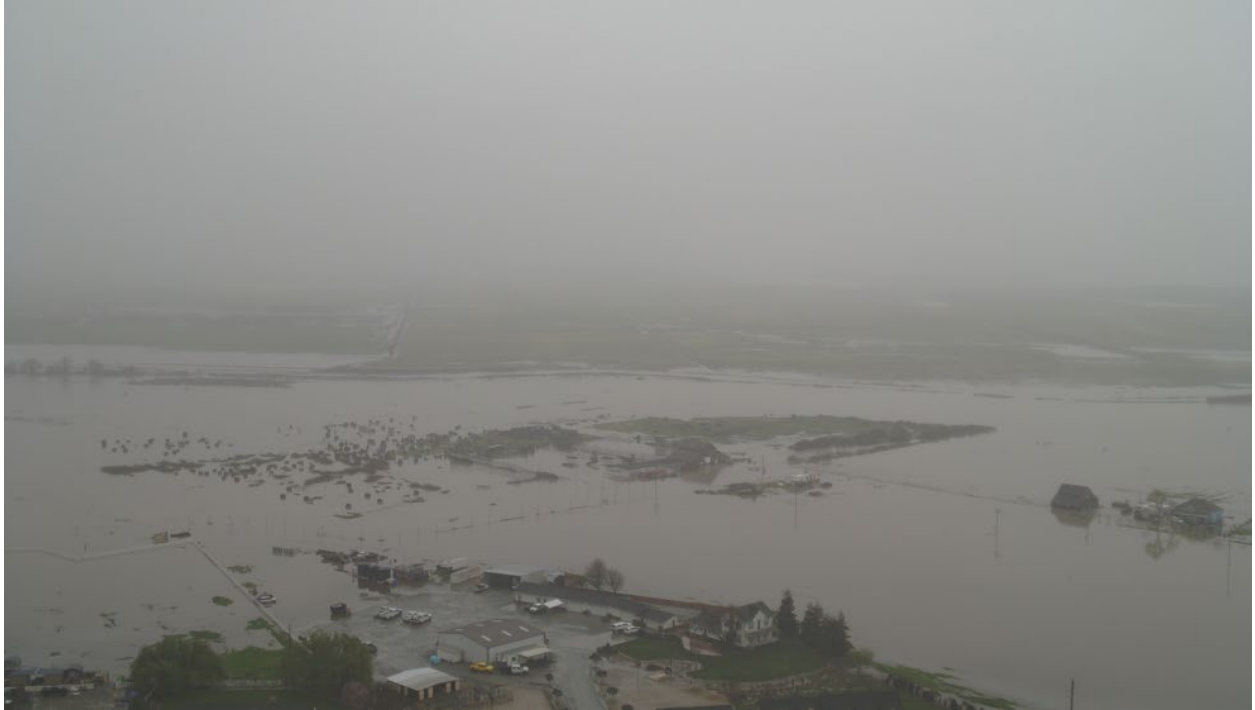
*Figure 57. Widespread Overland Flooding near Dunneville (3/10/23)*

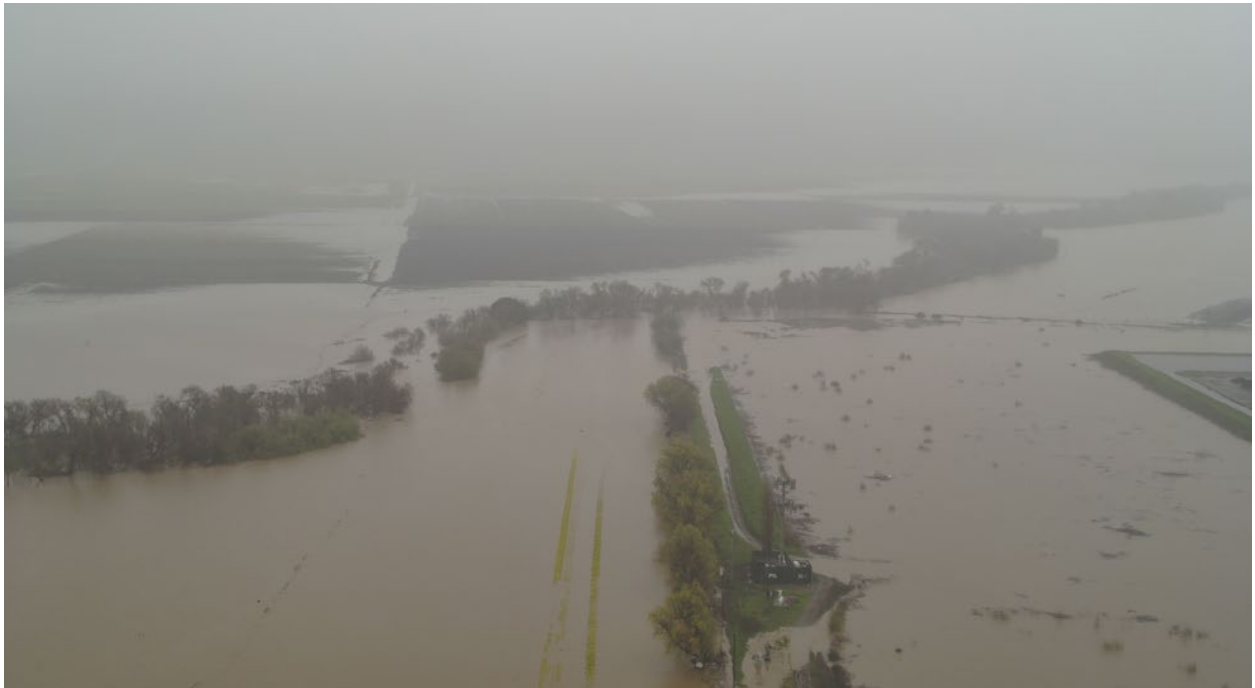
*Figure 58. Widespread Overland Flooding on Llagas Creek in Soap Lake US-101 (3/10/23)*
