# Coyote Percolation Dam History Booklet

This documentation, and related signage installed near the site of the Coyote Percolation Dam, was prepared in 2024 by Rincon Consultants, Inc. to support mitigation measures for the Coyote Percolation Dam Replacement Project per Stipulation III.B of the Programmatic Agreement between the Federal Energy Regulatory Commission and the California State Historic Preservation Officer Regarding Activities Associated with the Anderson Dam at the Anderson Dam Hydroelectric Project (FERC Project No. 5737-007) Santa Clara County, California executed in 2020.

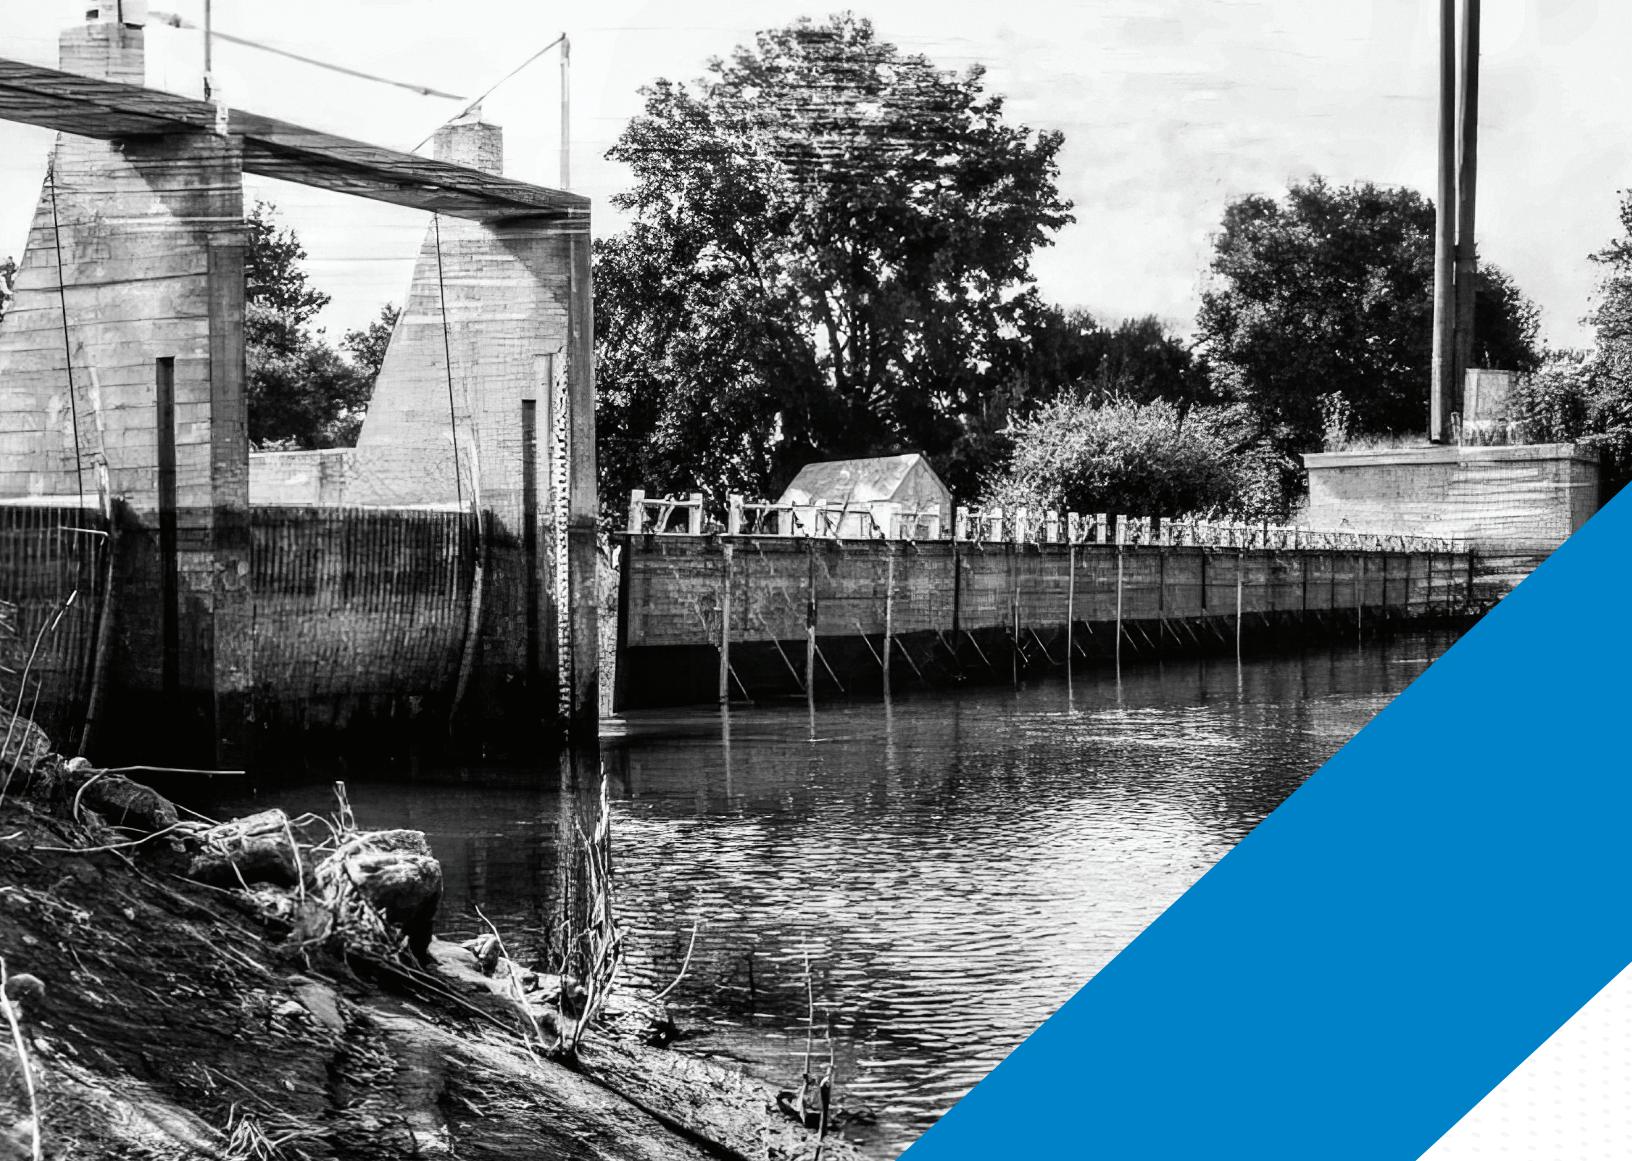
#### *Cover Image:*

Downstream side of Coyote Percolation Dam, July 14, 1965. L.D. Wilson Photographer (photograph from Valley Water's archives).

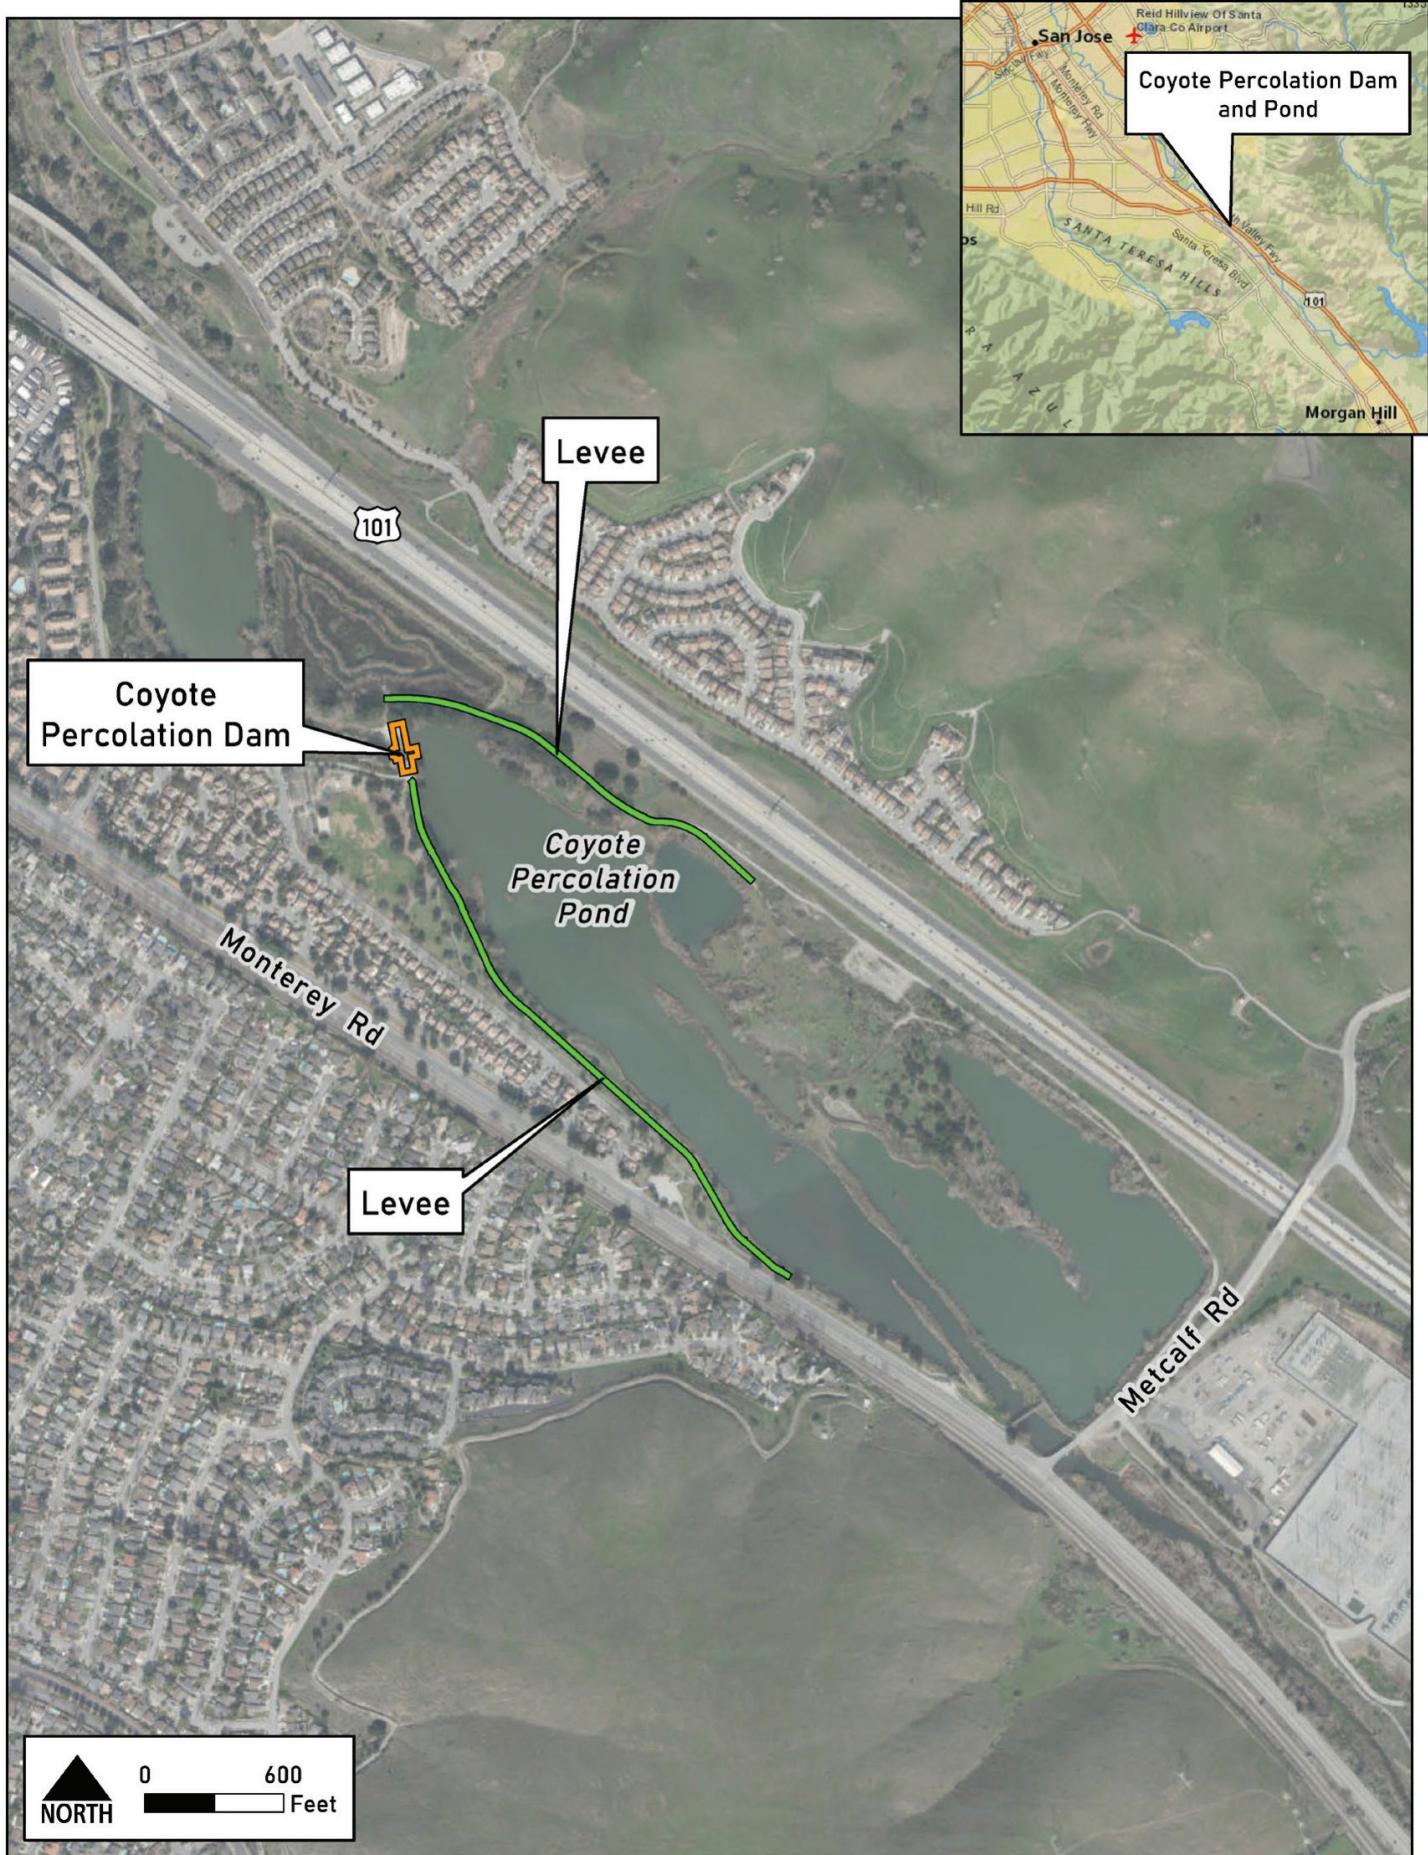
**Figure 1.** The Coyote Percolation Dam is located 11 miles downstream of Anderson Dam and is used by Valley Water to impound water within the 32-acre Coyote Percolation Pond for the purpose of groundwater recharge.

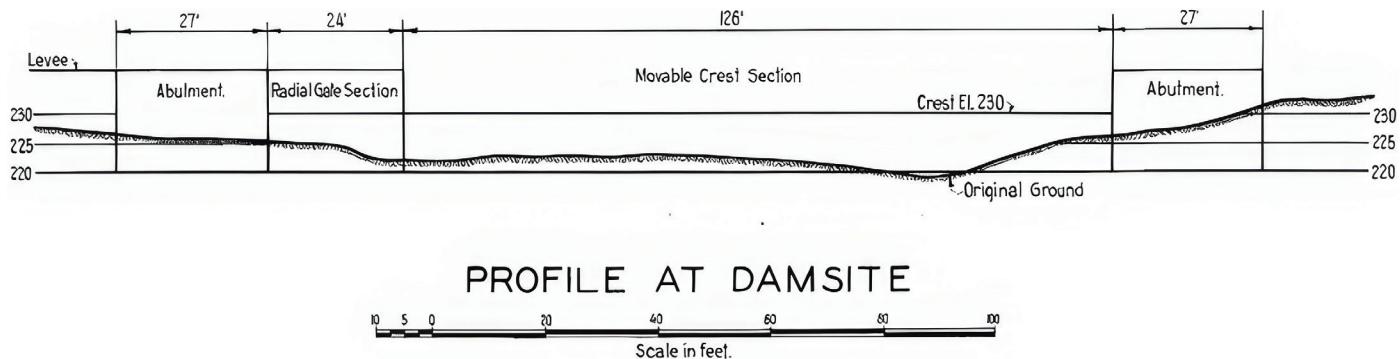
*Figure 2.* Engineer's drawing of Coyote Percolation Dam's site profile showing a levee, abutments, and the movable crest section, where the dam's flashboard would be positioned for water flow control. Fred H. Tibbetts, Santa Clara Valley Water Conservation District: Coyote Percolation Reservoir to Accompany Water Right Application, File No. 2023-84, May 1935 (on file at Valley Water's Archives).

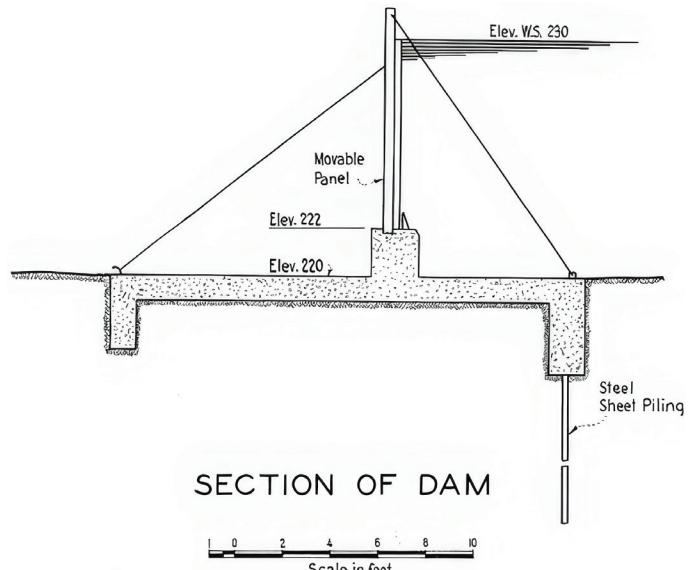
*Figure 3.* Engineer's section drawing of Coyote Percolation Dam. Fred H. Tibbetts, Santa Clara Valley Water Conservation District: Coyote Percolation Dam, South of San Jose, California, File No. 1933-21, August 1933, 2024-B-40, Sheet 2 of 3 (on file at Valley Water's archives).

- A 150-foot-wide concrete sill between the north and south abutments
- Two 15-foot-long, steel sheet pile cutoff walls beneath the upstream wall at both abutments
- A cable-anchored, concrete-block mattress that extended 25 feet downstream from the sill along the creek floor and up the interior slopes of both levees
- A flashboard made of 21, 6-foot, removable panels that managed water flow and storage in the related Coyote Percolation Pond. Each panel was made of 12 horizontal wood planks bolted to a metal frame.
- A metal catwalk with a cable car for work crews to access the flashboard panels

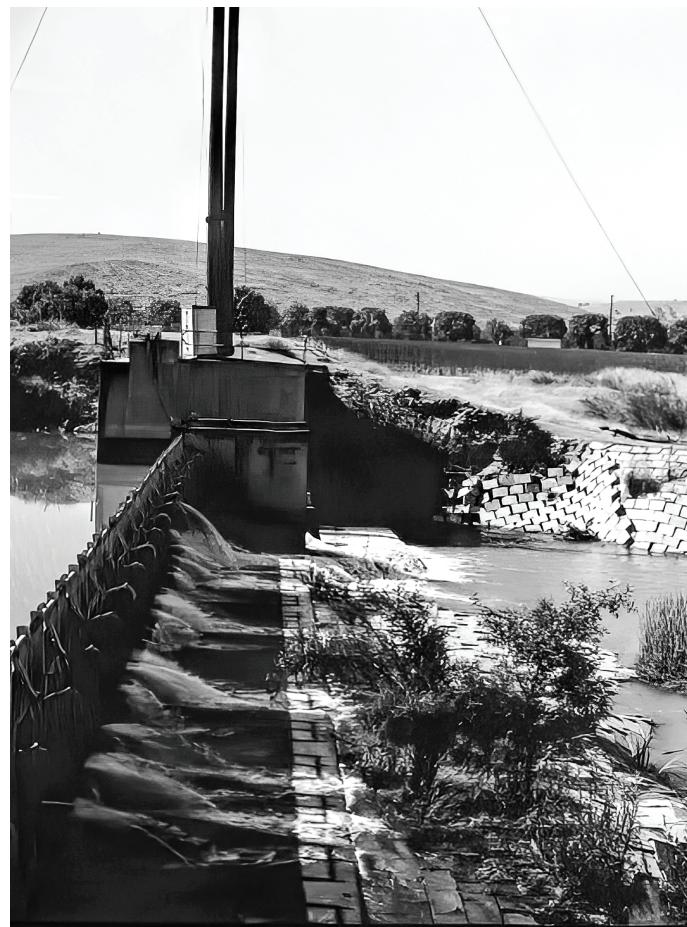
*Figure 4.* Historic view of the Coyote Percolation Dam. Photographer unknown. Coyote Percolation Dam, erosion of left bank [photograph], June 27, 1960 (photograph on file at Valley Water's archives).

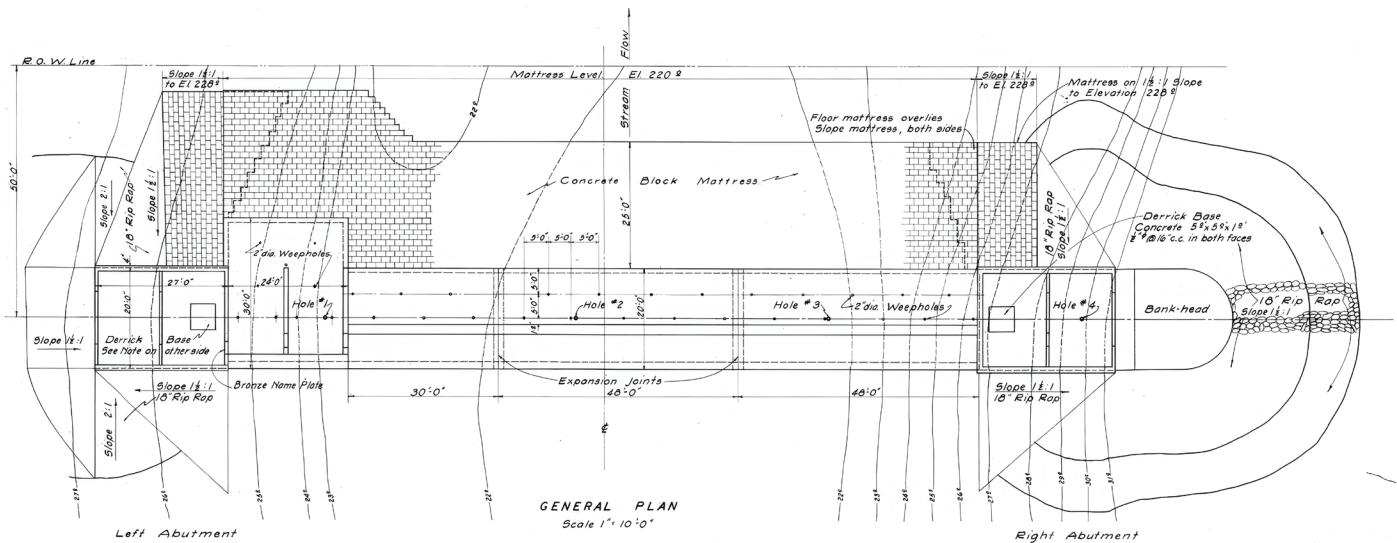
**Figure 5.** Historic plan of the Coyote Percolation Dam showing its general plan view (top-down). Fred H. Tibbetts, Santa Clara Valley Water Conservation District: Coyote Percolation Dam, South of San Jose, California, File No. 1933-21, August 1933, 2024-B-40, Sheet 1 of 3 (on file at Valley Water's archives).

- Portable utility buildings with removable roofs for storage and retrieval of the flashboard panels
- Two derrick cranes to assist in flashboard panel removal and transport of the panels to the utility buildings
- West and east levees
- A concrete diversion dam and ditch downstream of Metcalf Road at the south end of the reservoir

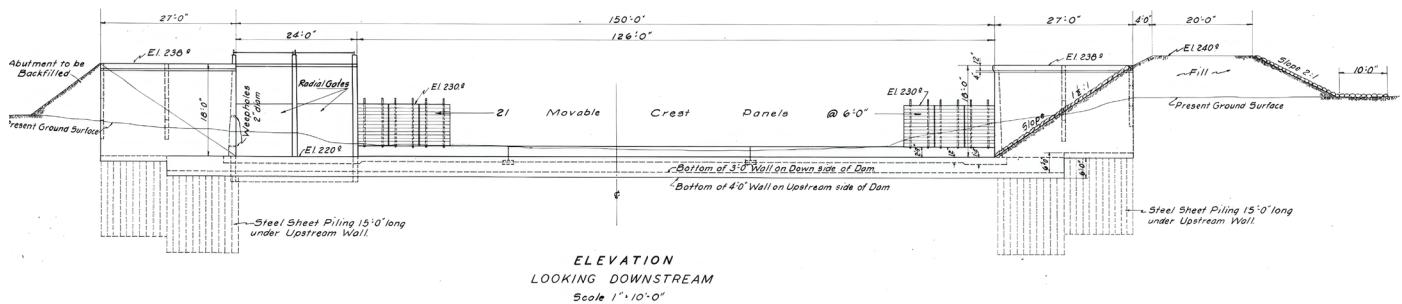
**Figure 6.** Historic plan of the Coyote Percolation Dam showing its general elevation view (head-on). Fred H. Tibbetts, Santa Clara Valley Water Conservation District: Coyote Percolation Dam, South of San Jose, California, File No. 1933-21, August 1933, 2024-B-40, Sheet 2 of 3 (on file at Valley Water's archives).

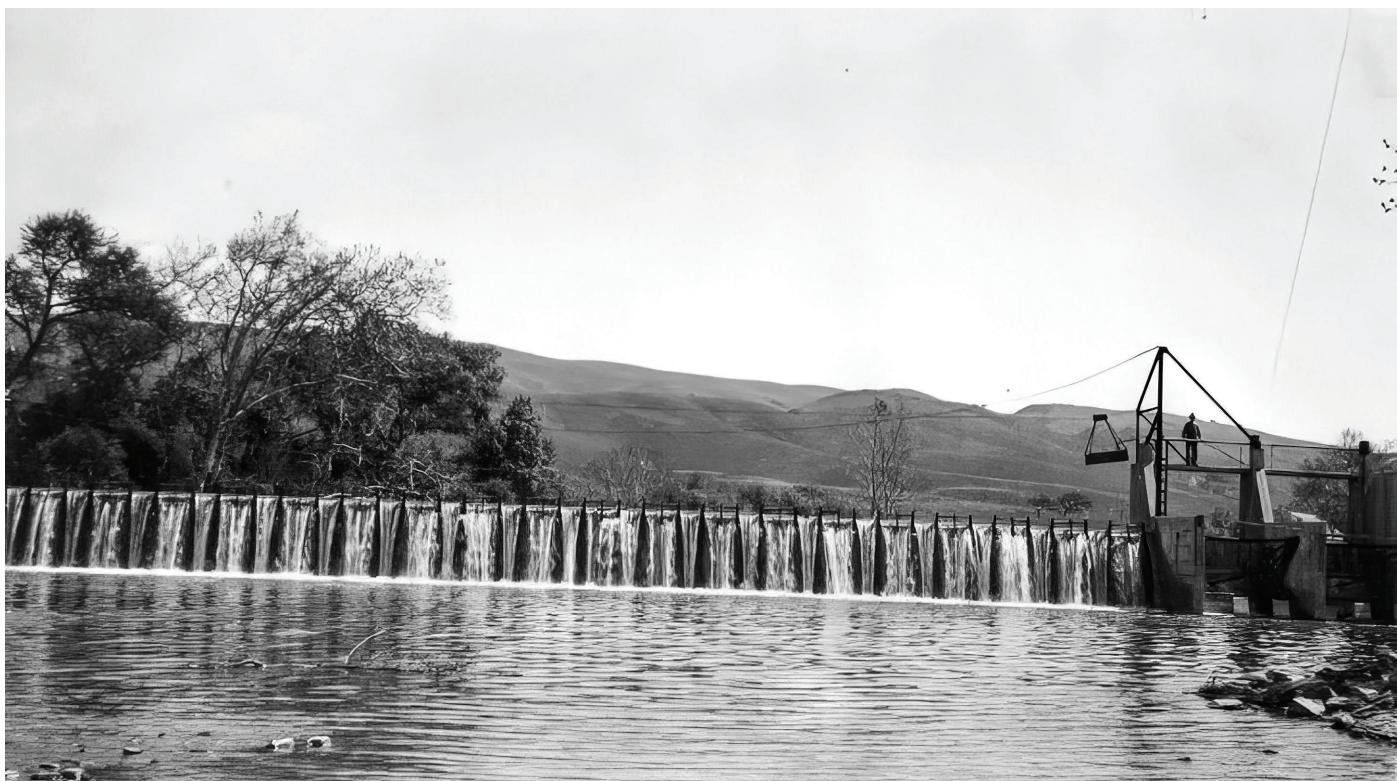
**Figure 7.** Historic view showing water flowing over the Coyote Percolation Dam's flashboard while a staff member oversaw crane operations. Photographer unknown, Coyote Percolation Dam, February 1, 1934 (on file at Valley Water's archives).

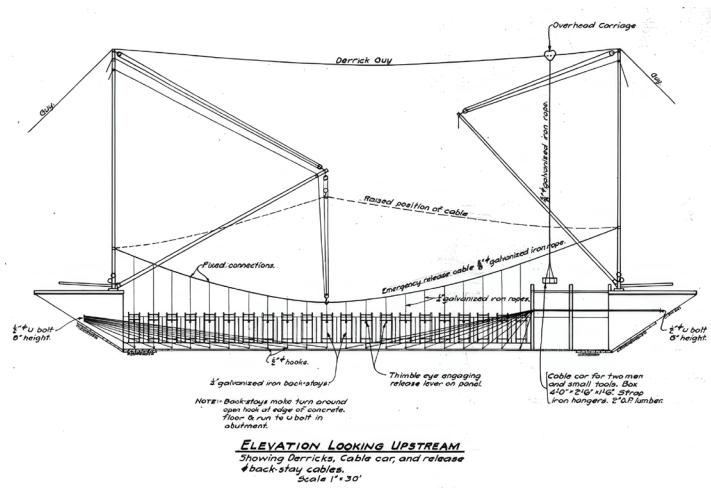
**Figure 8.** Historic Coyote Percolation Dam elevation plan showing key features of the dam from a similar perspective as the historic photograph above. Fred H. Tibbets, Santa Clara Valley Water Conservation District: Coyote Percolation Dam, South of San Jose, California, File No. 1933-21, August 1933 (on file at Valley Water's archives).

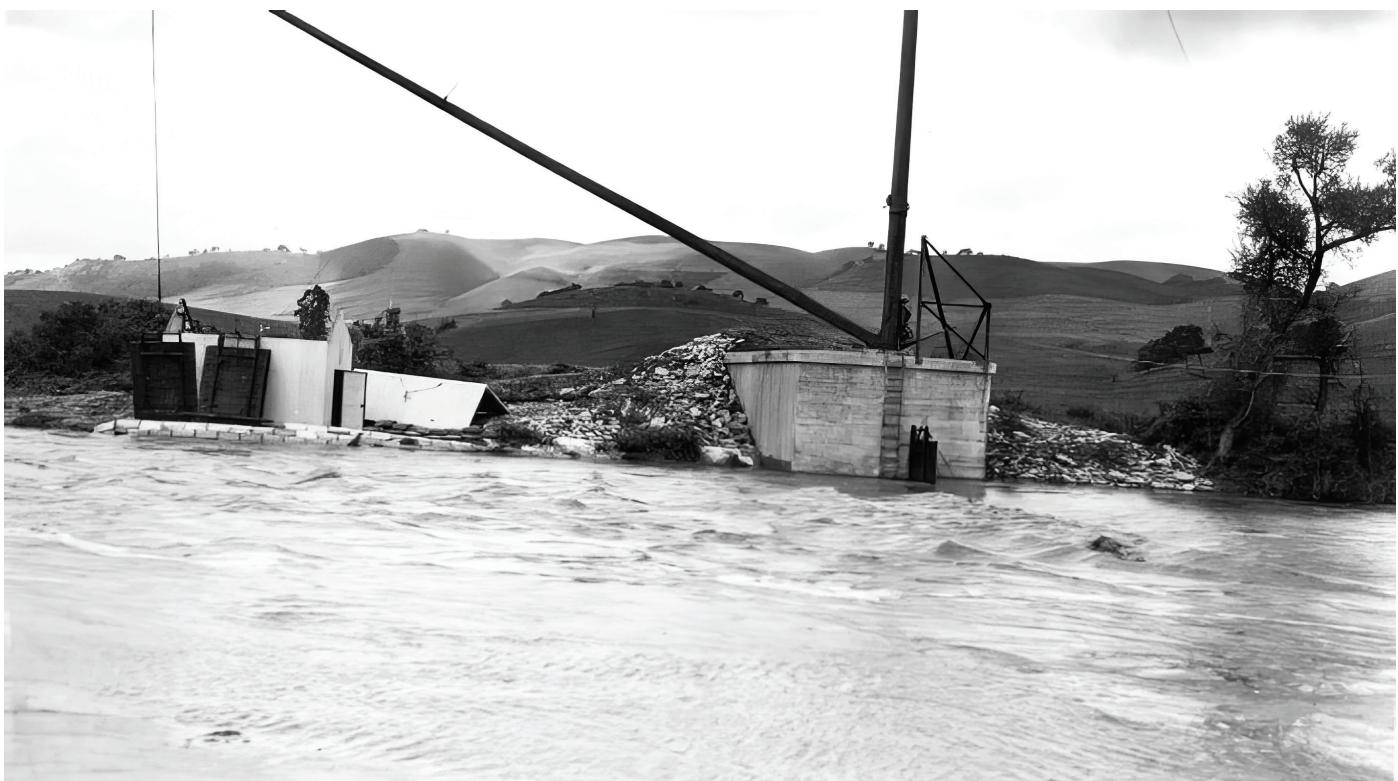
*Figure 9.* A derrick crane placed removed flashboard panels next to a utility building at the Coyote Percolation Dam. The removable gable roof appears to the right of that building. Photographer Unknown, Coyote Percolation Dam, April 8, 1935 (on file at Valley Water's archives).

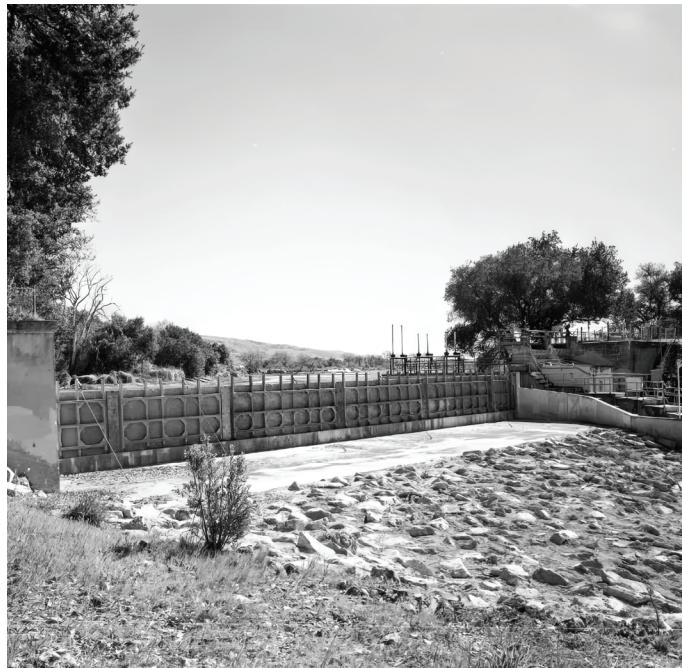
*Figure 10.* Contextual view of the west side of the Coyote Percolation Dam. William Dewey, photographer, February 16, 2022 (on file at Valley Water's archives).

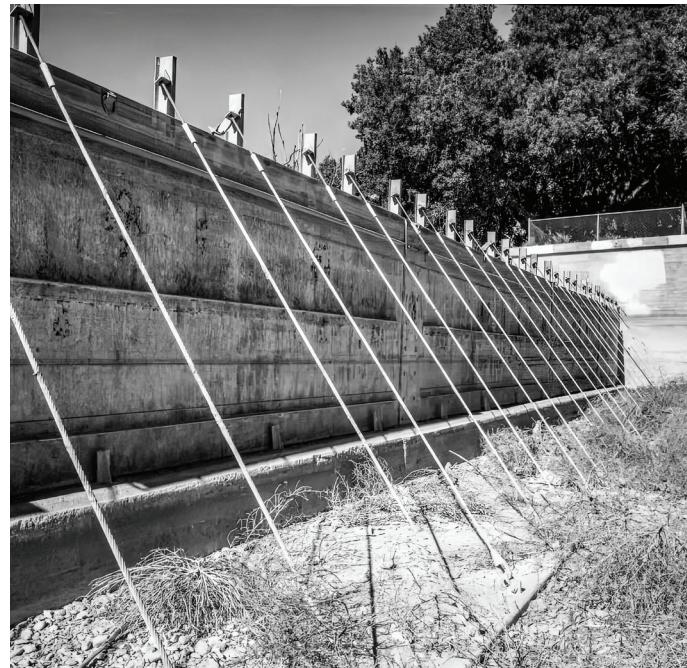
*Figure 11.* View of the downstream side of the Coyote Percolation Dam. William Dewey, photographer, February 16, 202 (on file at Valley Water's archives).

- Late 1960s: Original concrete block mattress washed away during flood - replaced with concrete armoring
- 1977-1978: Original timber flashboards replaced with steel panel flashboards and original derrick cranes and cable car system removed
- 1997: Metal radial gates replaced in-kind
- 1999: Concrete fish ladder added
- 2007: Fish screen added to the east levee, upstream from the dam
- 2014: New steel panel flashboards installed to replace those installed in 1978

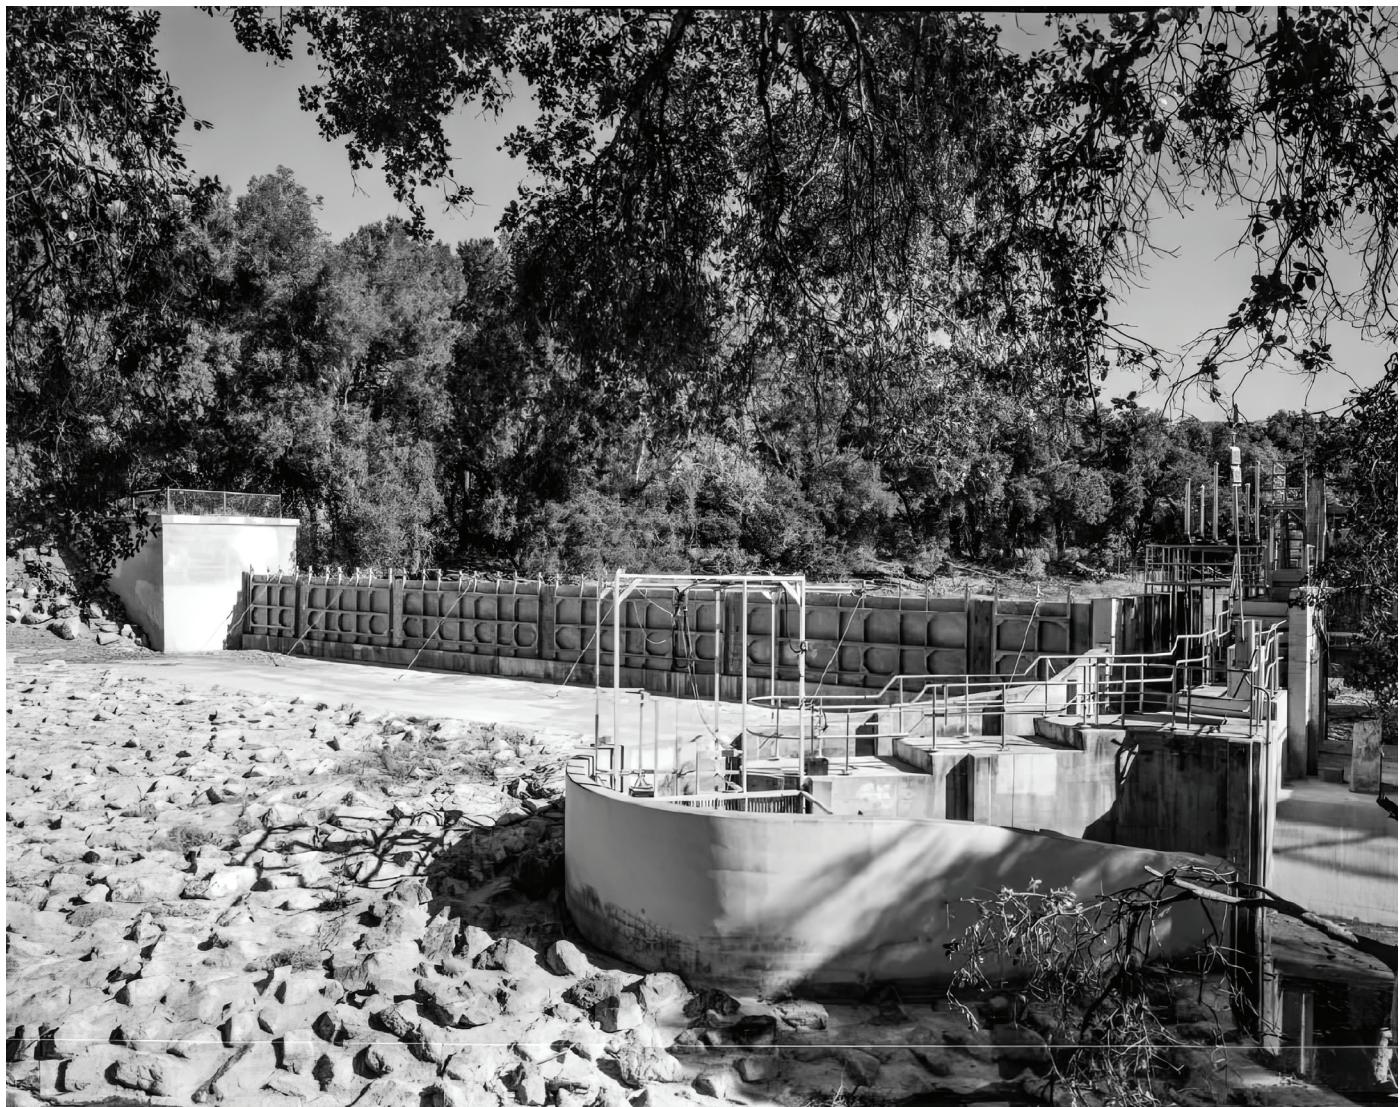
*Figure 12.* View of west side of Coyote Percolation Dam, camera facing east. Taken February 16, 2022, by photographer William Dewey (on file at Valley Water's archives).

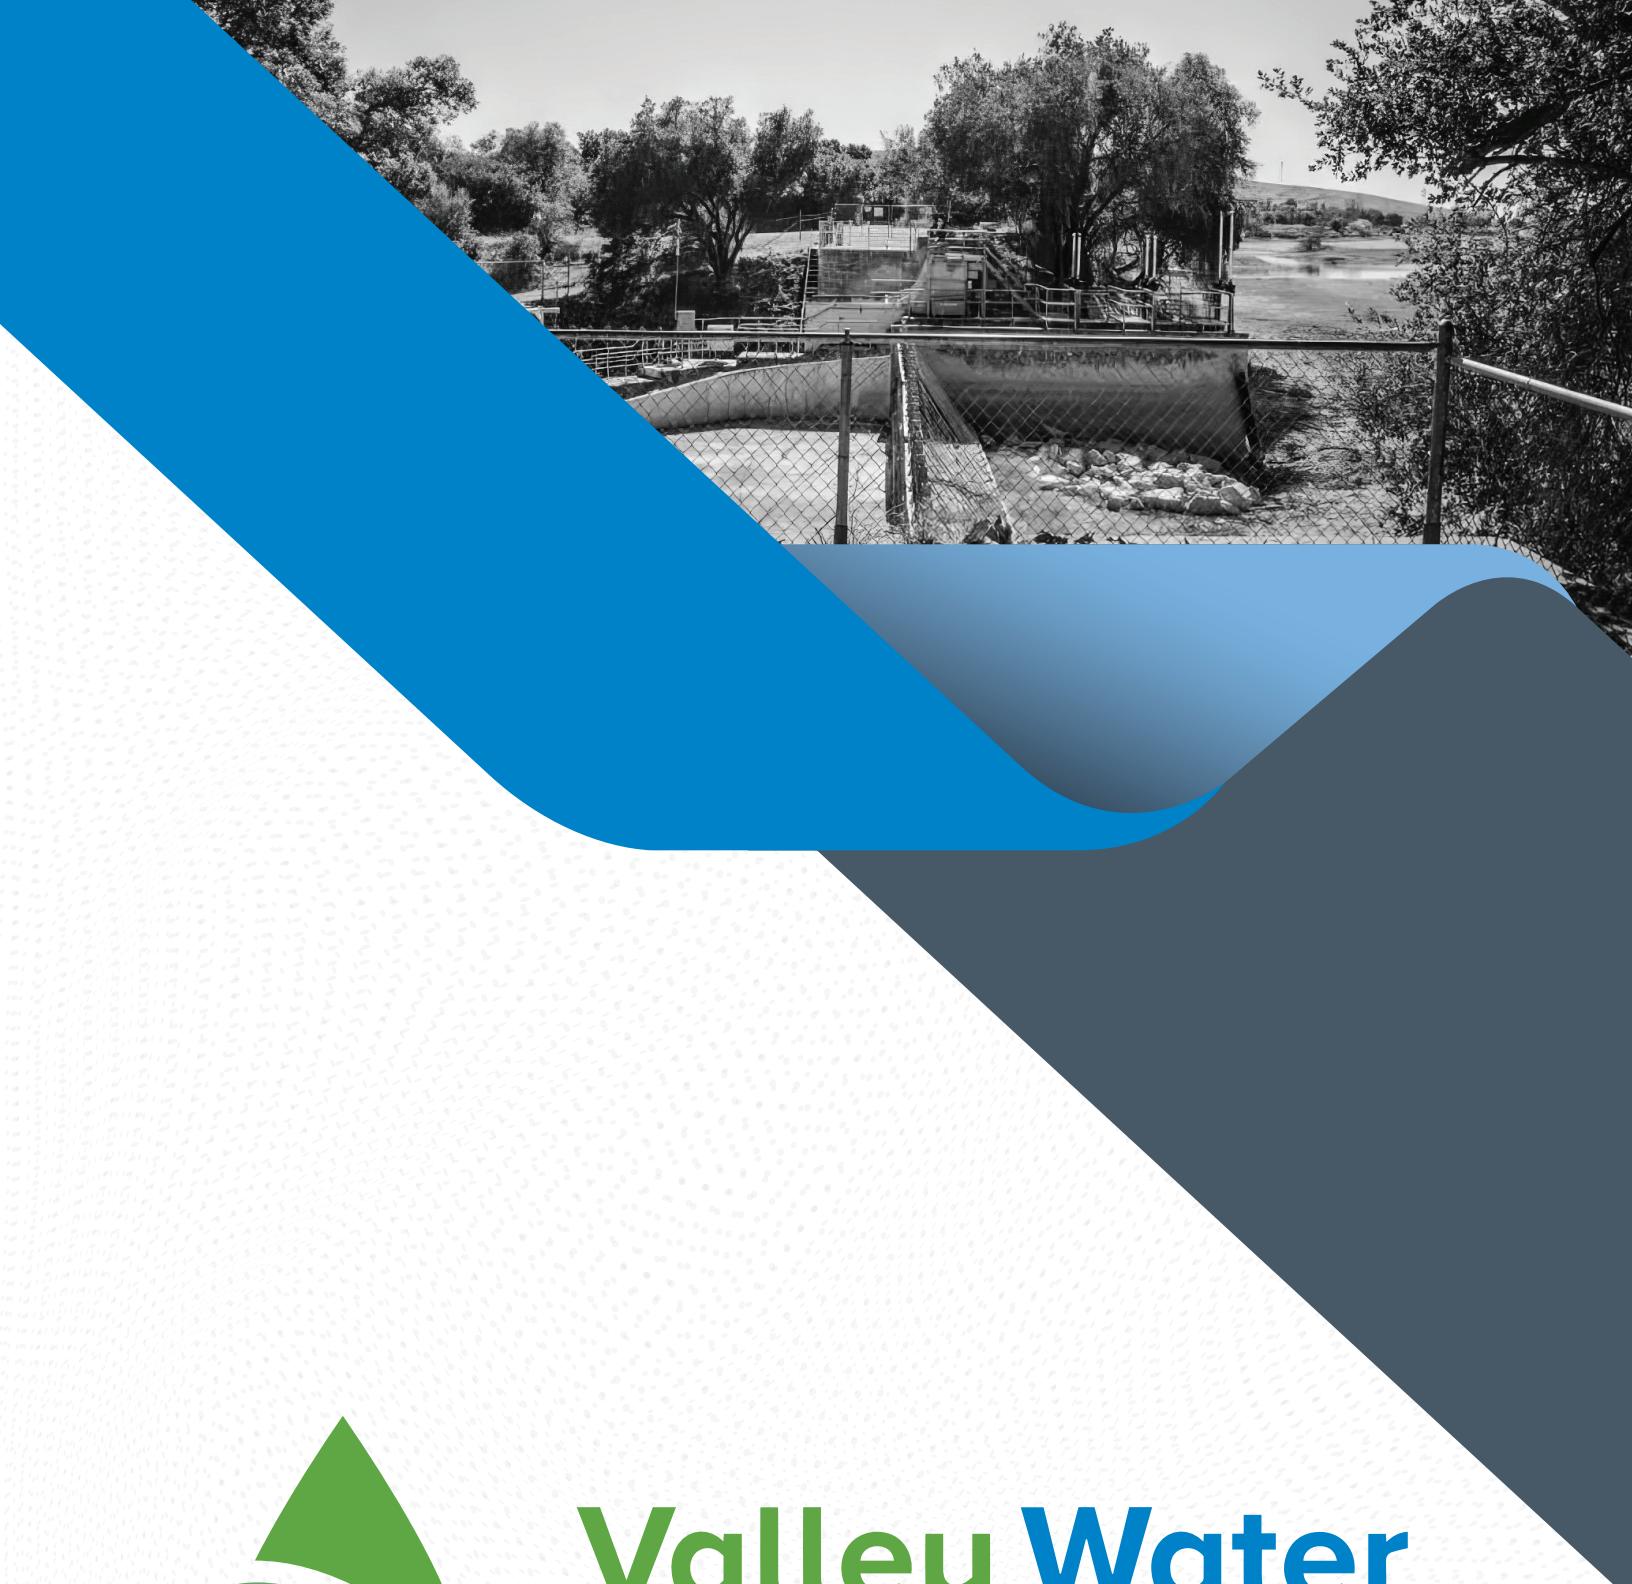
#### *Back Cover Image:*

View of Coyote Percolation Dam from east abutment showing former concrete derrick crane base in foreground, camera southeast. William Dewey, photographer, February 16, 2022 (photograph from Valley Water's archives).

"Photograph 5. View of Coyote Percolation Dam from east abutment showing former concrete derrick crane base in foreground, camera facing southeast." February 16, 2022. Found in: McMorris, Christopher and Samuel Skow, "Historic American Engineering Record: Coyote Percolation Dam (State Dam No. 72-000), San José, Santa Clara County, California." JRP Historical Consulting, LLC, 2022. On file at the Santa Clara Valley Water District Library, San José, California.
