Guadalupe River Watershed Reassessment 2022:

10-Year Reassessment of the Ecological Condition of Streams
Based on the California Rapid Assessment Method

Technical Report prepared for the Santa Clara Valley Water District (Valley Water)

SUBMITTED BY: **San Francisco Estuary Institute**

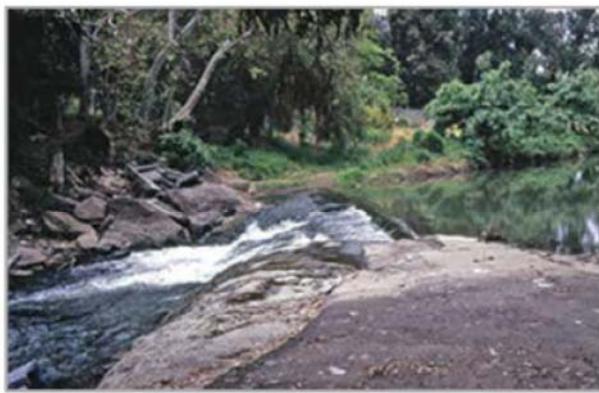
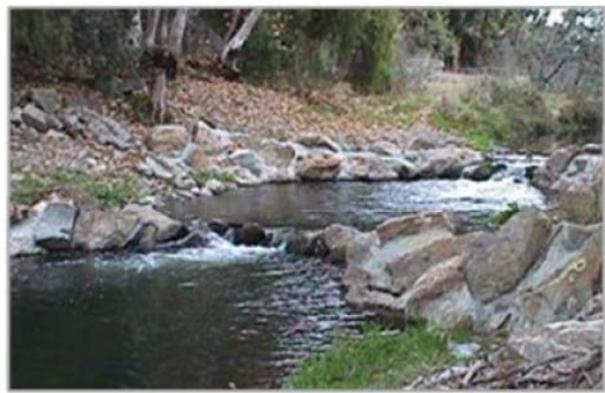
Pre- and post-project photos from the San Jose Water Company Low Flow Crossing Barrier Removal. For more information, visit the Valley Water Fish and Aquatic Habitat Collaborative Effort mapping webpage for the Guadalupe River Watershed at:

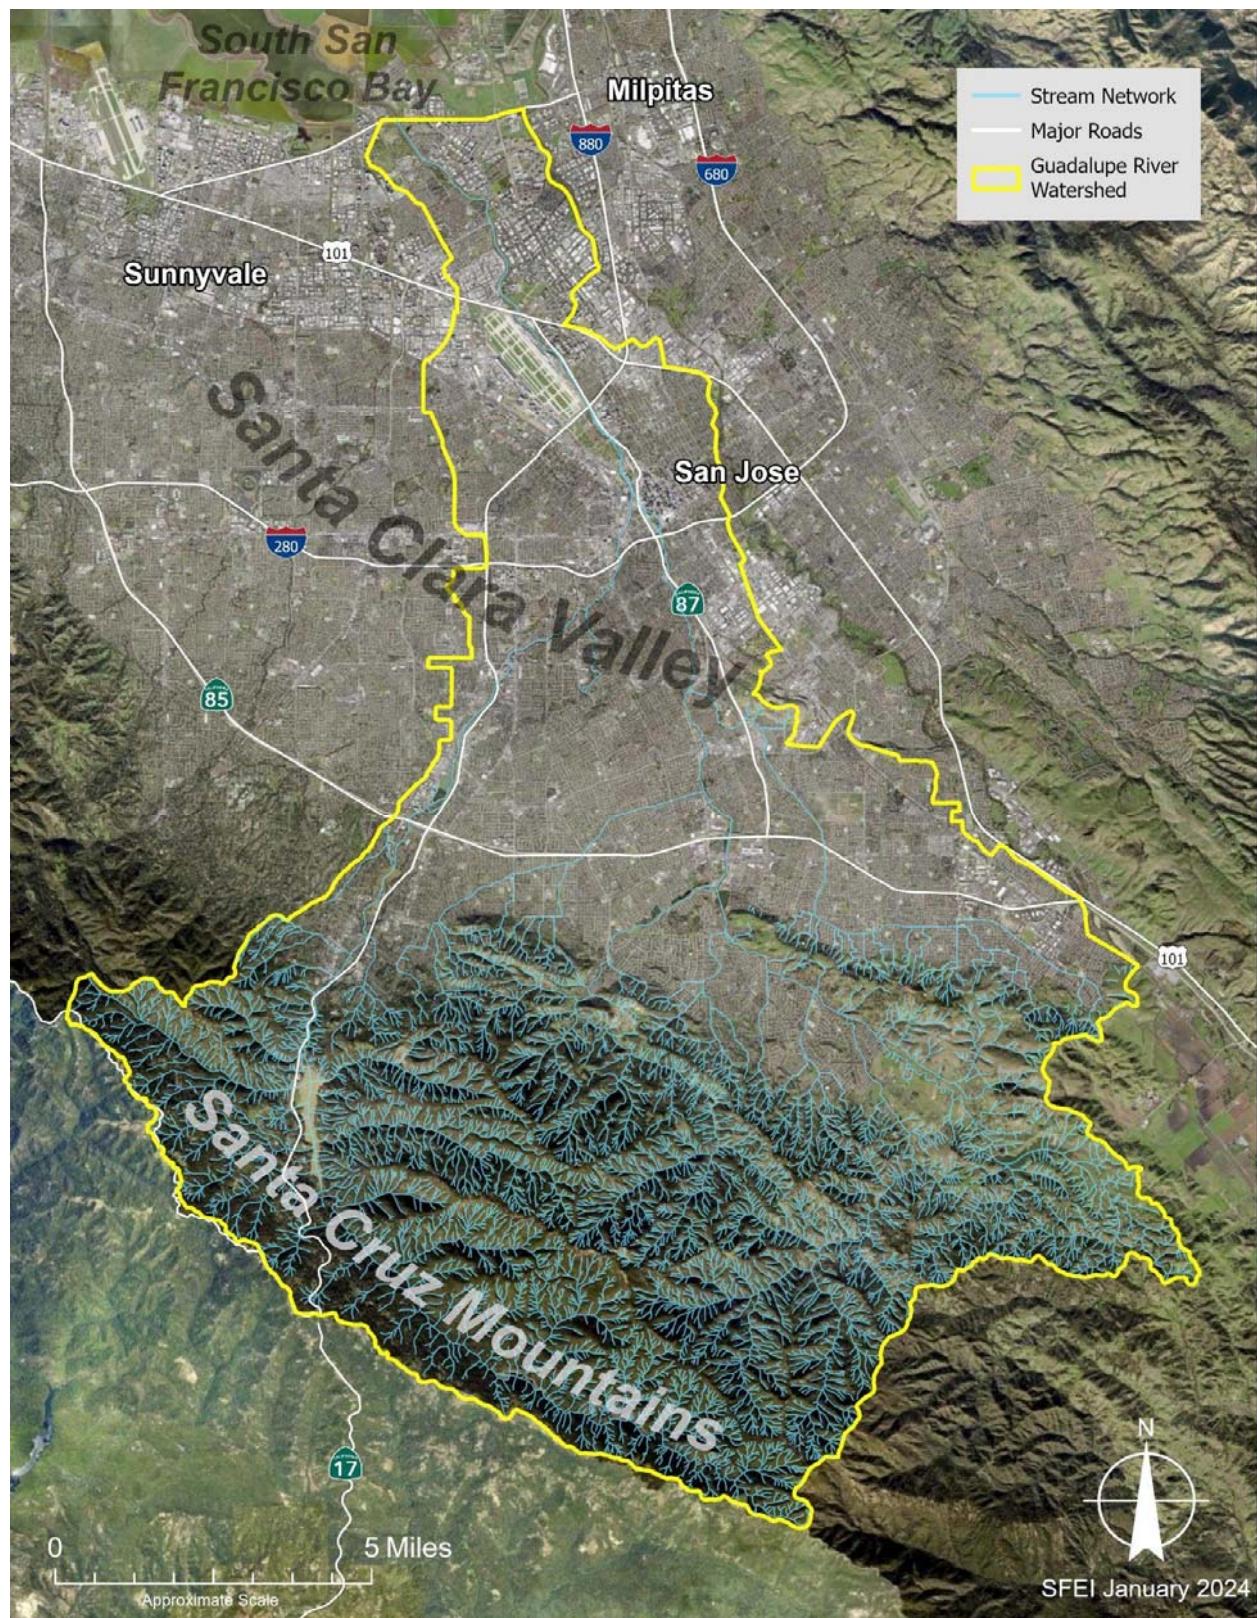
Figure 2. Aerial image of the Guadalupe River Watershed highlighting the topography and current urban land cover in the Santa Clara Valley versus the non-urban land cover in the Santa Cruz Mountains.

The Guadalupe River watershed is a 170 mi² (440 km²) watershed that is the third largest watershed within the five major watersheds in Santa Clara County, behind the Upper Pajaro River and Coyote Creek. It covers about 16 percent of the total five-watershed extent, and includes 13 percent of the stream resources (not including 1st order streams). The Guadalupe River begins in tributaries near the summits of Loma Prieta (elevation 3,786 ft) and Mount Umunhum (elevation 3,489 ft), draining the eastern Santa Cruz Mountains of Santa Clara County. The tributaries flow north from the mountains into the Santa Clara Valley, becoming the Guadalupe River downstream of the confluence of Alamitos Creek and Guadalupe Creek. The Guadalupe River continues to flow north through the City of San Jose, draining into South San Francisco Bay through Alviso Slough (Figure 2).

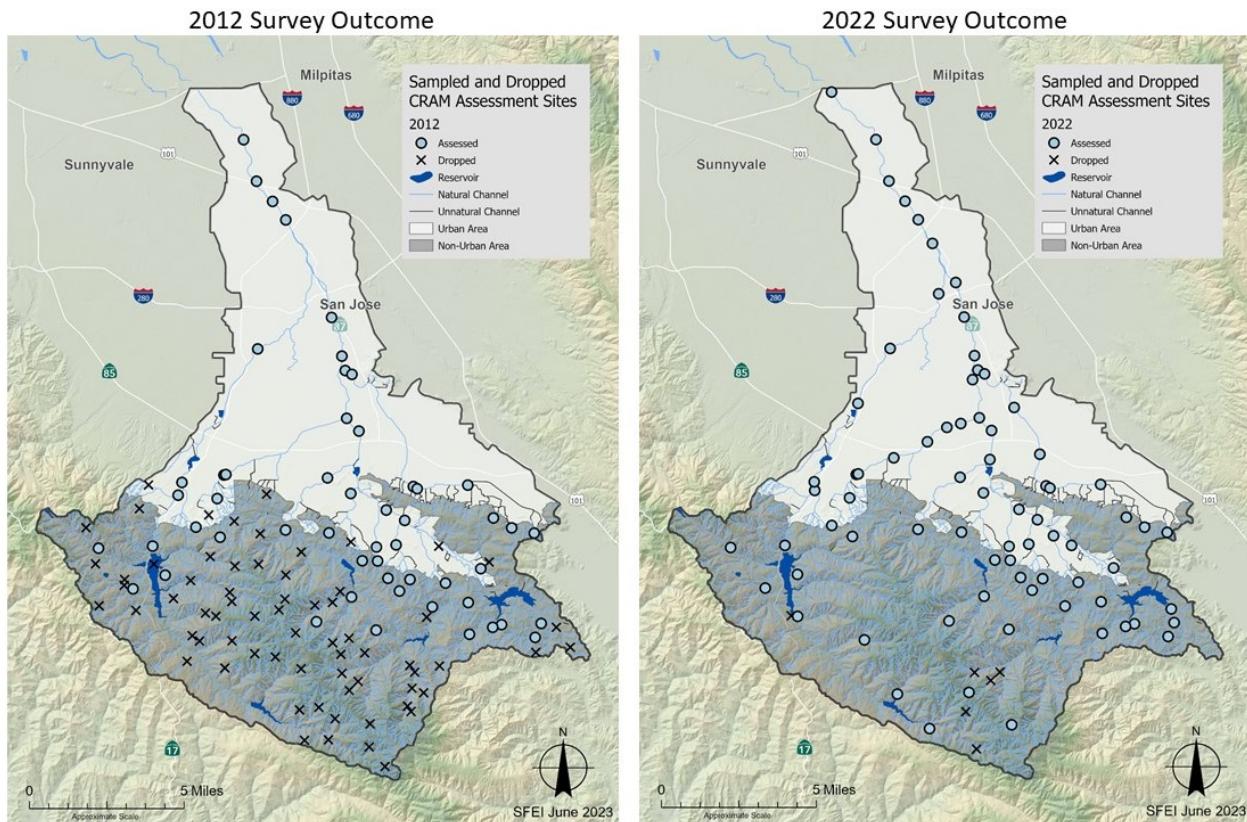
Figure 4. Guadalupe River watershed field assessment outcomes of the 2012 (n=53) and 2022 (n=75) ambient stream condition surveys showing successfully assessed CRAM sites and dropped sites.

Figure 4 shows maps of the final distribution of all candidate CRAM AAs that were evaluated for assessment and their final outcomes (sites were either assessed or dropped) for both the 2012 and 2022 stream condition surveys employing CRAM. There was a noticeable gap in successfully sampled sites in the middle portion of the upper headwaters region of the watershed in the Non-urban PAI in 2012 in large part due to difficult access, safety issues, and the landowners not replying to requests for access. To address this gap, a number of new sites were added in 2022 to increase the total number of AAs in the upper headwater region of the watershed. In addition, the added sites in the Urban PAI improved the overall spatial distribution of AAs among the mainstem and tributaries in the urban valley region.

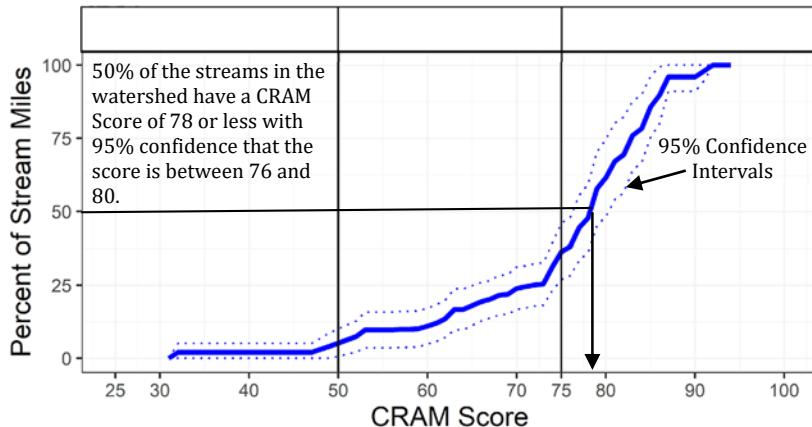
Figure 5. Example CDF estimate curve for a watershed-based stream condition assessment employing CRAM.

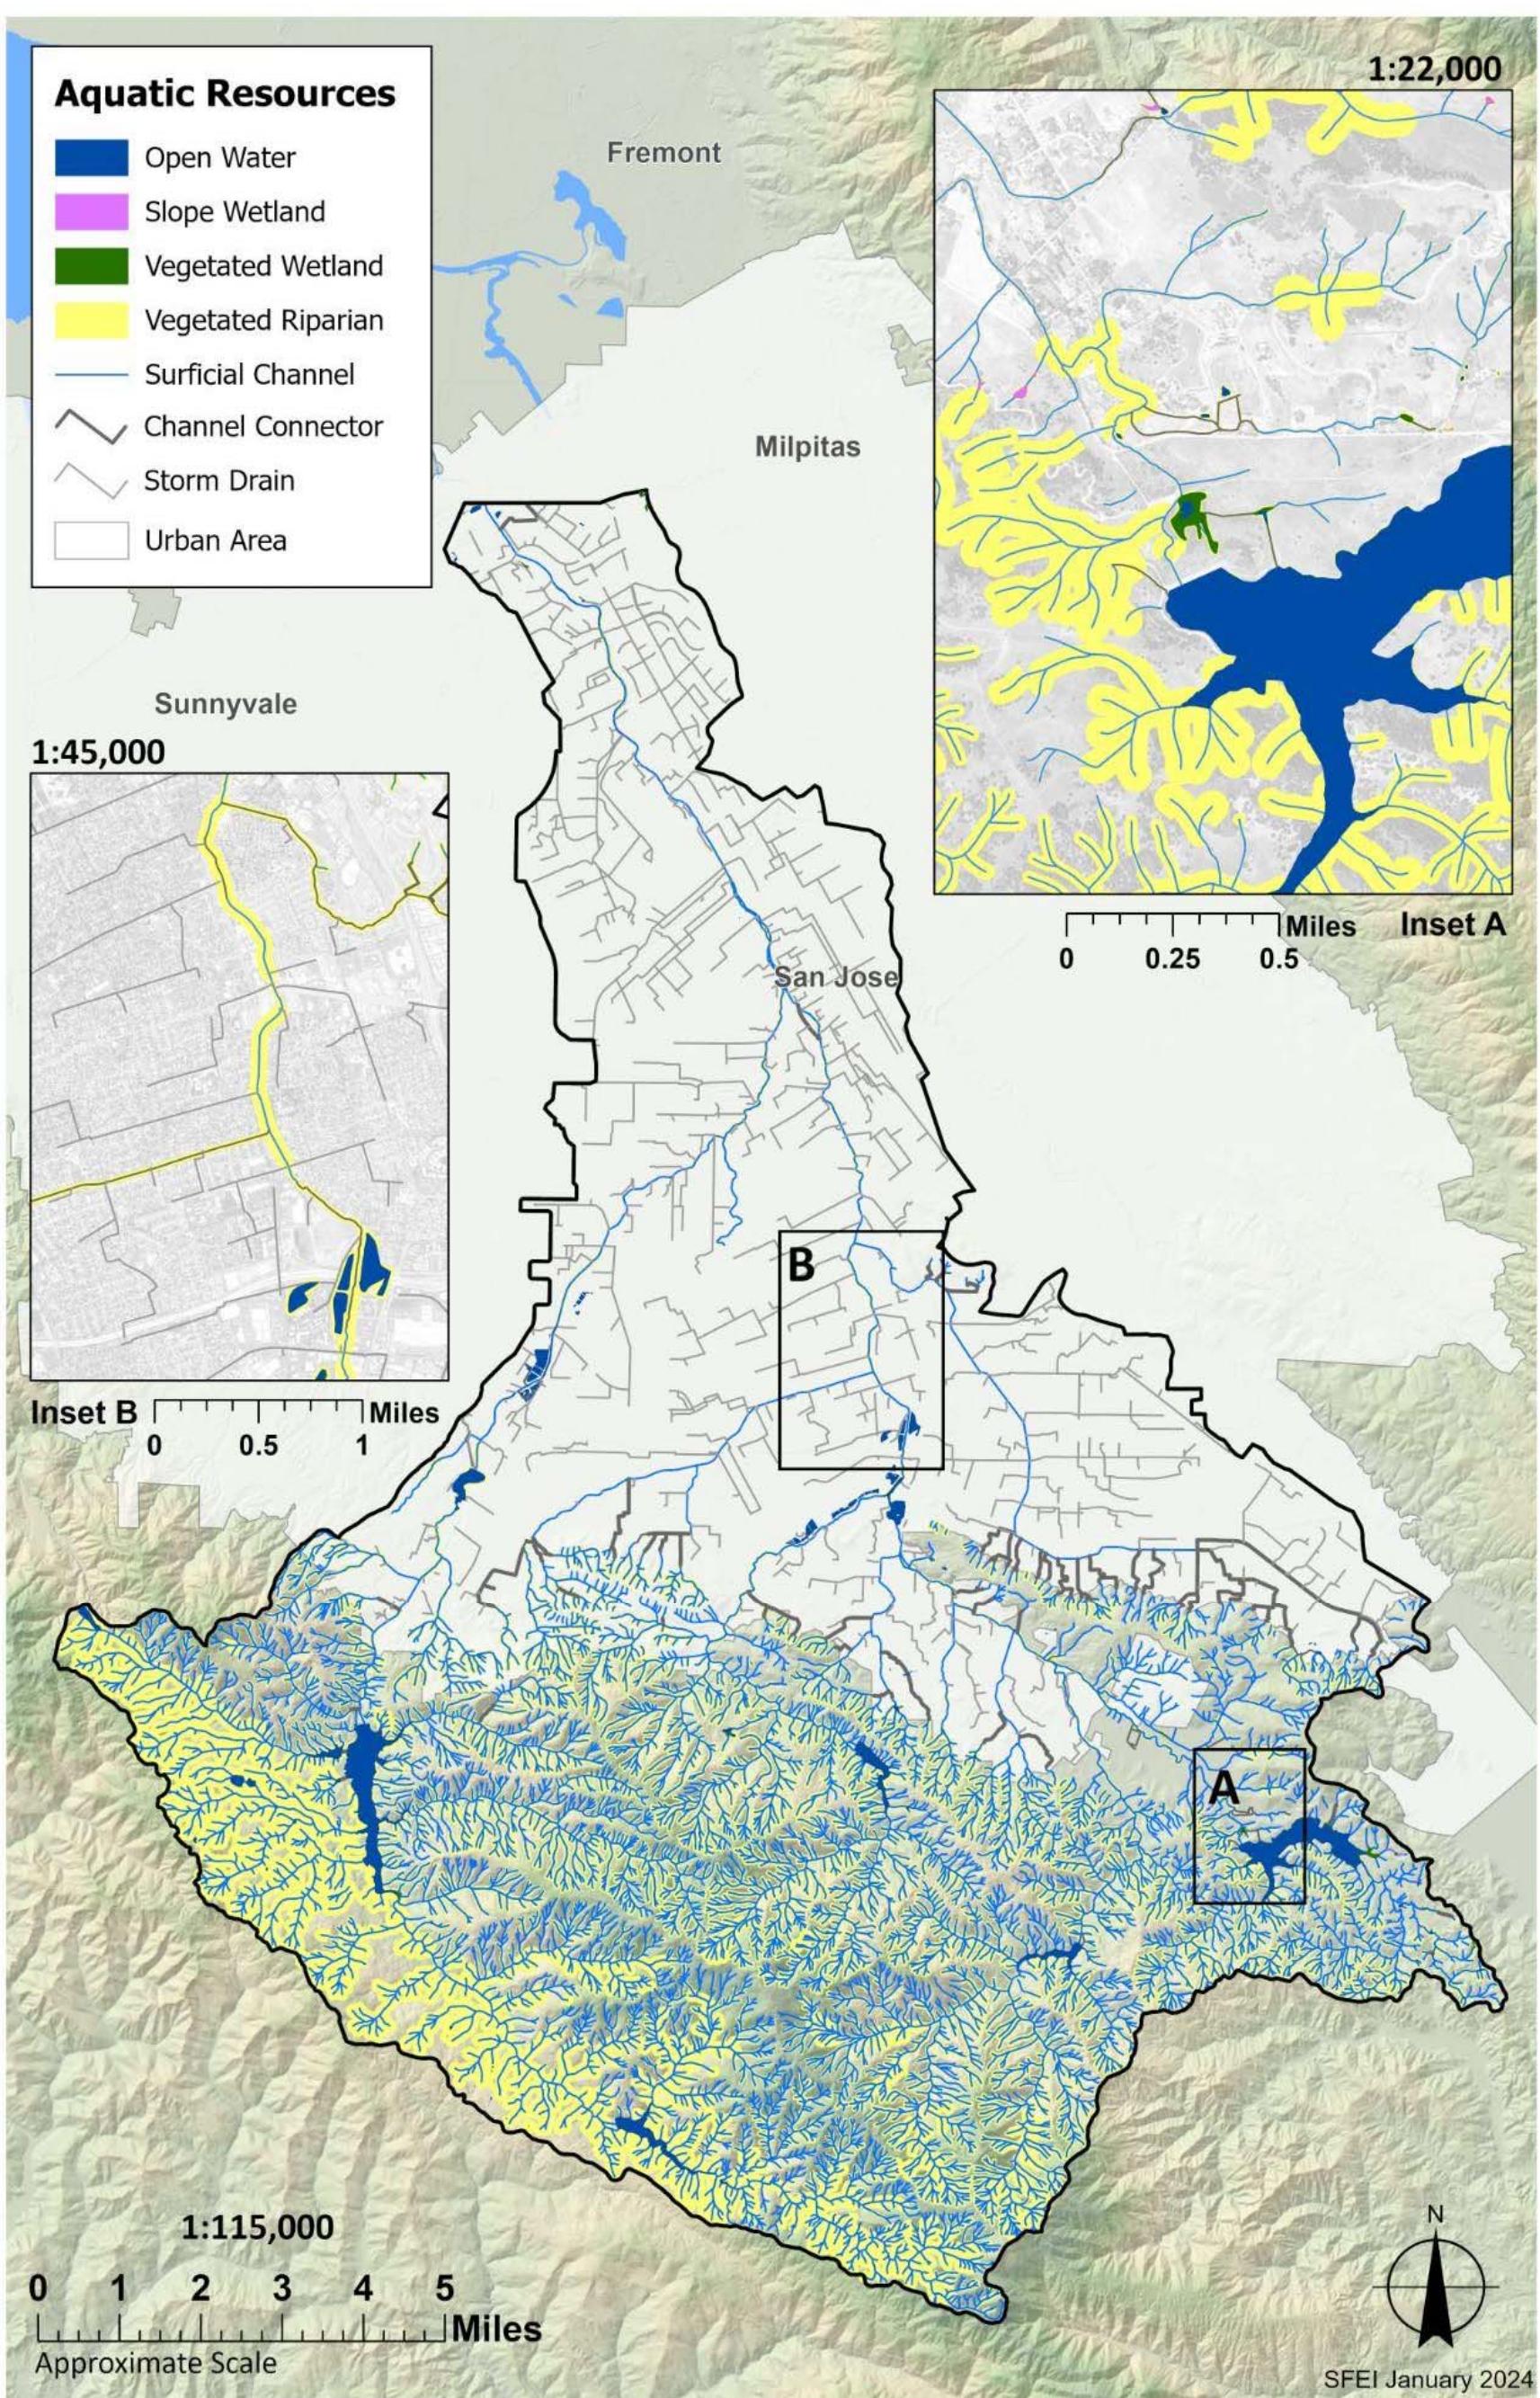
Figure 6. Distribution of aquatic resources in the Guadalupe River watershed including streams and non-riverine wetlands (slopes, seeps, ponds, vegetated portions of lakes and reservoirs, and open water portions of lakes and reservoirs) based upon BAARI (v2.1, SFEI ASC, 2017).

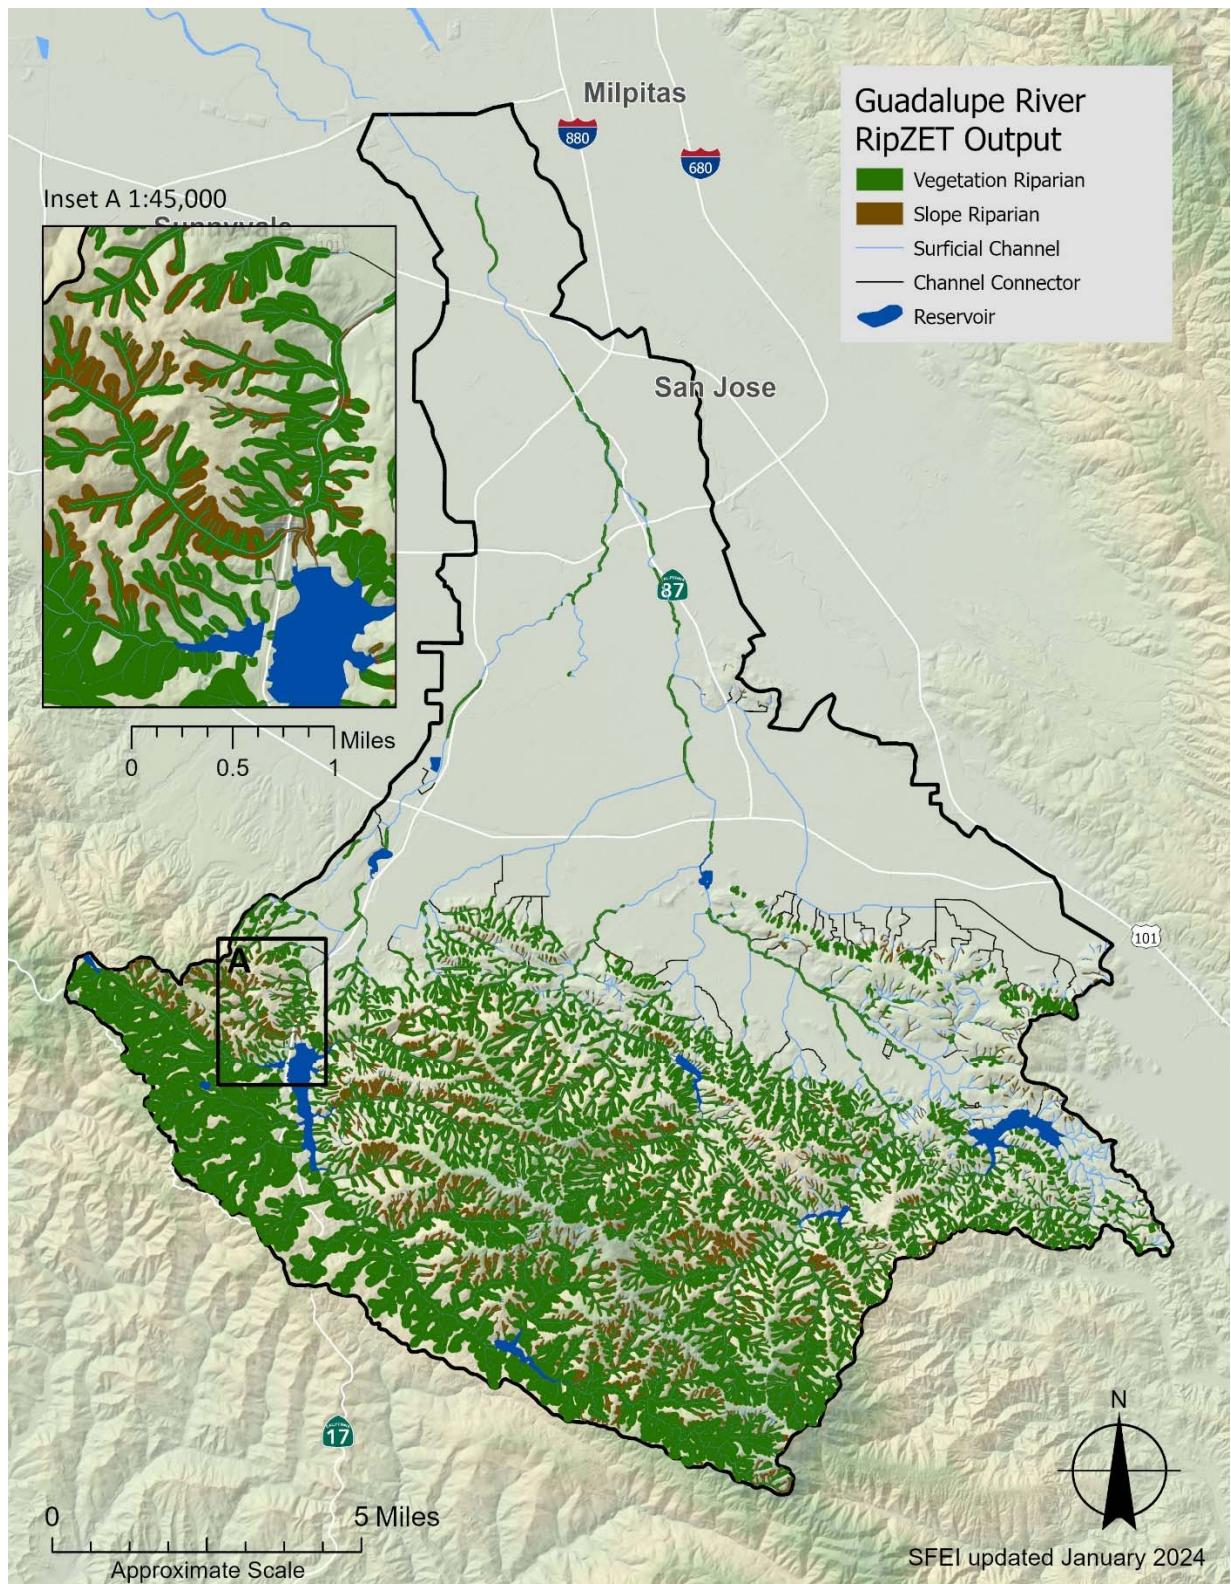
Figure 7. Modeled distribution of riparian areas adjacent to streams within the Guadalupe River watershed determined using RipZET. Areas of hillslope functions (brown) are largely encompassed by vegetation functions (green, overlaid on the hillslope layer), except in steep terrain dominated by short vegetation (chaparral or grasslands). Riparian width is generally constrained in the Urban PAI by urban or suburban development.

shape of the stream network is slightly altered by buffering the GIS-based thalweg flow-line to estimated left and right stream banks, and partly because subsurface drainage features are not included in the estimate of riparian extents.

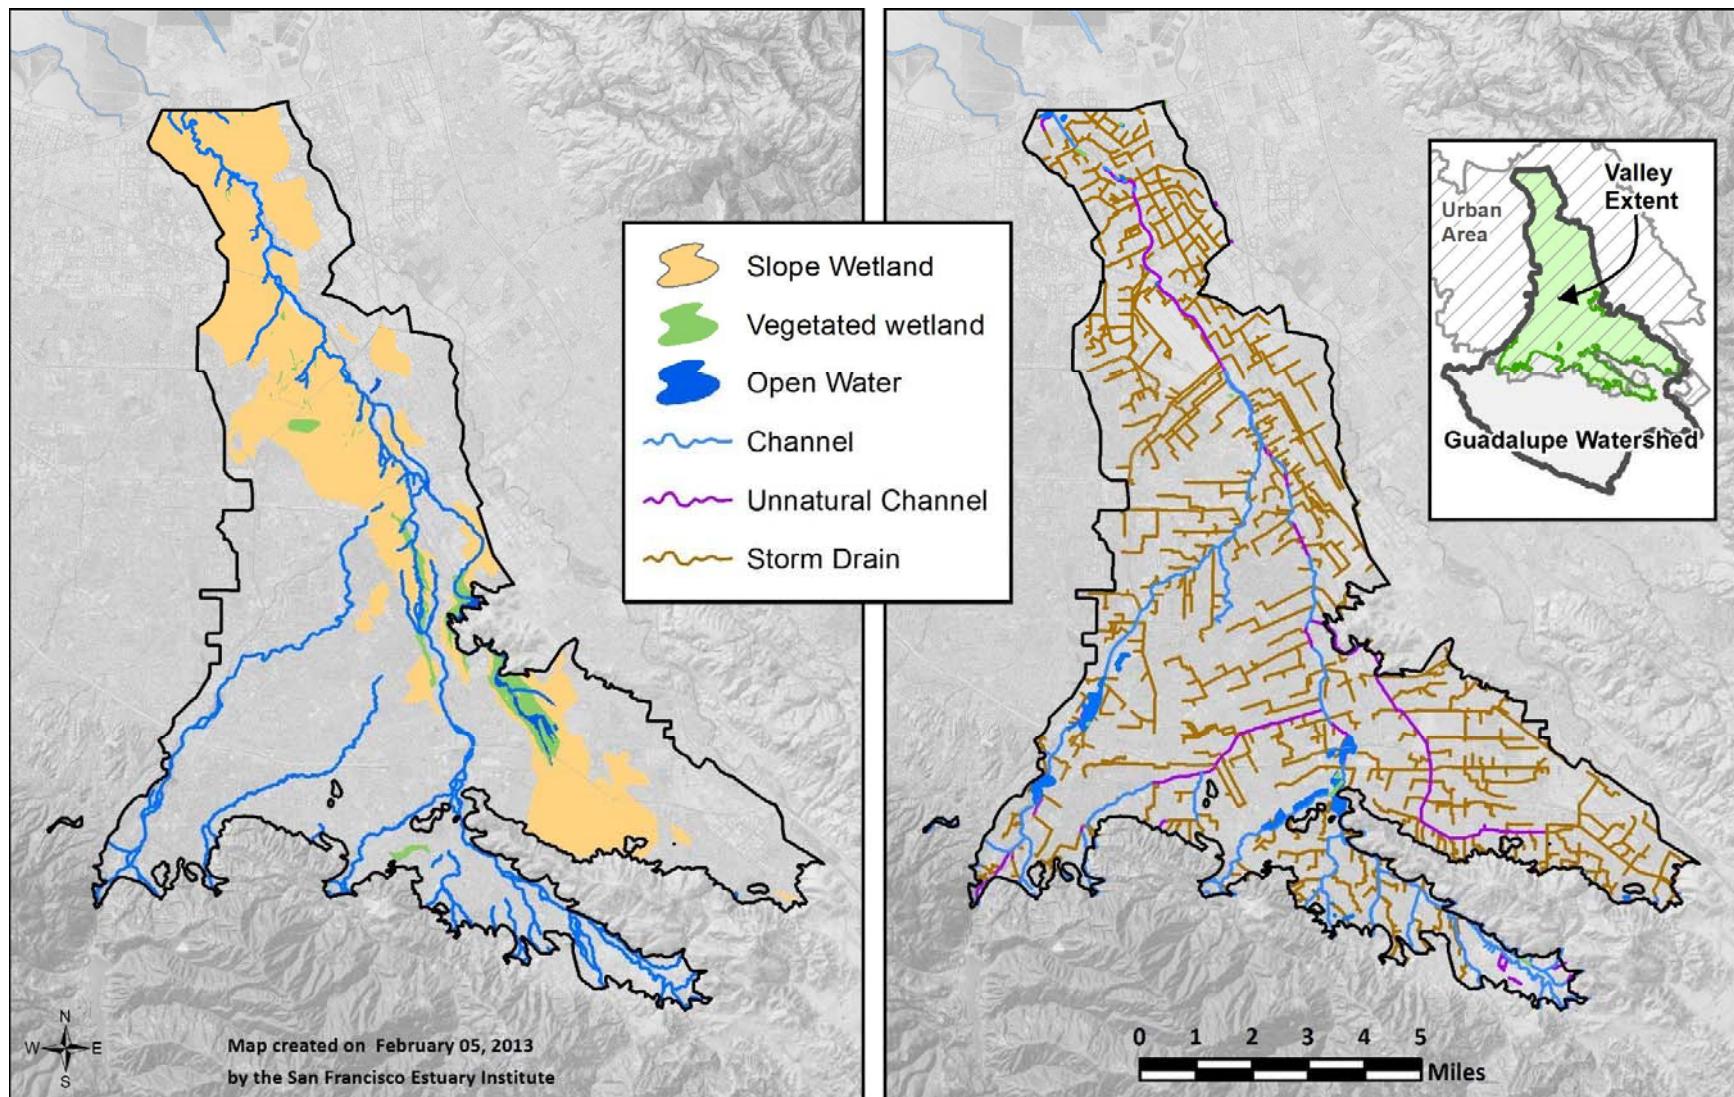
Figure 8. Maps of historical (circa 1850) and modern aquatic resources in the Guadalupe River watershed valley floor, where there are overlapping historical ecology spatial data from the Historical Vegetation and Drainage Patterns of Western Santa Clara Valley (Beller *et al.*, 2010) and BAARI v.0.2 (SFEI, 2011).

Figure 8 shows the historical (circa 1850) and modern aquatic resources in the Guadalupe River watershed within the valley area for which there are overlapping mapped historical ecology data from the *Historical Vegetation and Drainage Patterns of Western Santa Clara Valley* report (Beller *et al.*, 2010) and BAARI v.0.2 (SFEI, 2011). Figure 9 quantifies the difference in channel length between the historical and modern time periods.

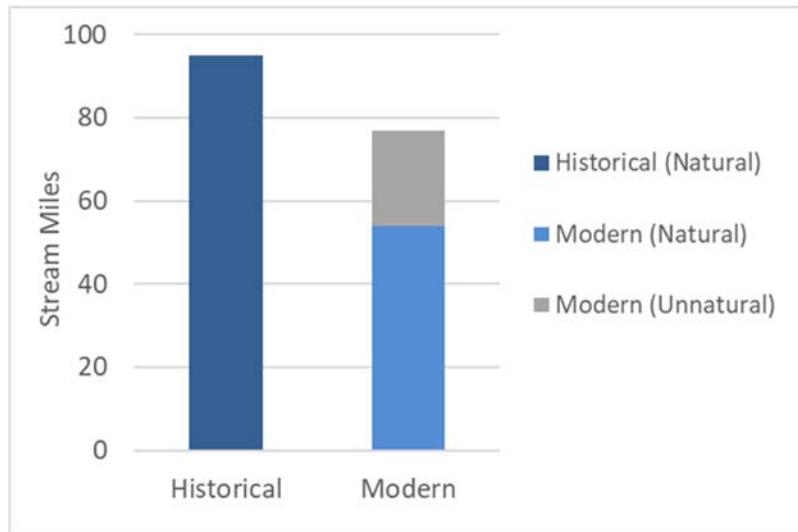
Figure 9. Comparison of historical (circa 1850) and modern (circa 2008) stream length in the valley portion of the Guadalupe River watershed based on data provided by the *Historical Vegetation and Drainage Patterns of the Western Santa Clara Valley* (Beller *et al.*, 2010) and BAARI v.0.2 (SFEI, 2011).

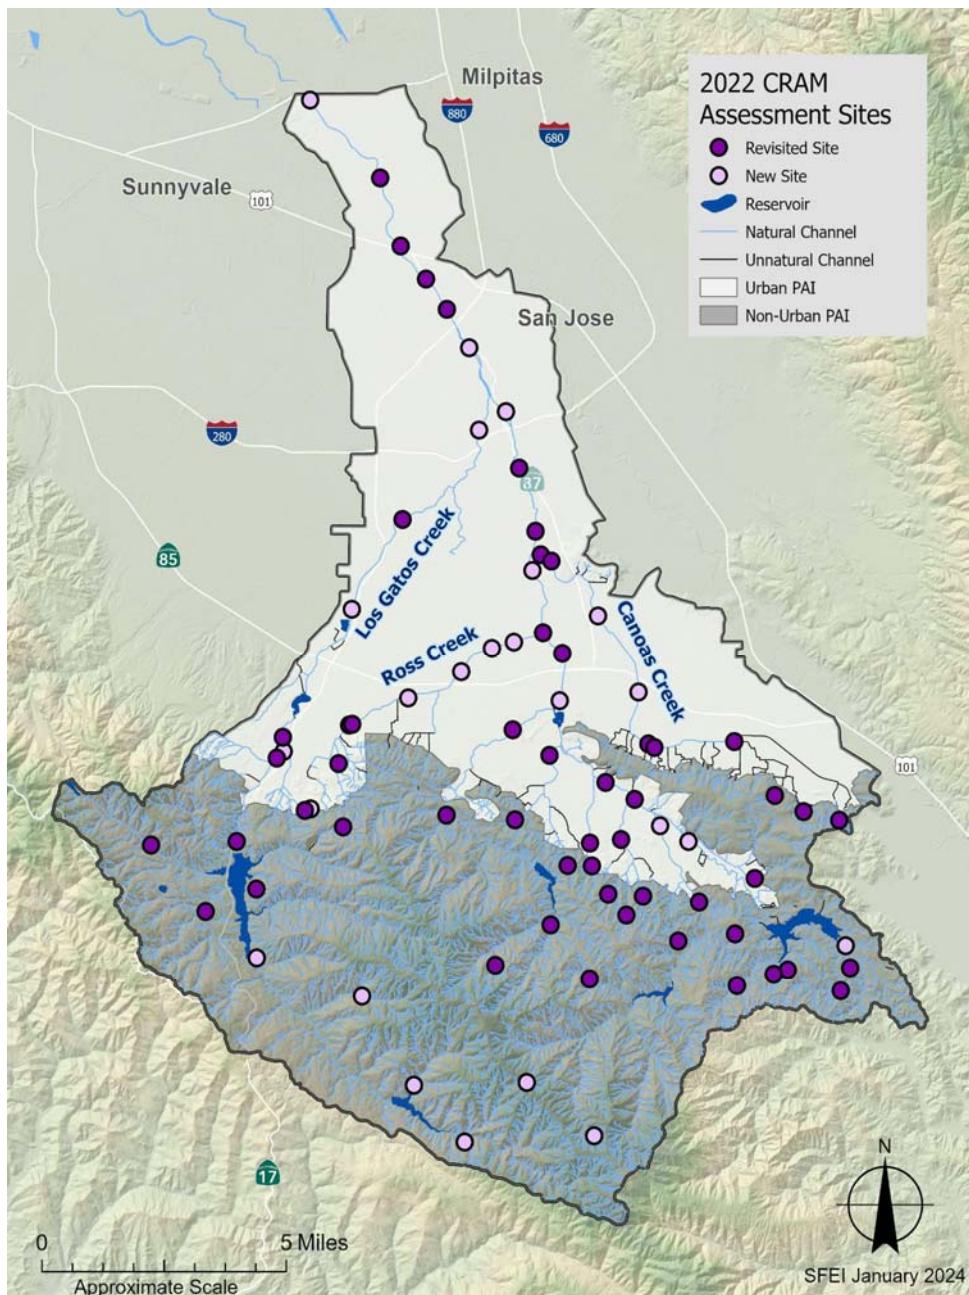
Figure 11. Map of the 2022 survey sites showing the distribution of the 53 revisit sites (dark purple) and 22 new AAs (light purple) in areas previously under-represented stream reaches including Ross, Canoas, and Los Gatos Creeks in the Urban PAI and upper headwater reaches in the Non-urban PAI.

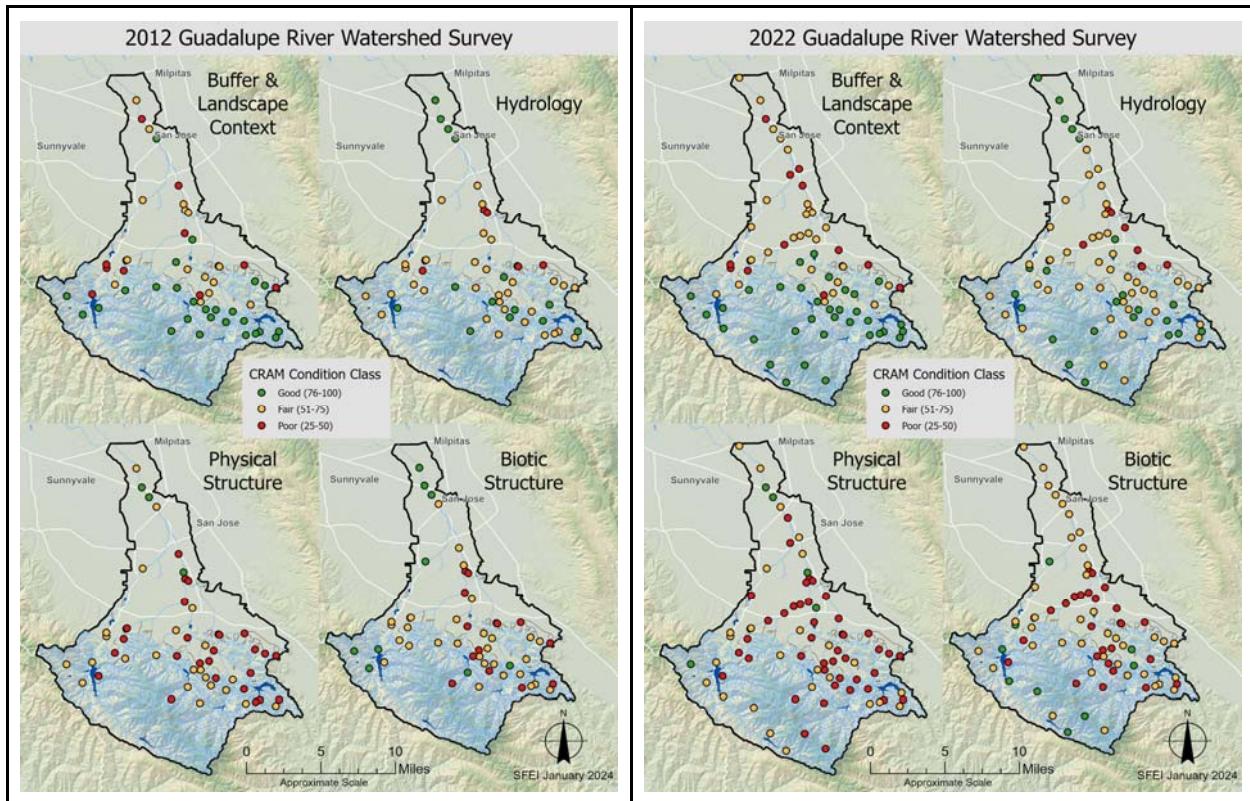
Figure 12. Stream condition survey sites (AAs) in 2012 (left) and 2022 (right) for the Guadalupe River watershed, color-coded for their CRAM Attribute condition class of Good, Fair, and Poor.

The change in the spatial distributions of AAs between surveys is best seen in the maps in Figure 12. Each map shows the Attribute level spatial distribution of stream conditions, color-coded by condition class, across the watershed including: (1) differences among the Urban and Non-urban PAIs, (2) differences between the mainstem and individual tributaries, and (3) temporal differences among survey periods (between the left and right sets of maps).

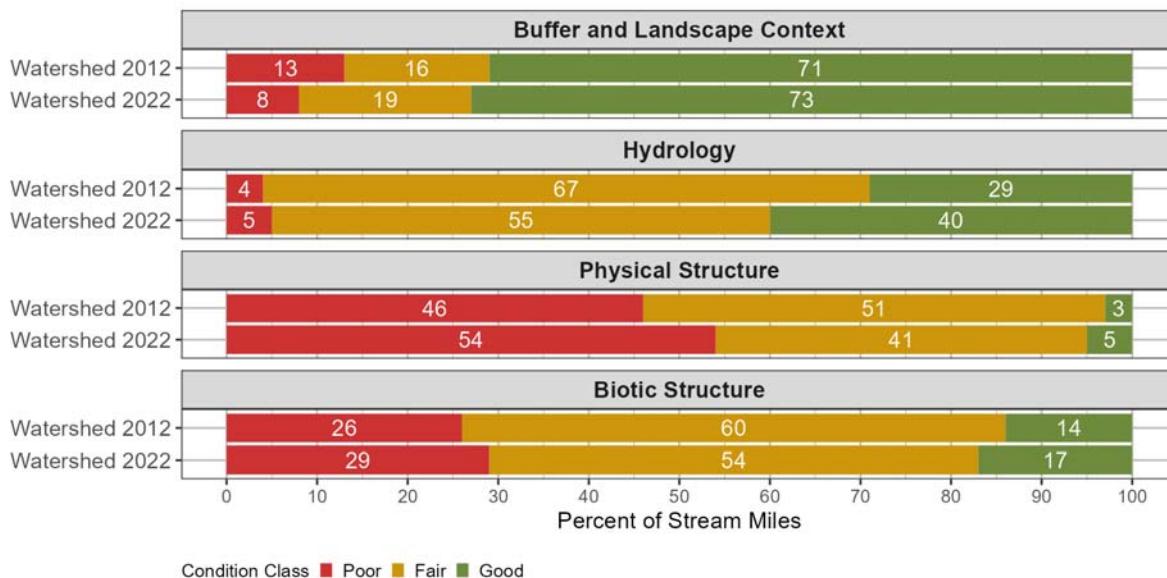
Figure 13. Percent of stream miles in Poor, Fair, and Good ecological condition for the Guadalupe River watershed as a whole for the 2012 and 2022 ambient surveys based on CDF estimates of the four CRAM Attributes. Ecological condition classes are based on three CRAM equal-interval health classes of Poor 25-50, Fair 51-75, and Good 76-100. The number of AAs differed between surveys: 2012 Watershed = 53; 2022 Watershed = 75 (consisting of 53 revisit AAs and 22 new AAs).

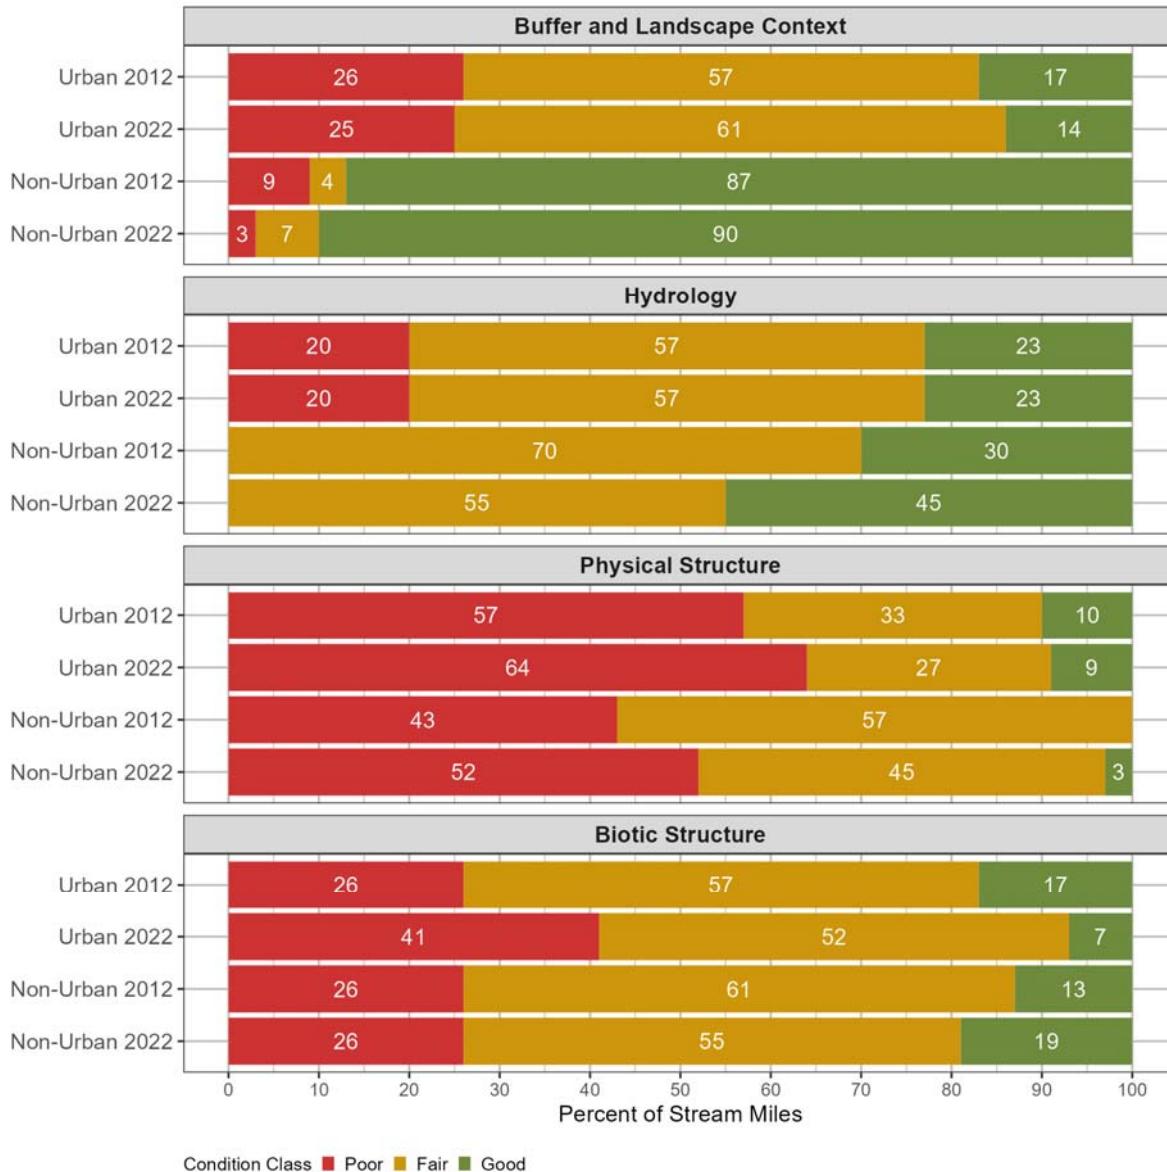
Figure 14. Percent of stream miles in Poor, Fair, and Good ecological condition for the Urban and Non-urban PAIs within the Guadalupe River watershed for the 2012 and 2022 ambient surveys based on CDF estimates of the four CRAM Attributes. Ecological Condition Classes are based on three CRAM equal-interval health classes of Poor 25-50, Fair 51-75, and Good 76-100. The number of AAs differed between surveys: 2012 Urban = 30, 2012 Non-urban = 23, 2022 Urban = 44, 2022 Non-urban = 31.

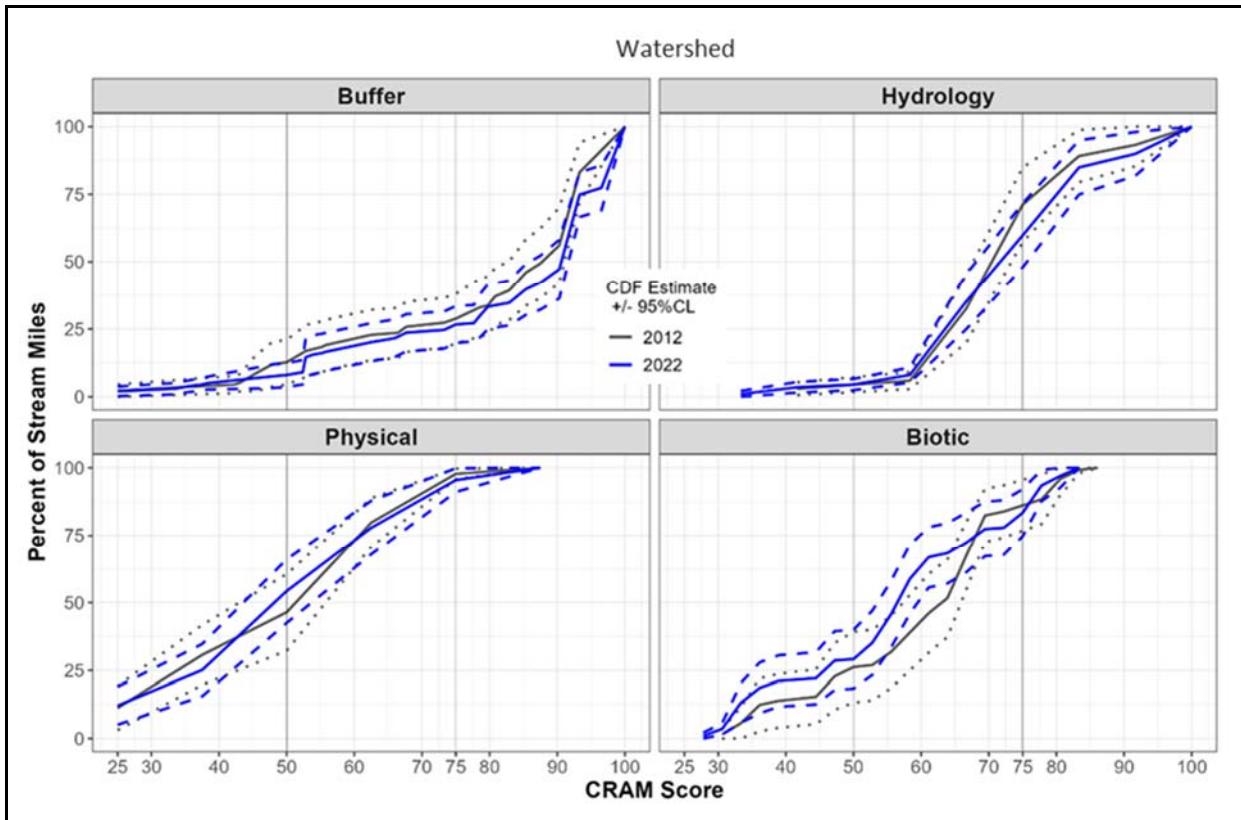
Figure 15. CDF estimates comparing CRAM Attribute Scores for the 2012 and 2022 Guadalupe River Watershed ambient stream condition surveys for the whole watershed. Curves visually compare the relative conditions of streams within each PAI and between survey periods.

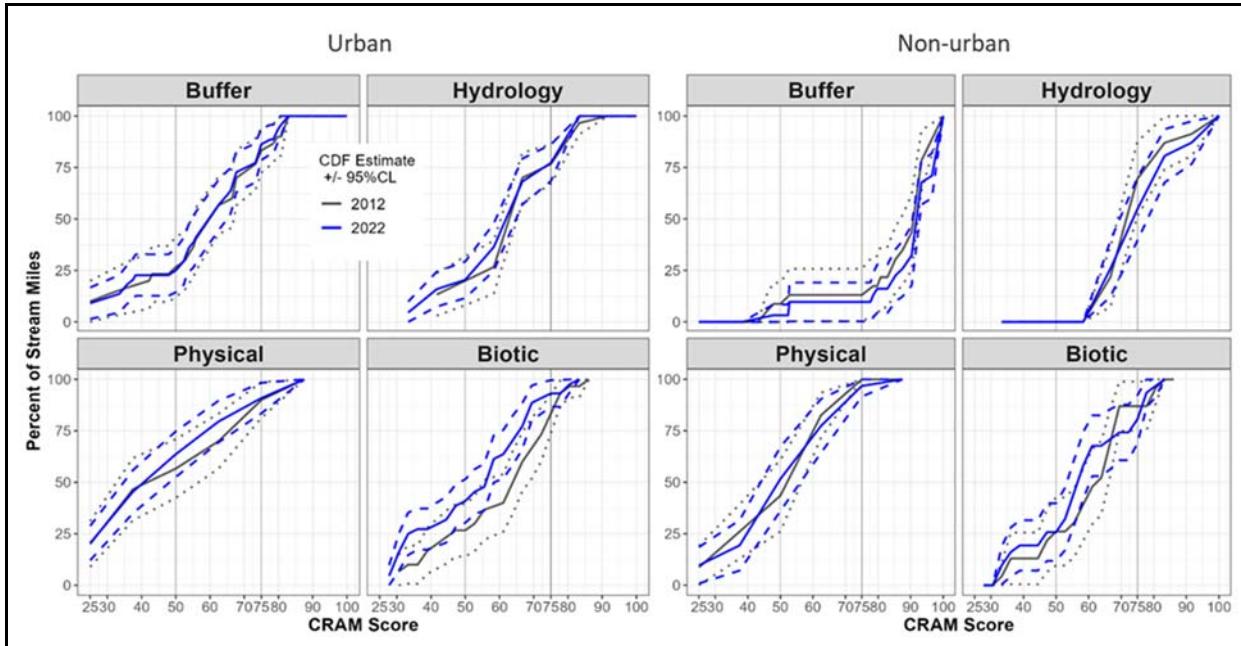
Figure 16. CDF estimates comparing CRAM Attribute Scores for the 2012 and 2022 Guadalupe River watershed ambient stream condition surveys for the Urban PAI (left), and the Non-urban PAI (right). Curves visually compare the relative conditions of streams within each PAI and between survey periods.

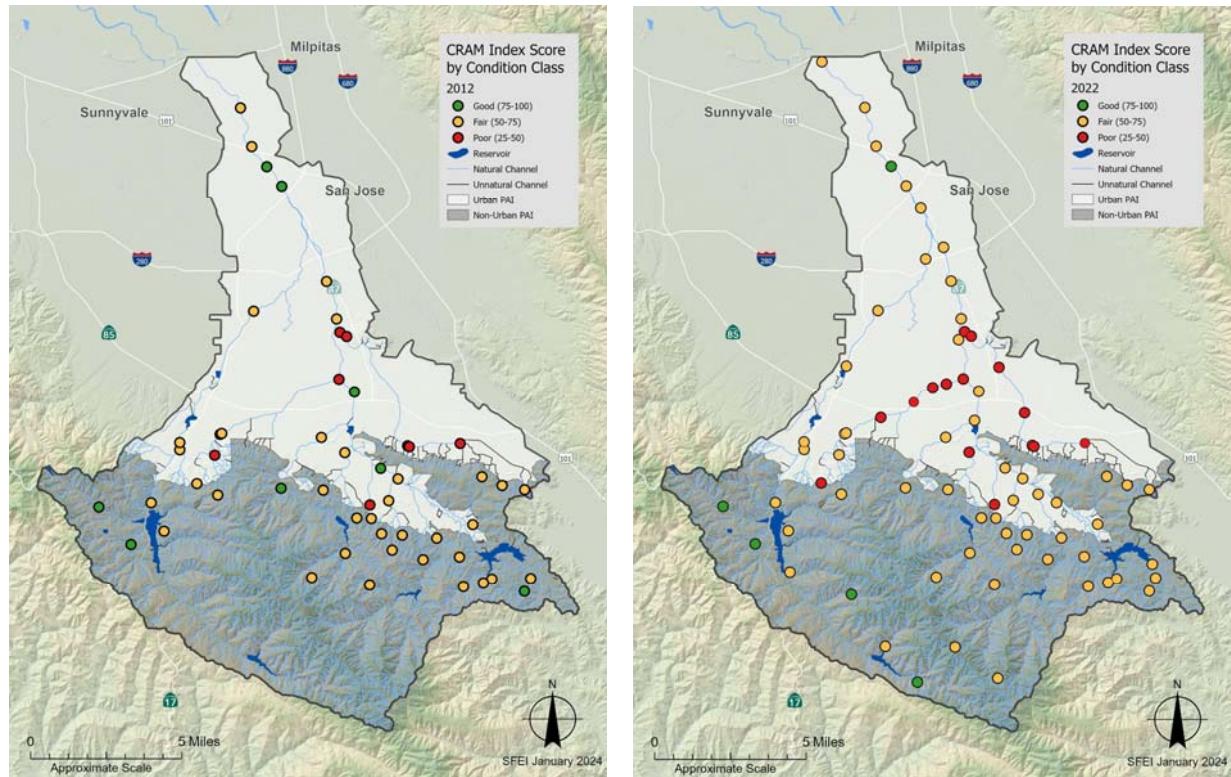
Figure 17. Guadalupe River watershed, Urban and Non-urban PAIs stream condition survey sites (AAs) color-coded by Poor, Fair, and Good ecological condition (CRAM Index Scores ≤ 50 , 51-75, > 75 , respectively). 2012 survey results are shown on the left, and 2022 survey results are shown on the right.

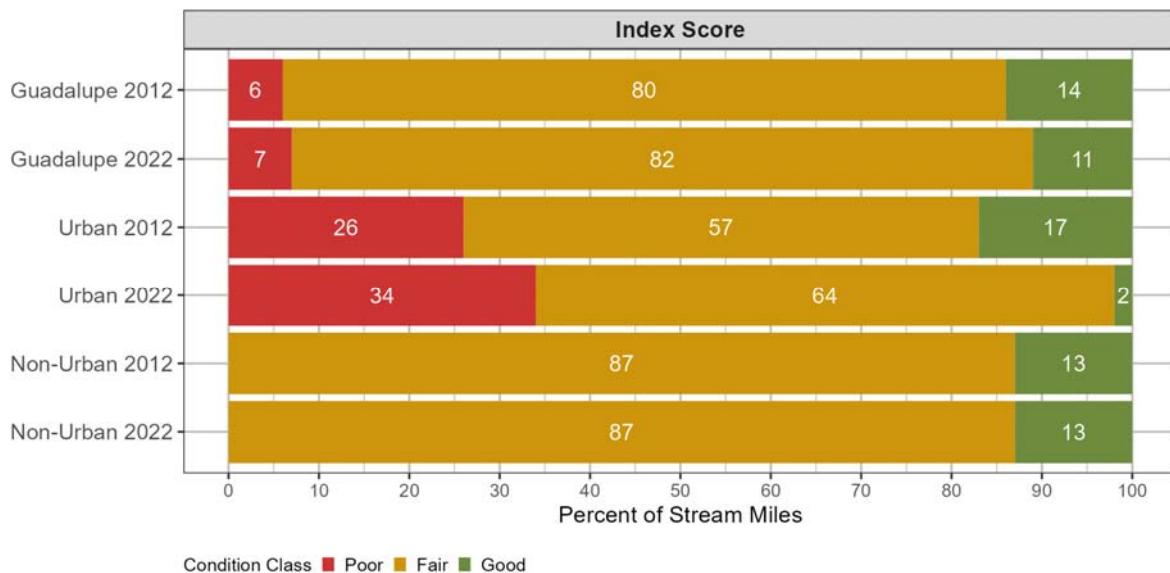
Figure 18. Percent of stream miles in Poor, Fair, and Good ecological condition throughout the Guadalupe River watershed, Urban and Non-urban PAIs in 2012 and 2022.

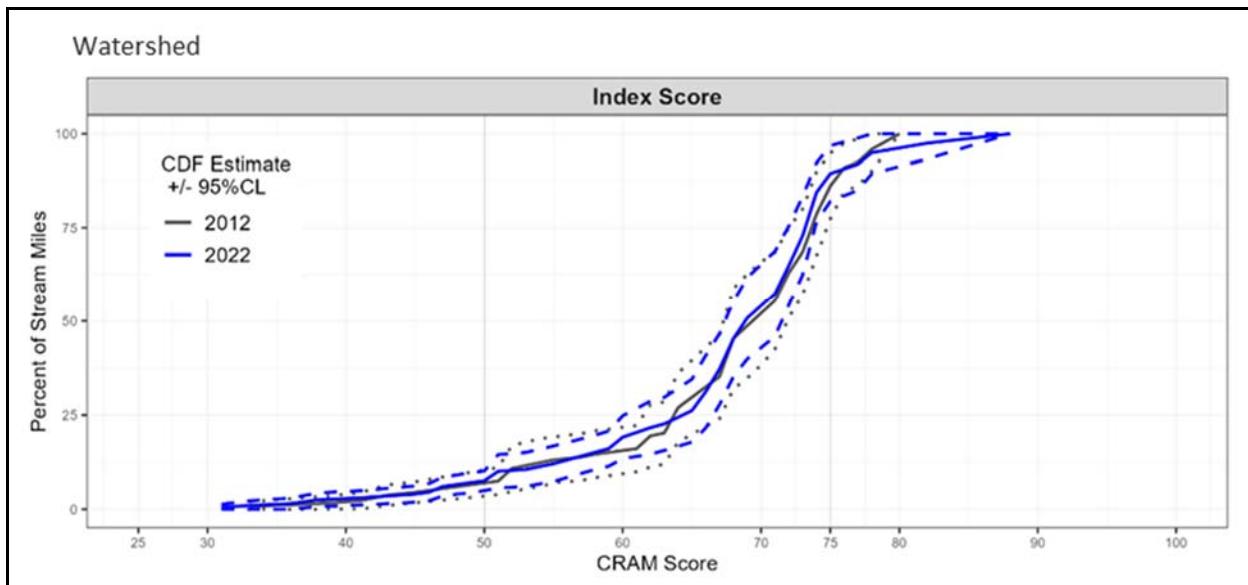
Figure 22. CDF estimates comparing CRAM Index Scores for the 2012 and 2022 Guadalupe River Watershed ambient stream condition surveys at the watershed scale.

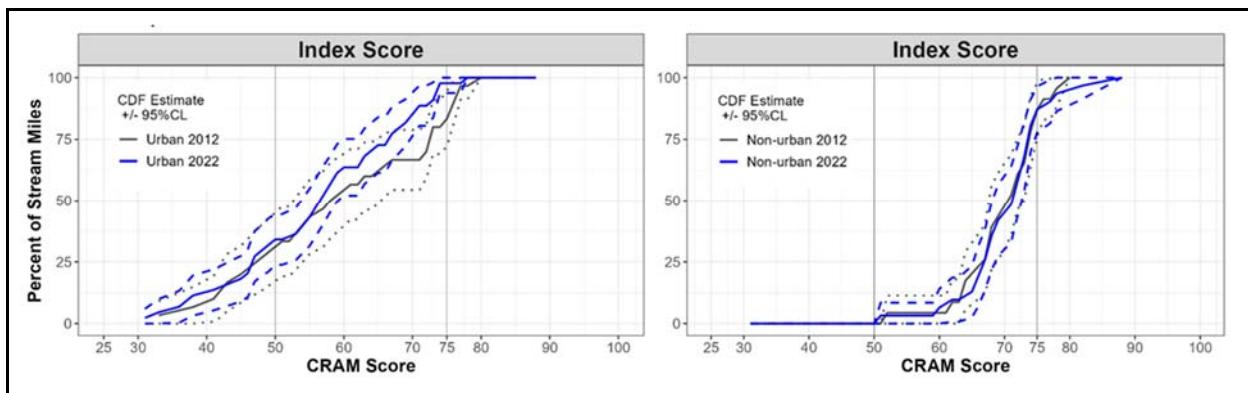
Figure 23. CDF estimates comparing CRAM Index Scores for the 2012 and 2022 Guadalupe River watershed ambient stream condition surveys at the Urban and the Non-urban PAI scales.
