Guadalupe River Watershed Reassessment 2022:

10-Year Reassessment of the Ecological Condition of Streams
Based on the California Rapid Assessment Method

Technical Report prepared for the Santa Clara Valley Water District (Valley Water)

SUBMITTED BY: **San Francisco Estuary Institute**

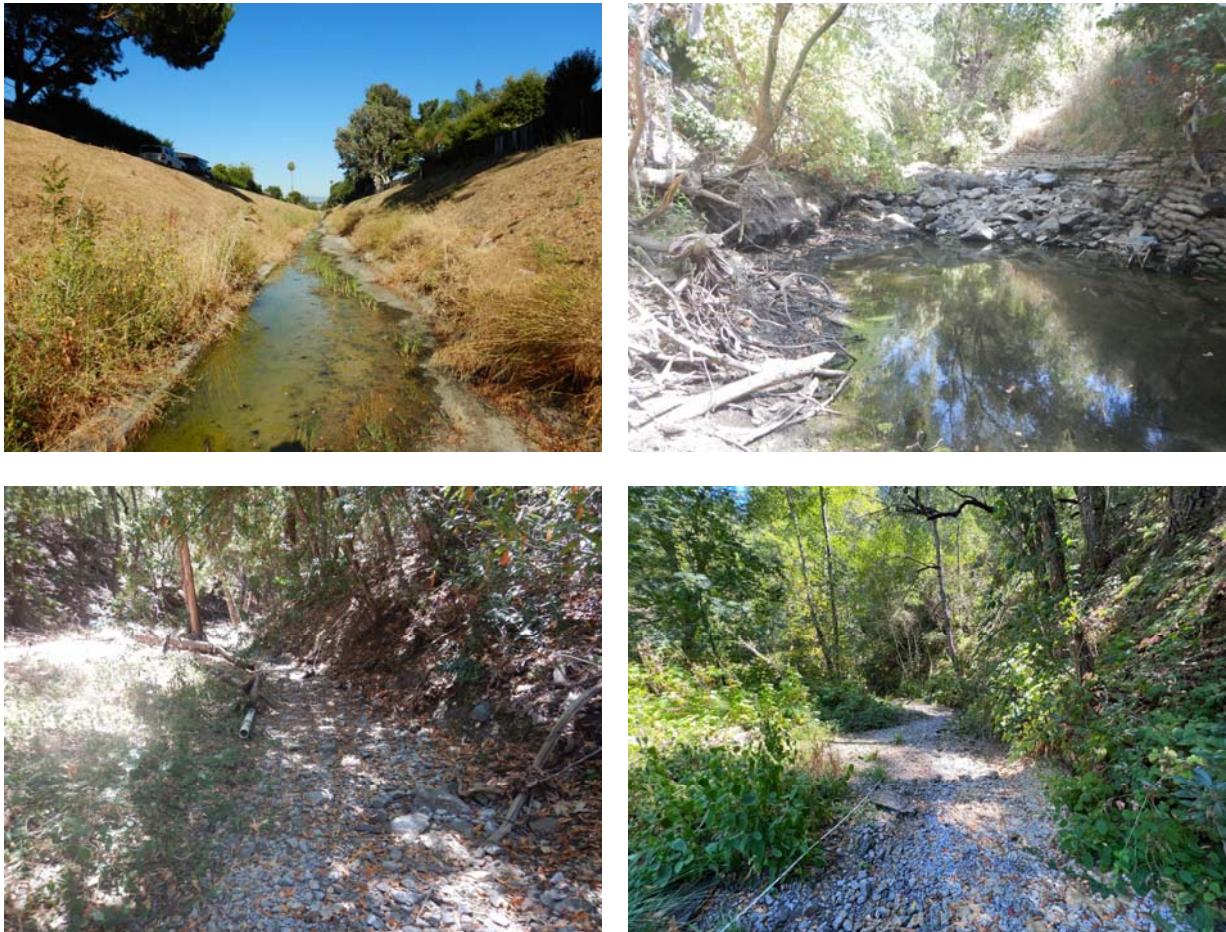
Figure 21. Examples of different stream reaches within Guadalupe River watershed show a range of ecological conditions (from Poor to Good) based on CRAM. Upper left: GR-0128 (2022 Index Score = 31) Upper right: GR-0112 (2022 Index Score = 55) Lower left: GR-0052 (2022 Index Score = 71) Lower right: GR-0701 (2022 Index Score = 88).

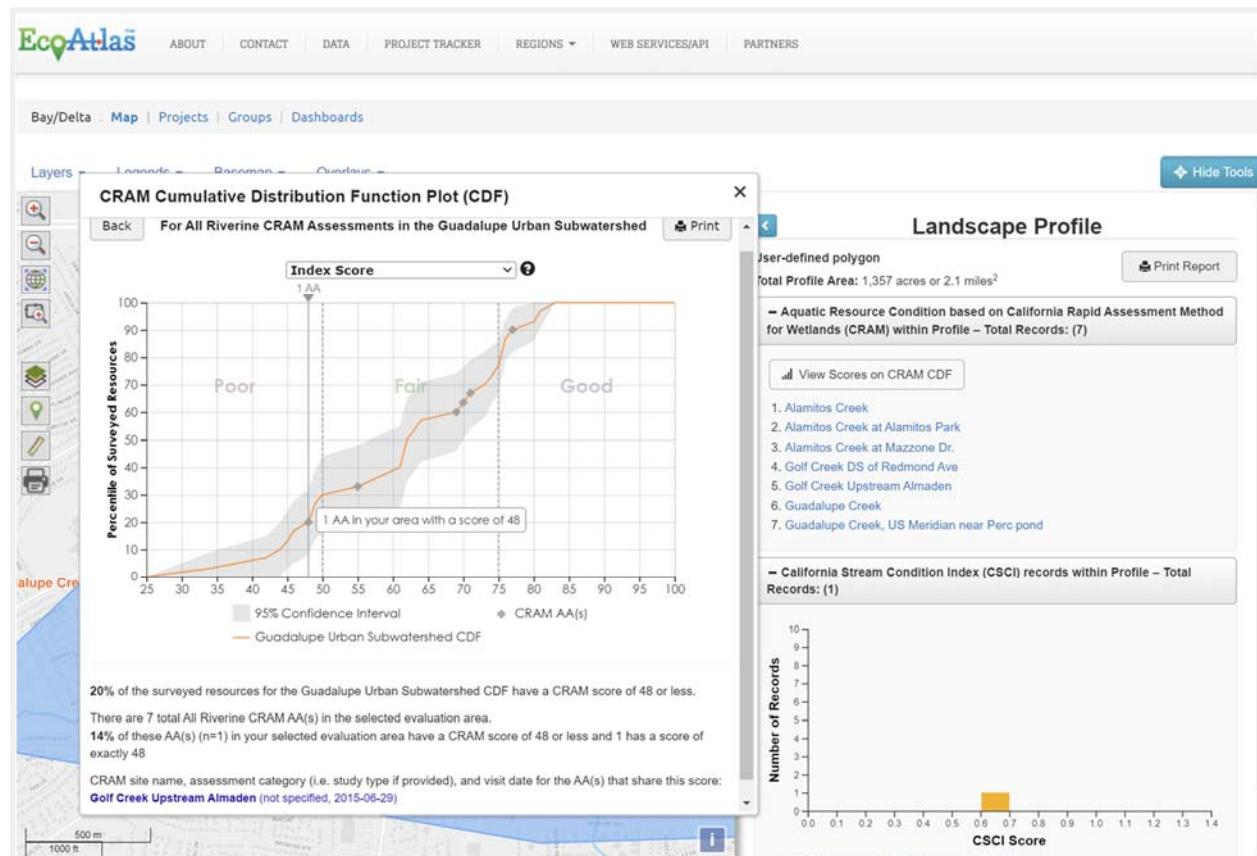
Figure D.2. Screenshot of the Guadalupe River Urban PAI CDF (2012) accessed through EcoAtlas with overlaid CRAM scores (gray diamonds) from AAs located within the user defined area shown in Figure D.1.

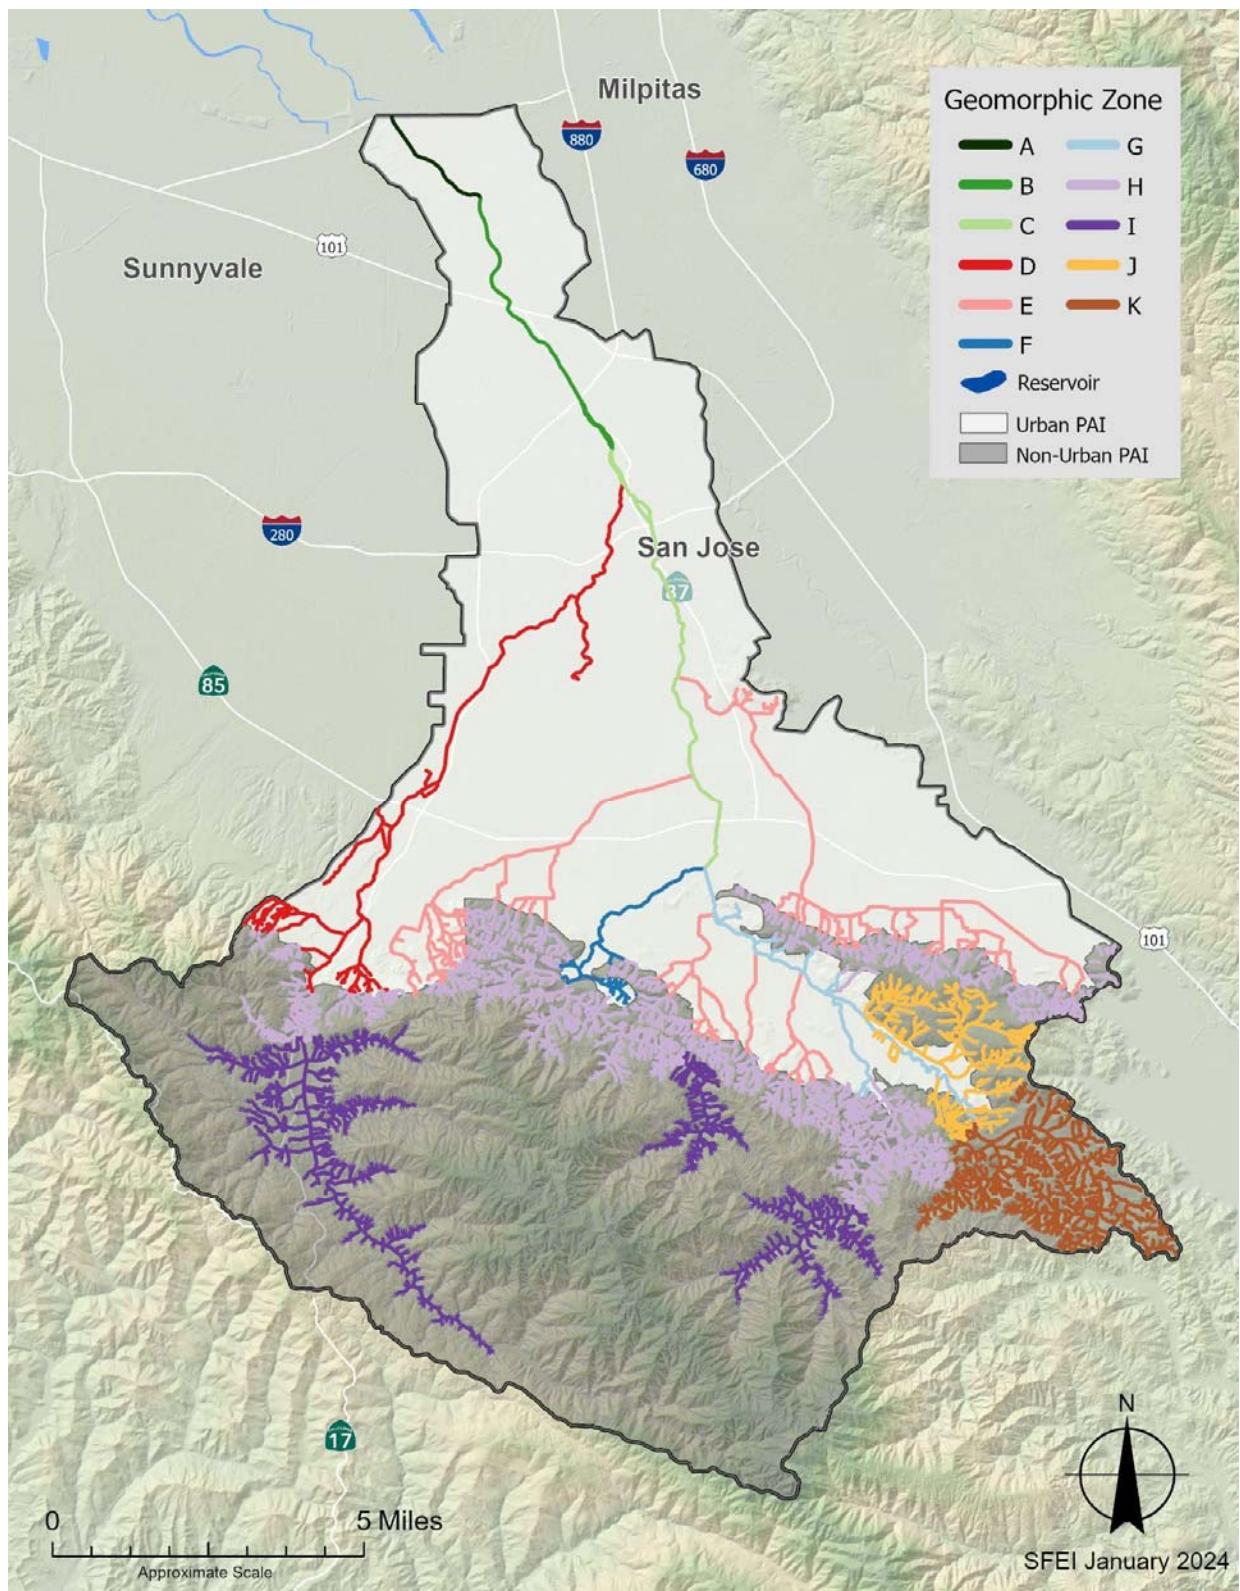
Figure F.1. Map illustrating the channel network within the 11 Geomorphic Zones (color coded and lettered) defined within the Guadalupe River Watershed below the 1,000 ft boundary. In addition, the Urban region PAI boundary and the Non-urban region PAI boundary are shown.

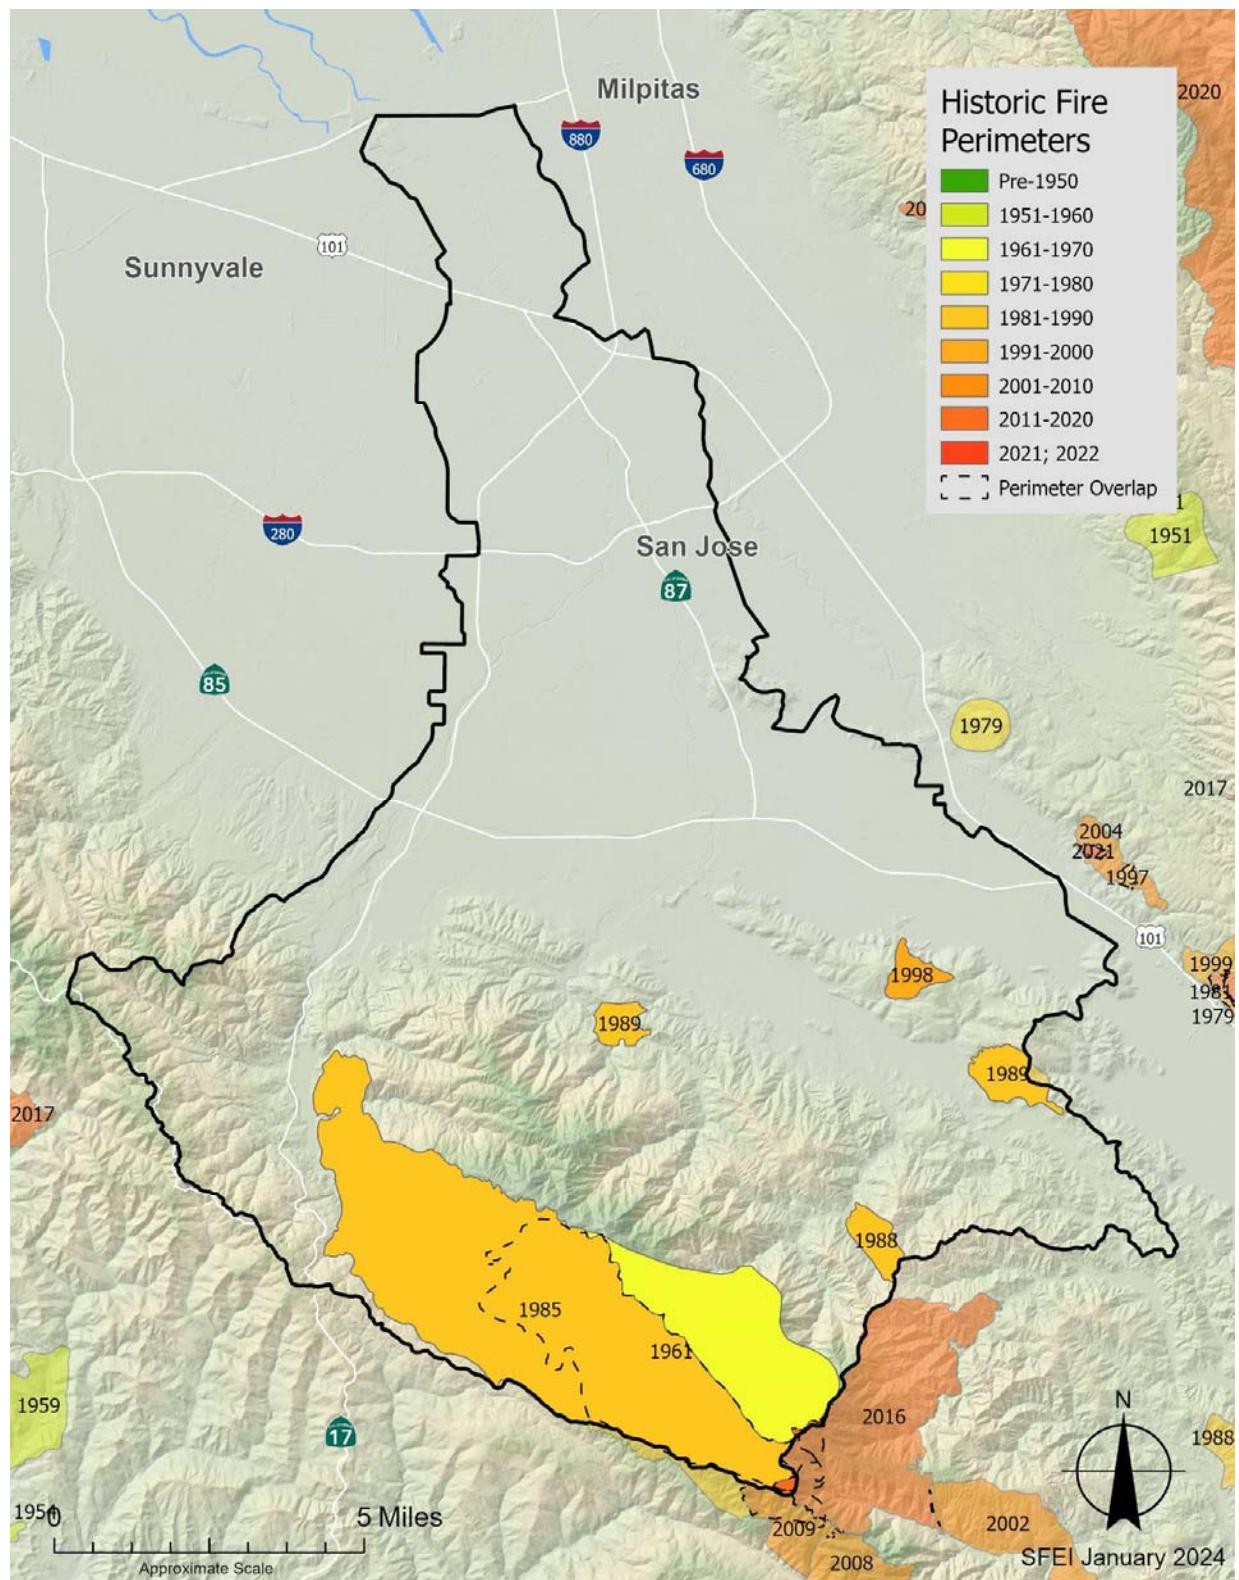
Figure G.1. Map showing the most recent footprint of wildfires (>10 acres/4 ha) that have occurred in and around the Guadalupe River watershed between 1950 and 2022 as documented by the Fire and Resource Assessment Program (FRAP, 2023). This map corresponds to fires listed in Table G.1.
