UPPER LLAGAS TECHNICAL STUDIES  
PROJECT NO. 26174053  
AGREEMENT NO. A2951A

GEOTECHNICAL INVESTIGATION  
UPPER LLAGAS CREEK FLOOD  
PROTECTION PROJECT  
SANTA CLARA COUNTY,  
CALIFORNIA

Subject: Geotechnical Engineering Report  
Upper Llagas Creek Flood Protection Project (ULFPP)  
Morgan Hill, California  
Agreement Number A2951A, File Number 2898

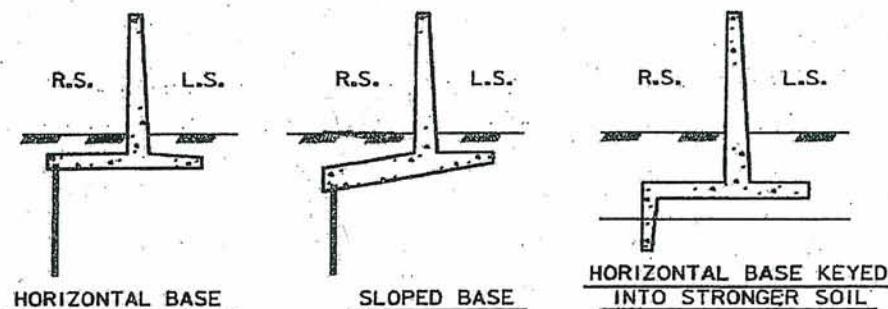
INVERTED T-TYPE CANTILEVER WALLS

The recommendations presented in this section are consistent with the Corps Manual No. EM 1110-2-1913 (Design and Construction of Levees, April 30, 2000) and Corps Manual No. EM 1110-2-2502 (Engineering and Design, Retaining and Flood Walls, September 29, 1989). According to EM 1110-2-2502, the most common types of flood walls are cantilever T-type or cantilever I-type walls. Examples of these two wall types are shown below (from EM 1110-2-2502).

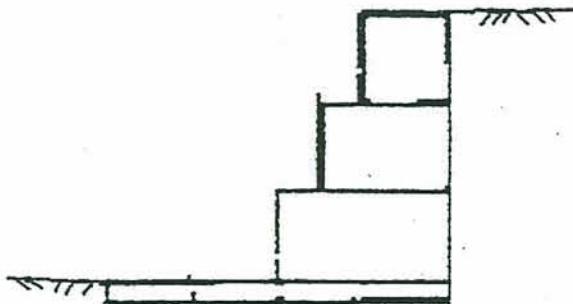
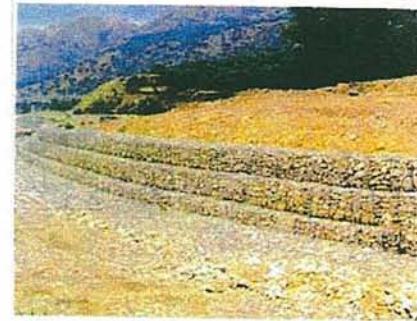
- In portions of Reach 8, the conceptual design includes vertical or near vertical side slopes covered with gabion baskets. Since factors of safety (FOS) are less than Corps requirements, other alternatives will need to be considered, such as:
  - Gabion gravity retaining wall. A schematic cross section and a photograph of the finished product are shown below

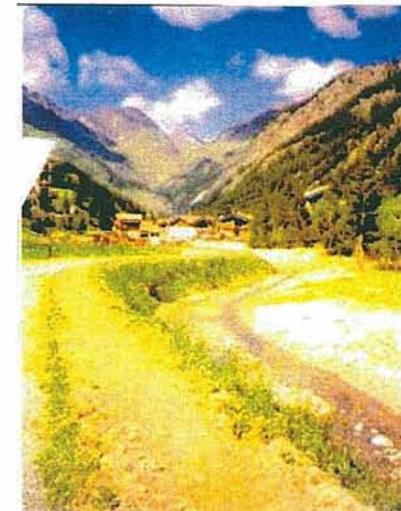
- Reinforced gabion wall with a face angle of less than 70 degrees from horizontal (with horizontal straps and granular backfill). Two schematic cross sections and a photograph of the finished product are shown below.

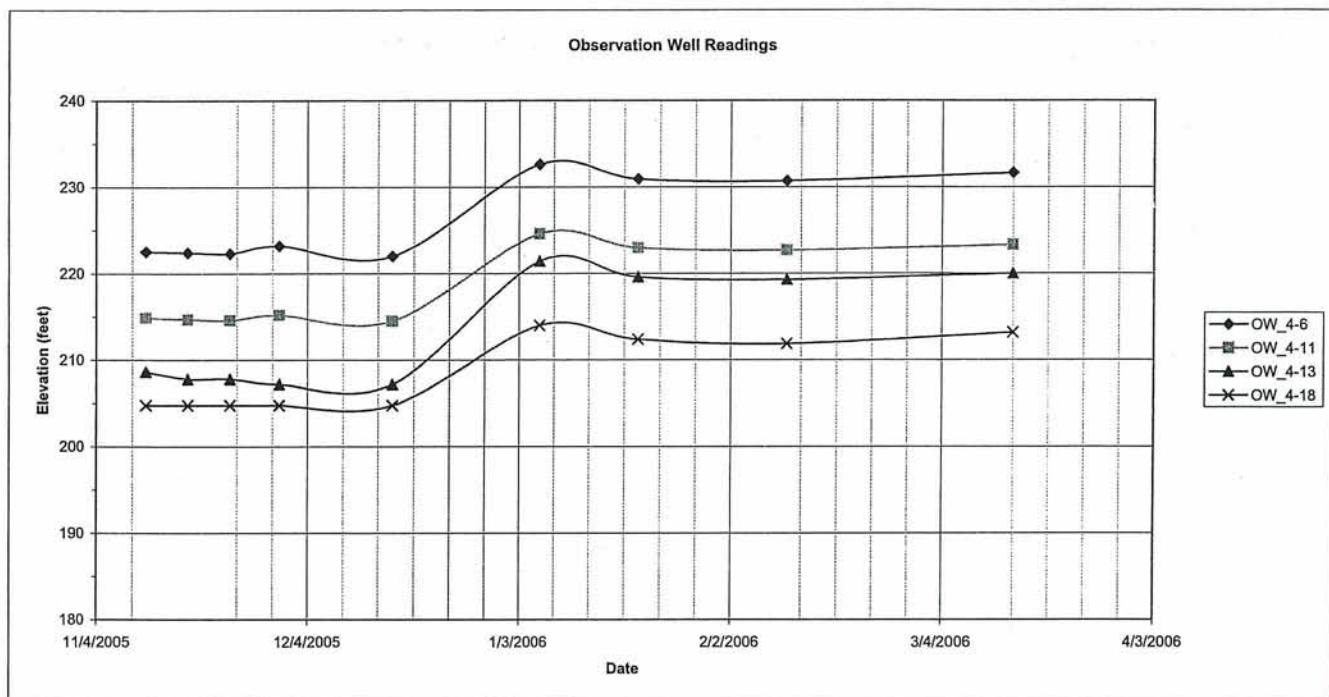
Table 16A  
Observation Well Readings  
Reach 4

Date	11-Nov-05	17-Nov-05	23-Nov-05	30-Nov-05	16-Dec-05	06-Jan-06	20-Jan-06	10-Feb-06	14-Mar-06
Well Number									
OW_4-6	222.53	222.43	222.33	223.23	222.03	232.63	230.93	230.73	231.63
OW_4-11	214.90	214.70	214.60	215.20	214.50	224.60	223.00	222.70	223.30
OW_4-13	208.60	207.80	207.80	207.20	207.20	221.40	219.60	219.30	220.00
OW_4-18	204.78	204.78	204.78	204.78	204.78	213.98	212.38	211.88	213.18

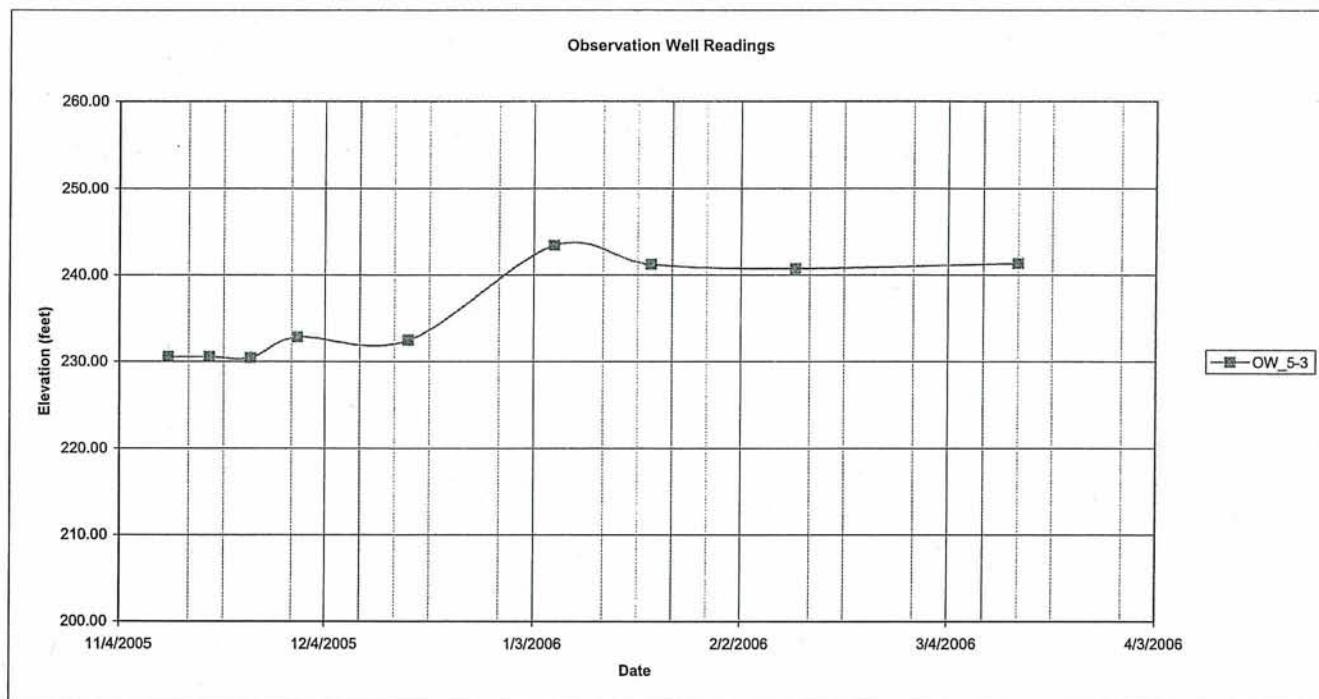
Table 16B  
Observation Well Readings  
Reach 5

Date	11-Nov-05	17-Nov-05	23-Nov-05	30-Nov-05	16-Dec-05	6-Jan-06	20-Jan-06	10-Feb-06	14-Mar-06	
Well Number	OW_5-3	230.54	230.54	230.44	232.84	232.44	243.44	241.24	240.74	241.34

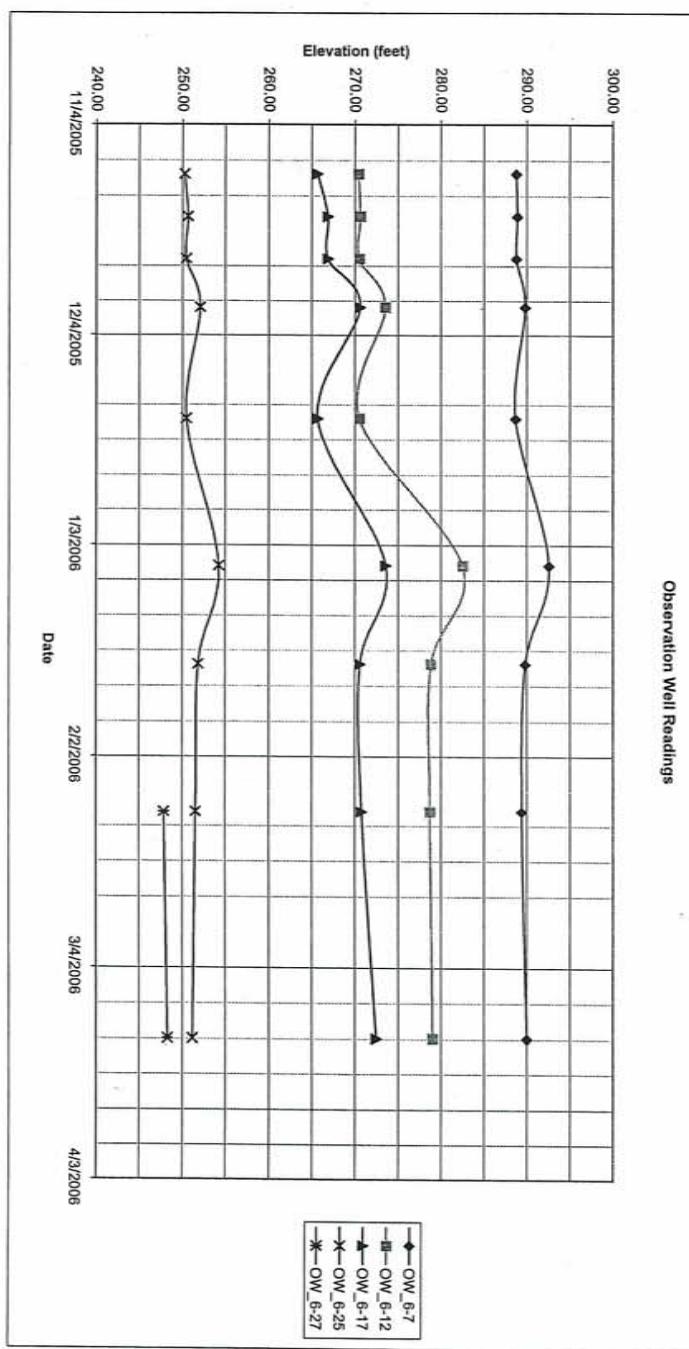
Table 16C  
Observation Well Readings  
Reach 6

Well Number	Date	11-Nov-05	17-Nov-05	23-Nov-05	30-Nov-05	16-Dec-05	06-Jan-06	20-Jan-06	10-Feb-06	14-Mar-06
OW 6-7		288.79	288.89	288.79	289.79	288.69	292.59	289.79	289.39	289.99
OW 6-12		270.41	270.61	270.51	273.51	270.51	282.51	278.81	278.71	279.01
OW 6-17		265.67	266.87	266.87	270.57	265.67	273.57	270.57	270.77	272.47
OW 6-25		250.25	250.65	250.45	252.05	250.45	254.25	251.85	251.55	251.15
OW 6-27								247.88	248.28

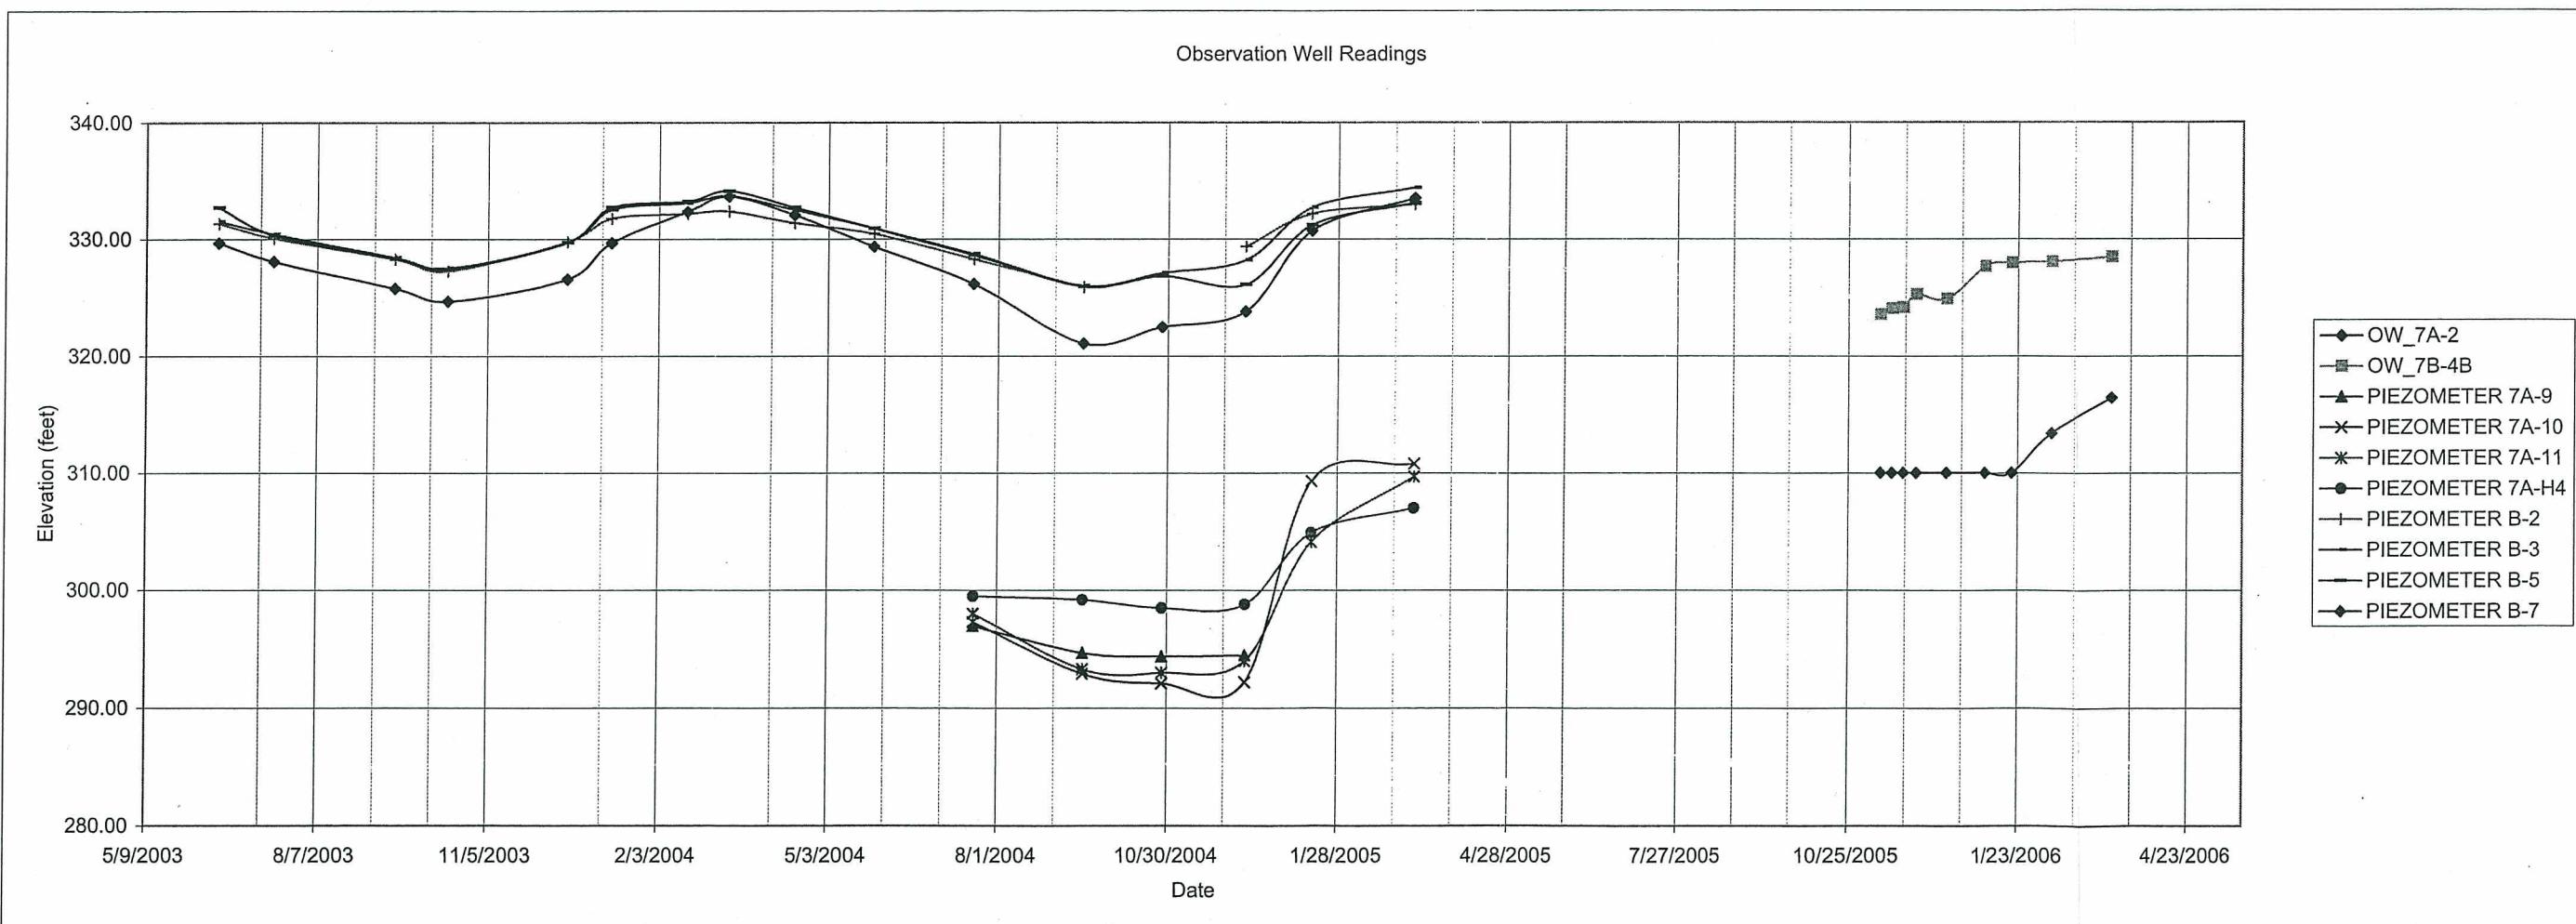
Table 16D  
Observation Well Readings  
Reach 7A and 7B

Date	19-Jul-04	15-Sep-04	27-Oct-04	10-Dec-04	14-Jan-05	9-Mar-05
Well Number						
PIEZOMETER 7A-9	296.97	294.67	294.37	294.47		
PIEZOMETER 7A-10	297.30	292.90	292.10	292.20	309.30	310.80
PIEZOMETER 7A-11	298.00	293.30	293.00	294.00	304.10	309.70
PIEZOMETER 7A-H4	299.50	299.20	298.50	298.80	304.90	307.00

Date	16-Jun-03	15-Jul-03	17-Sep-03	15-Oct-03	17-Dec-03	9-Jan-04	18-Feb-04	11-Mar-04	15-Apr-04	27-May-04	19-Jul-04	15-Sep-04	27-Oct-04	10-Dec-04	14-Jan-05	9-Mar-05
Well Number																
PIEZOMETER B-2	331.33	330.08	328.28	327.28	329.78	331.78	332.18	332.38	331.38	330.48	328.28	325.88		329.38	332.18	332.98
PIEZOMETER B-3	331.52	330.44	328.42	327.52	329.72	332.52	333.12	333.72	332.52	330.92	328.72	326.02	327.12	328.22	332.72	334.42
PIEZOMETER B-5	332.73	330.33	328.33	327.43	329.73	332.73	333.23	334.13	332.73	330.93	328.63	325.93	326.83	326.12	331.22	333.12
PIEZOMETER B-7	329.68	328.08	325.78	324.68	326.58	329.68	332.38	333.68	332.08	329.38	326.18	321.08	322.48	323.82	330.72	333.52

Date	11-Nov-05	17-Nov-05	23-Nov-05	30-Nov-05	16-Dec-05	06-Jan-06	20-Jan-06	10-Feb-06	14-Mar-06
Well Number									
OW 7A-2	310.02	310.02	310.02	310.02	310.02	310.02	310.02	313.42	316.42
OW 7B-4B	323.58	324.08	324.18	325.28	324.88	327.68	327.98	328.08	328.48

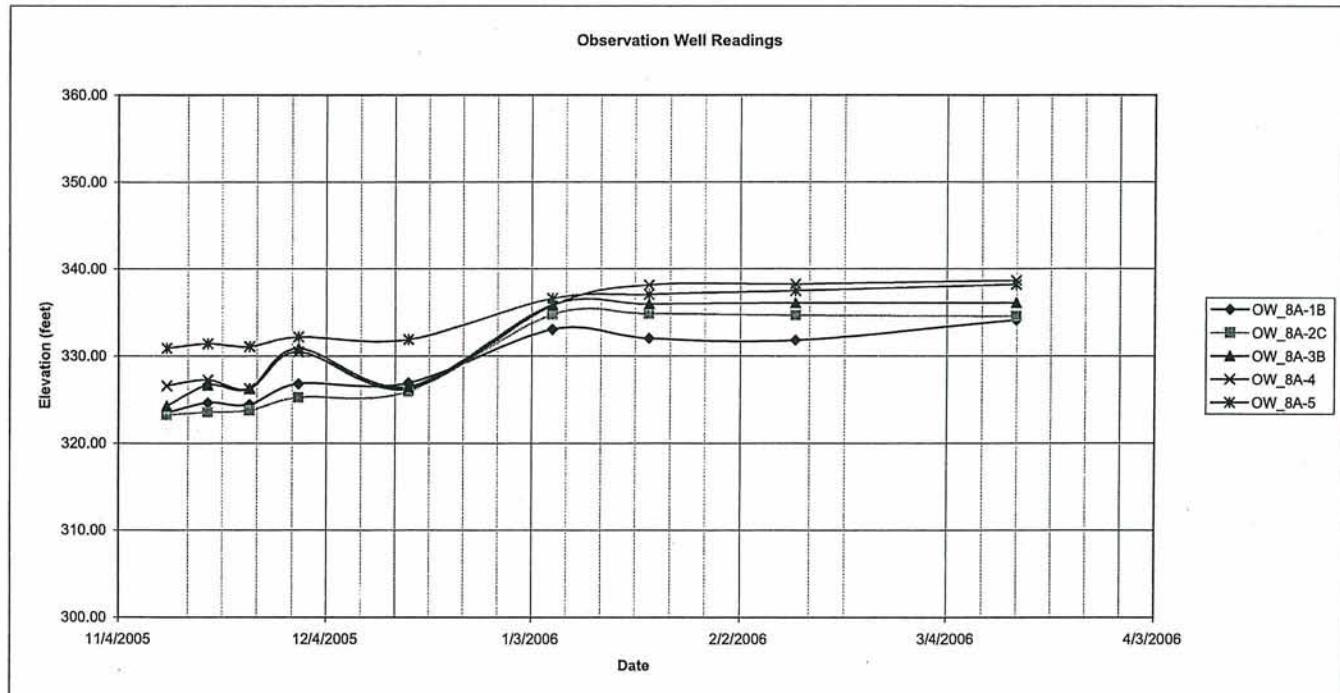
Table 16E  
Observation Well Readings  
Reach 8

Date	11-Nov-05	17-Nov-05	23-Nov-05	30-Nov-05	16-Dec-05	06-Jan-06	20-Jan-06	10-Feb-06	14-Mar-06
Well Number									
OW_8A-1B	323.53	324.63	324.43	326.83	326.93	333.03	332.03	331.83	334.13
OW_8A-2C	323.26	323.56	323.76	325.26	325.96	334.76	334.86	334.66	334.56
OW_8A-3B	324.27	326.67	326.27	330.87	326.47	335.87	335.97	336.07	336.07
OW_8A-4	326.57	327.27	326.27	330.47	326.27	335.77	338.17	338.27	338.67
OW_8A-5	330.89	331.39	331.09	332.19	331.89	336.59	337.09	337.49	338.19

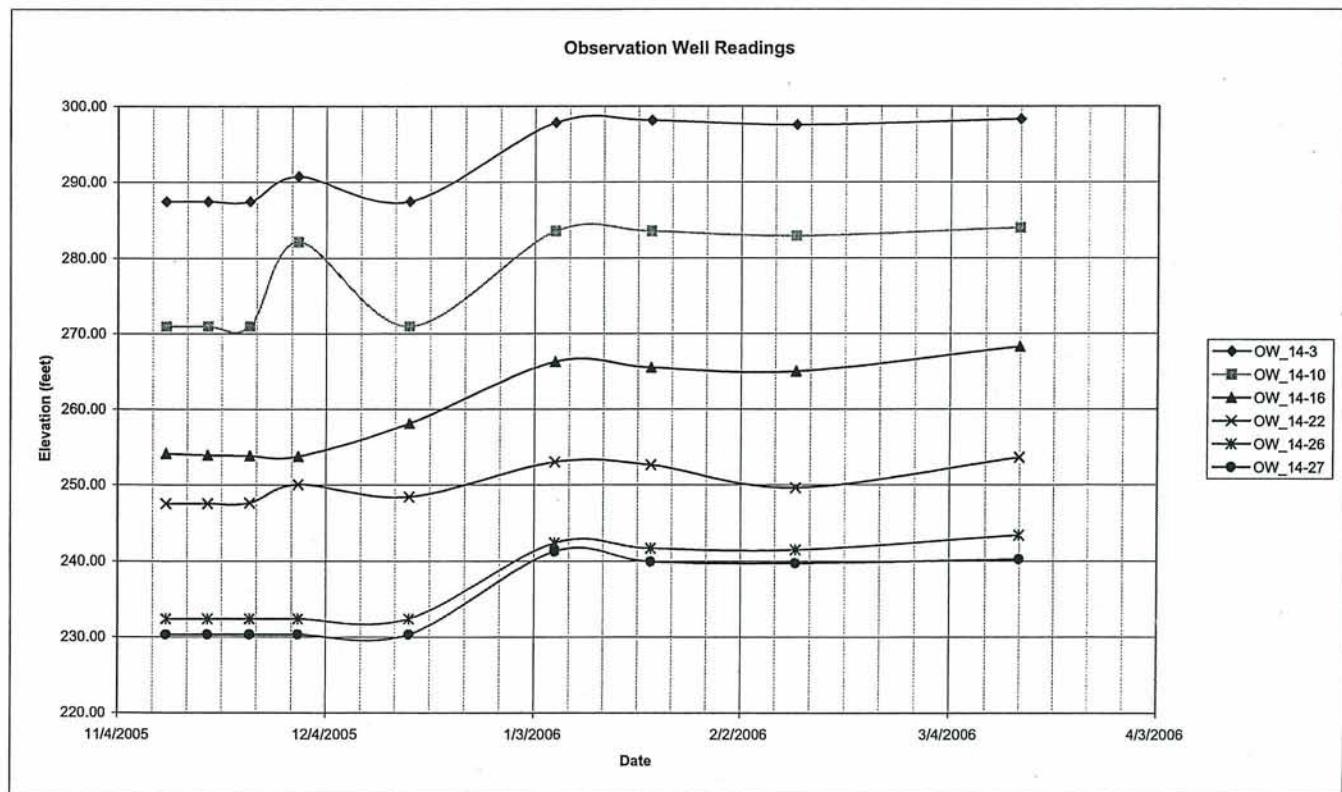
Table 16F  
Observation Well Readings  
Reach 14

Date	11-Nov-05	17-Nov-05	23-Nov-05	30-Nov-05	16-Dec-05	06-Jan-06	20-Jan-06	10-Feb-06	14-Mar-06
Well Number									
OW_14-3	287.42	287.42	287.42	290.72	287.42	297.82	298.12	297.52	298.32
OW_14-10	271.00	271.00	271.00	282.10	271.00	283.50	283.50	282.90	284.00
OW_14-16	254.13	253.93	253.83	253.73	258.13	266.33	265.53	265.03	268.33
OW_14-22	247.51	247.51	247.61	250.01	248.41	253.01	252.61	249.61	253.61
OW_14-26	232.38	232.38	232.38	232.38	232.38	242.38	241.68	241.48	243.38
OW_14-27	230.34	230.34	230.34	230.34	230.34	241.24	239.94	239.74	240.24

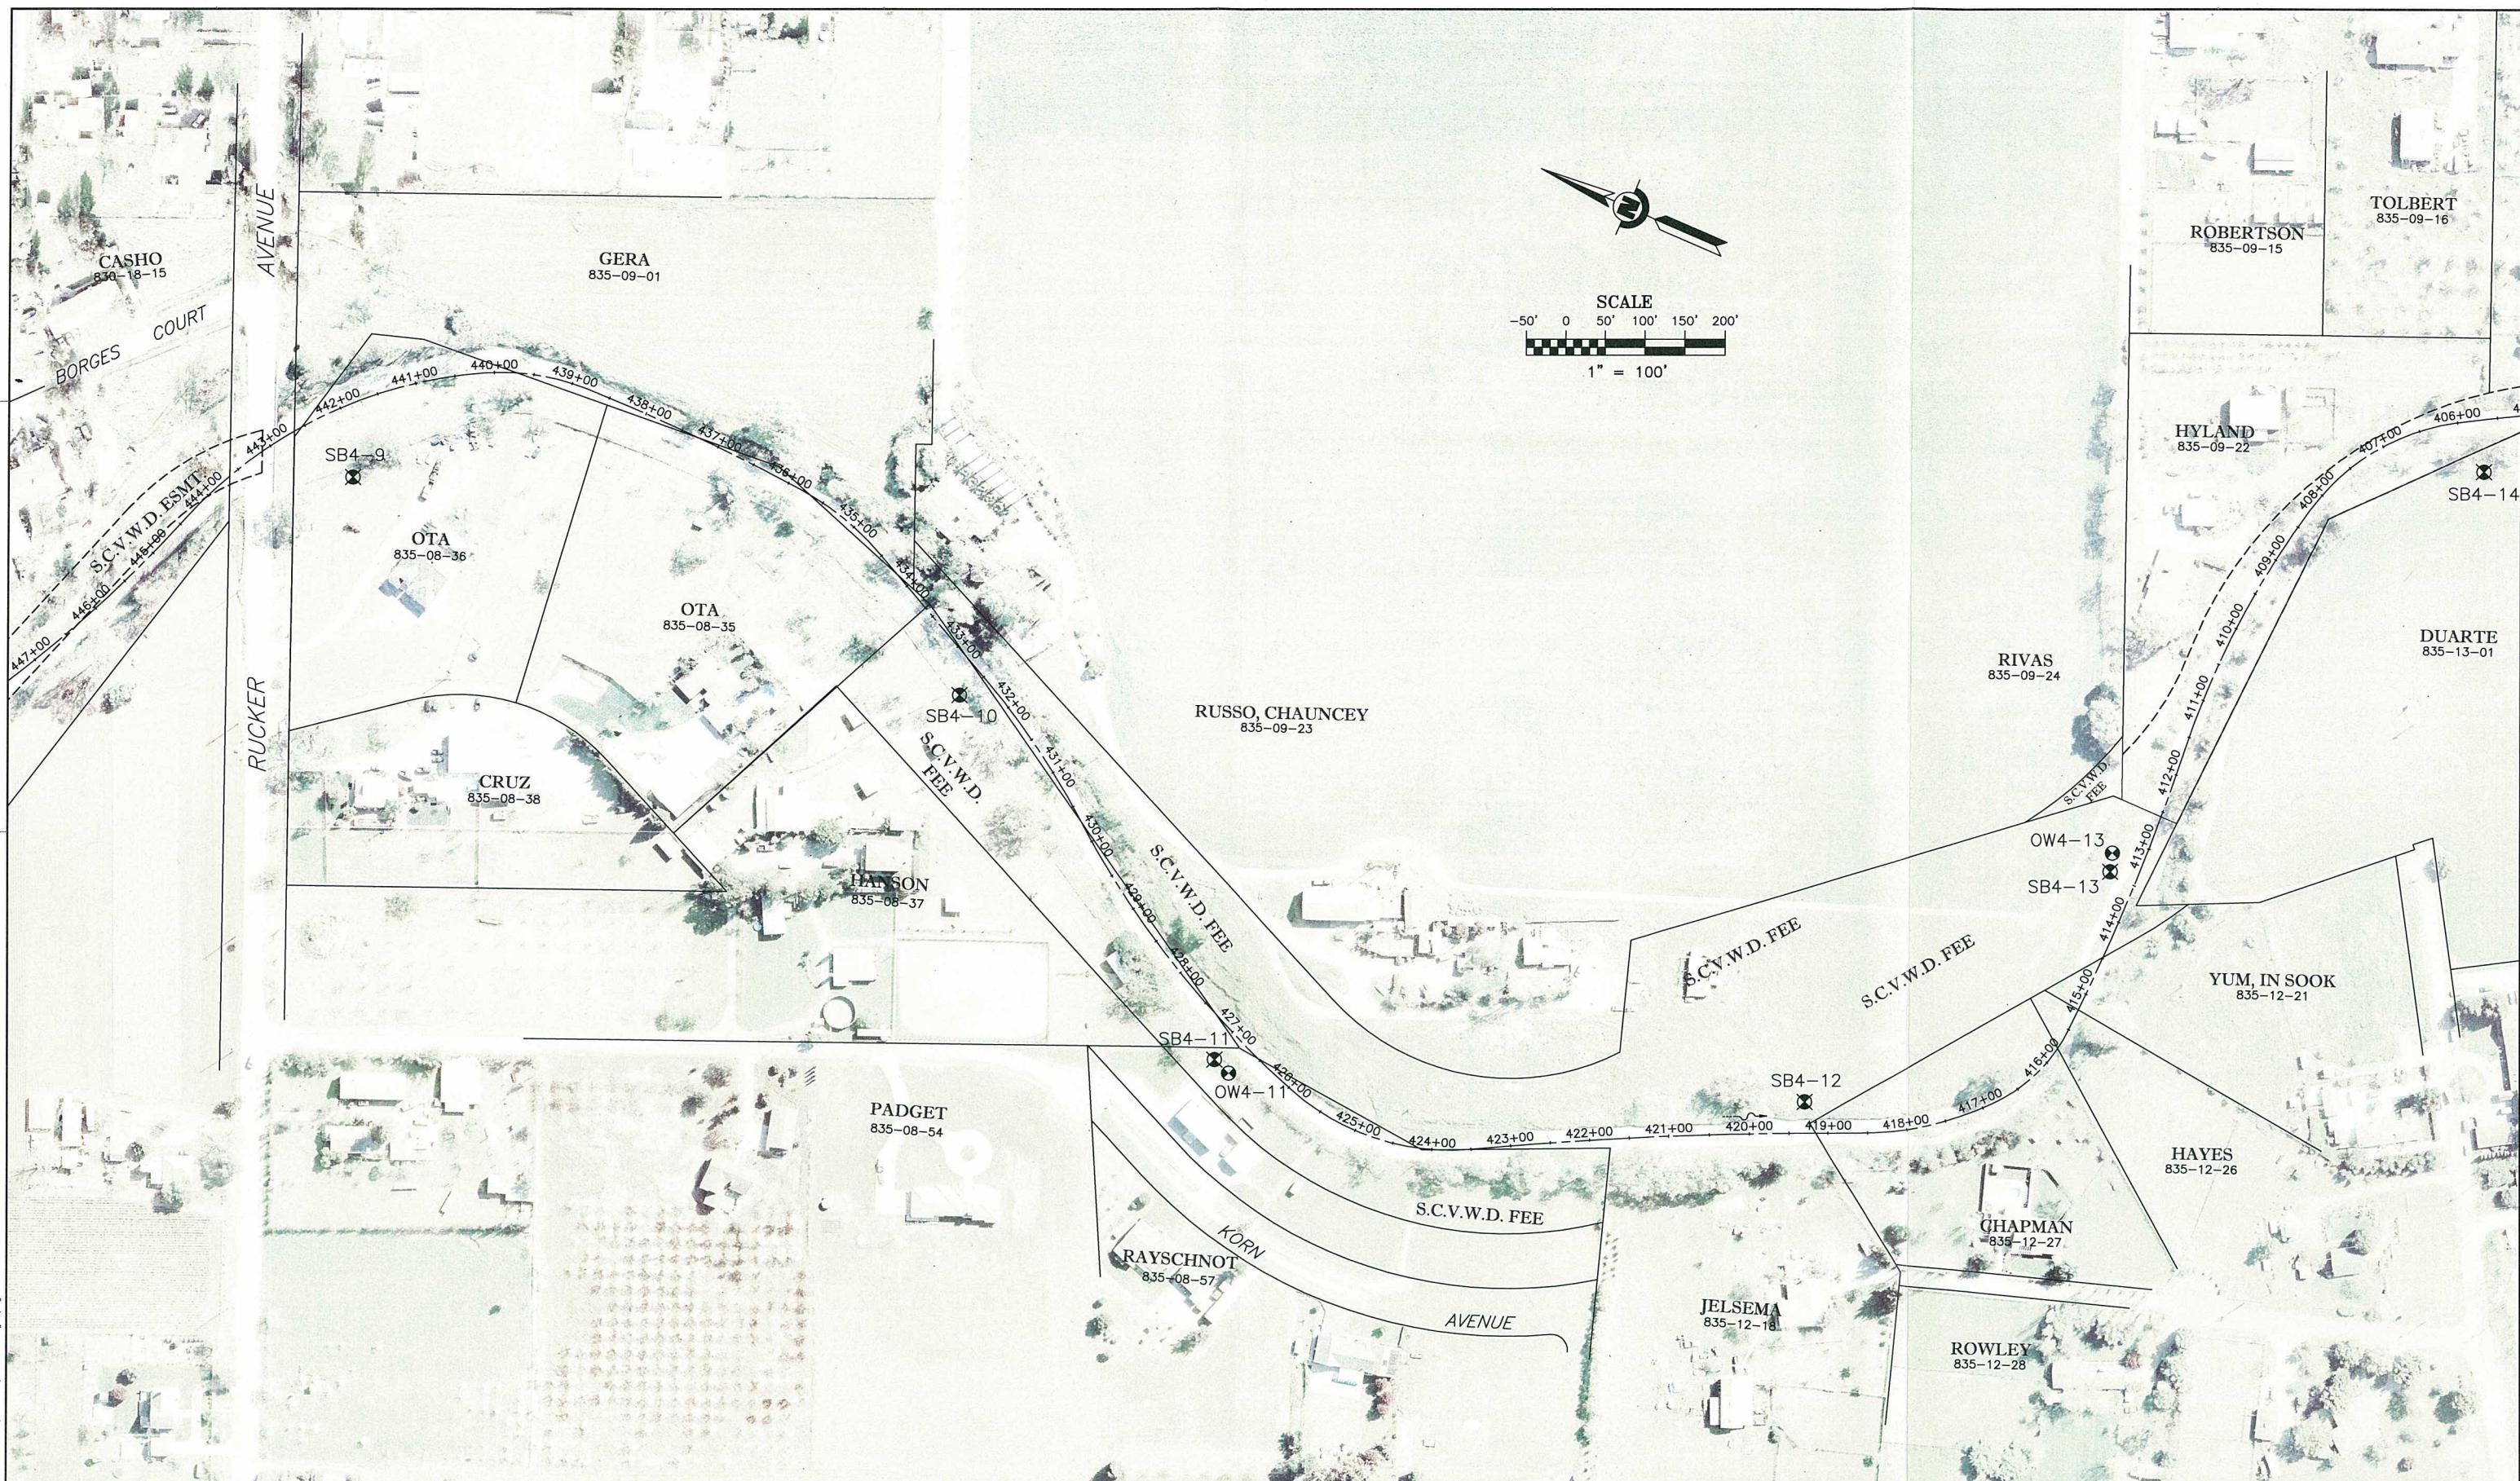
SCALE 1" = 100'	PROJECT NUMBER 26174053
VERIFY SCALES 0 1"	FIGURE 6
BAR IS ONE INCH ON ORIGINAL DRAWING IF NOT ONE INCH ON THIS SHEET, ADJUST SCALES ACCORDINGLY

PROJECT NAME AND SHEET DESCRIPTION:  
UPPER LLAGAS CREEK  
TECHNICAL STUDIES  
REPORT OF FIELD ACTIVITIES  
REACH 4  
SOIL BORING SITE PLAN

The locations and layout of the project are shown in Figure 1, Location Map, Figure 2, Site Map and in Figure 3, Reach Location Plan; the latter figure presents the location of the six reaches: Reach 4, Reach 5, Reach 6, Reach 7, Reach 8 and Reach 14. The Site Map, Sheet Index and Drawing List is presented in Figure 4. A more detailed layout of the project, including the approximate centerline with stationing presented in feet, is shown on the Soil Boring Site Plans, Figures 5 through 27.
