MEMORANDUM

SUBJECT: Stevens Creek Fish Passage
Remediation

STEVENS CREEK FISH PASSAGE ANALYSIS

CONCEPTUAL APPROACHES TO REMEDY FISH PASSAGE IMPEDIMENTS IN STEVENS CREEK

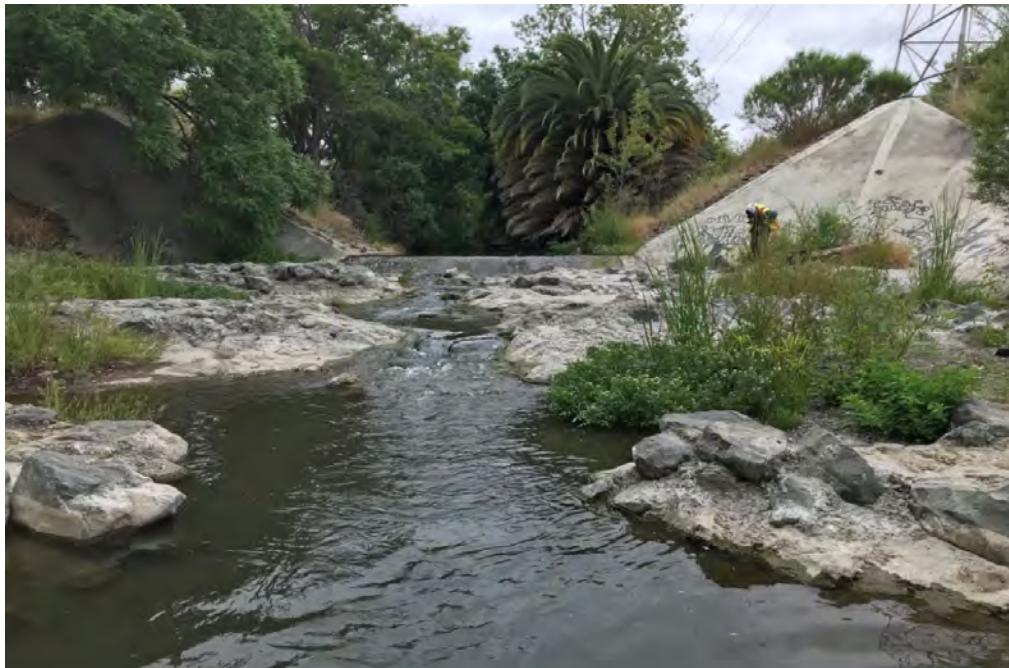
PAD ID: 713640

View from downstream looking upstream at grouted rock veins and concrete drop structure

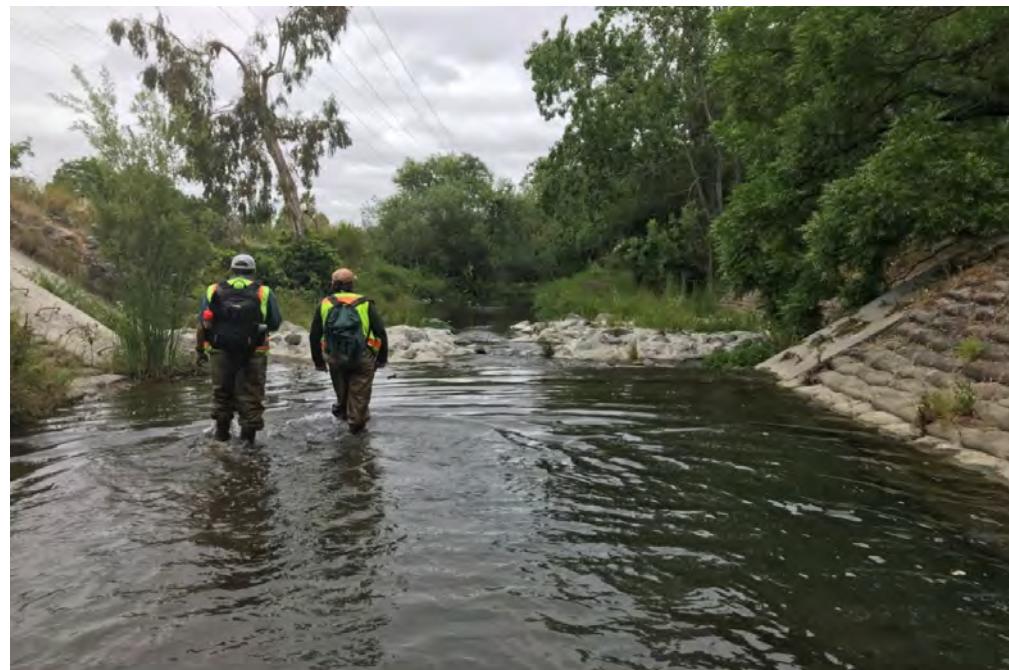
View from upstream looking downstream at drop structure

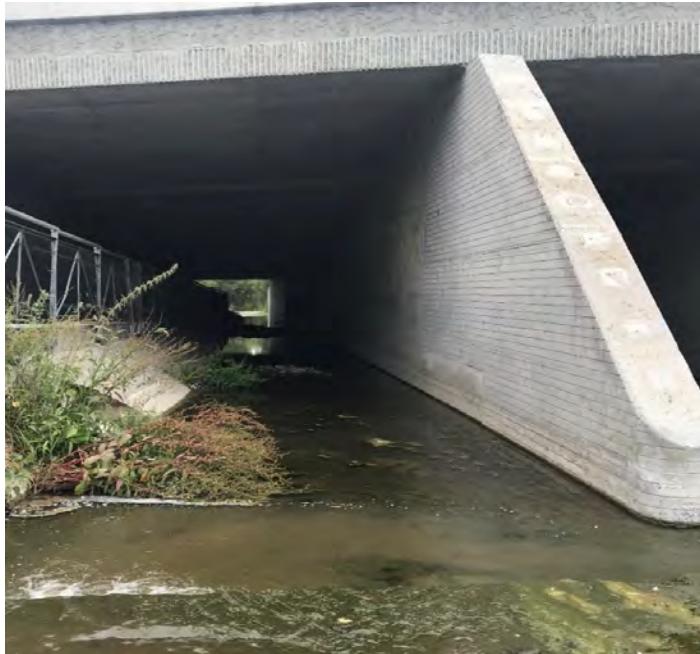
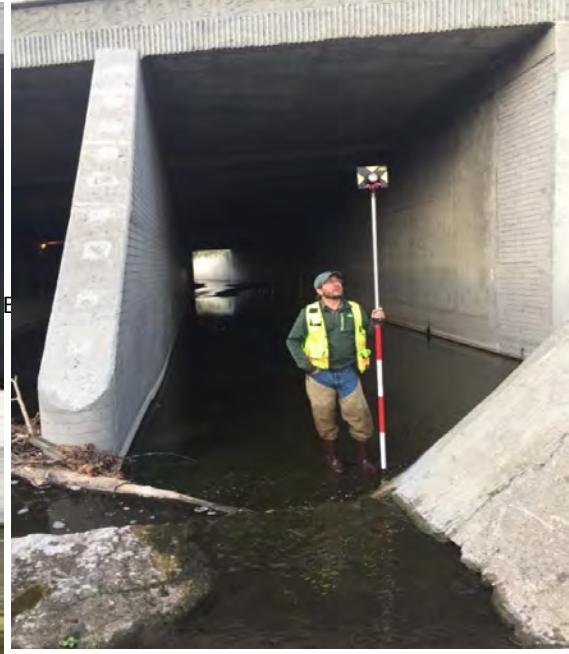
PAD ID: 705646

Looking downstream at Highway 101 inlet (a) west culvert and (b) east culvert, with inlet drop in foreground

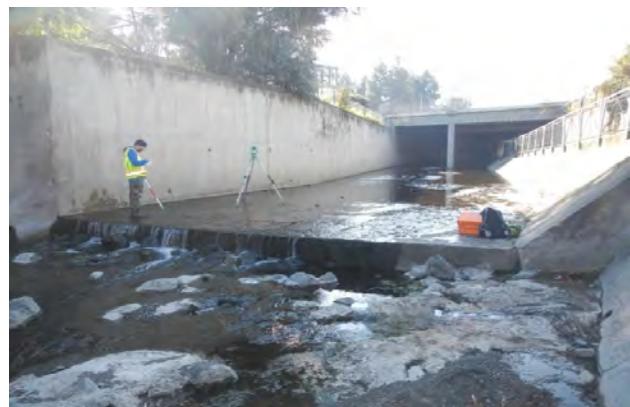
Highway 101 (a) culvert outlet looking upstream and (b) grouted rock veins looking downstream

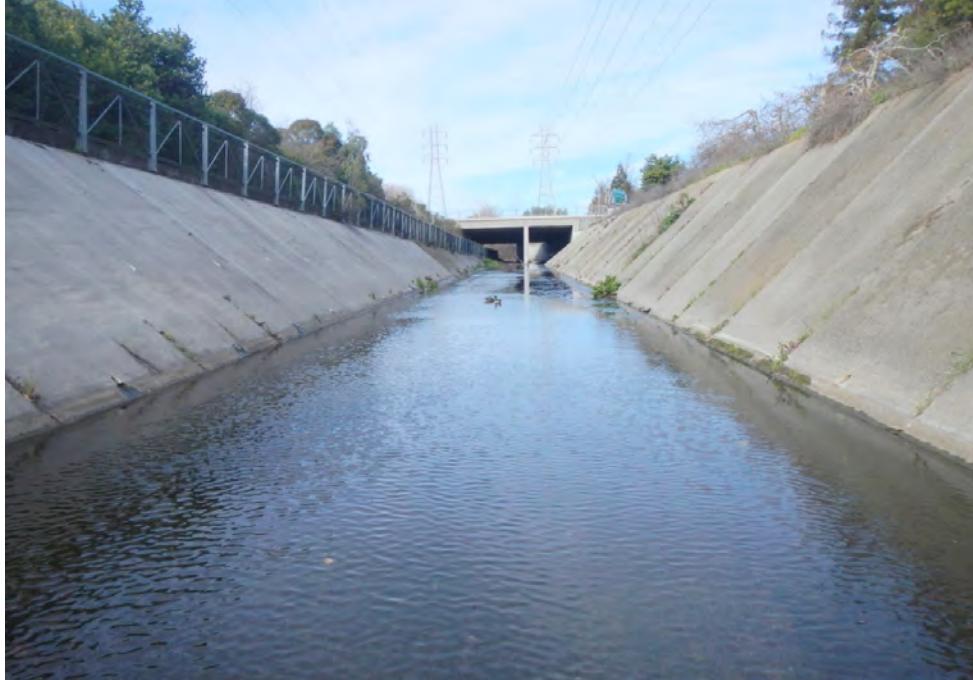
PAD ID: 707059

Concrete channel downstream of Moffett Drop Structure, looking downstream to Highway 101 crossing (Site 2)

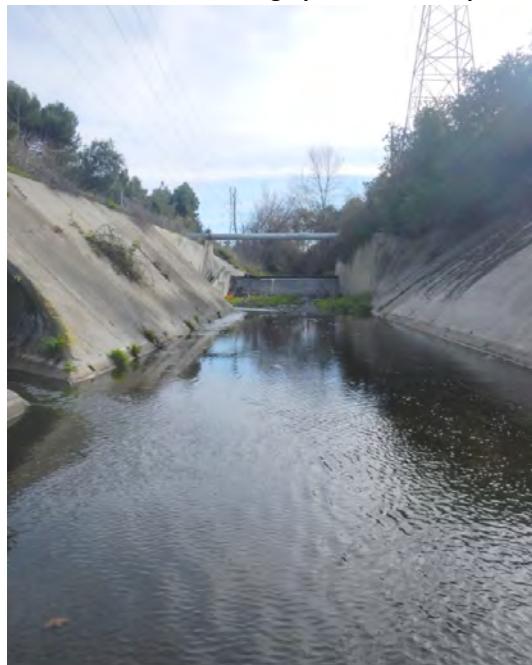
Concrete channel looking upstream to drop structure

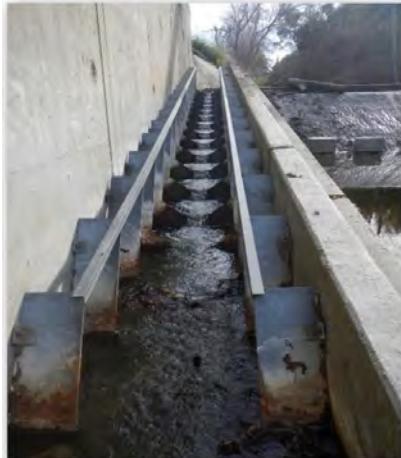
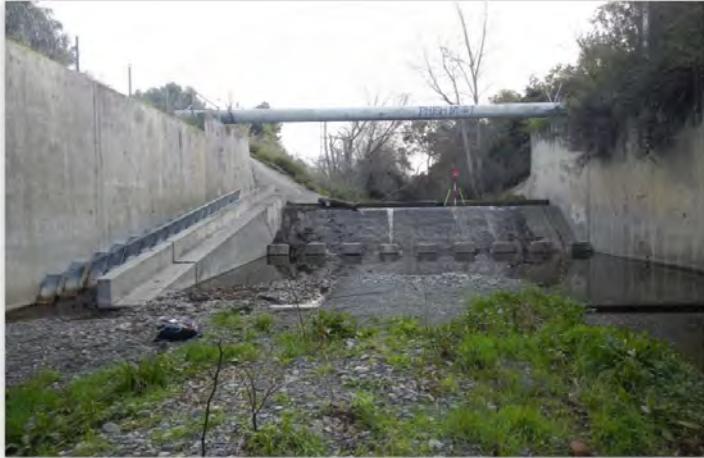
PAD ID: 707059

- Site 3 (Moffett fish ladder) received a score of 14 and is in the red score category. However, observed frequent clogging of the fish ladder with small debris, which makes it impassable much of the migration season, is not captured by the model results. Denil fish ladders (Site 3 and Site 21) have a propensity to clog with sediment and small debris. Maintenance during the migration season is restricted to manual debris removal, which is not always effective or possible during high flows, so these sites may be impassable during substantial portions of the migration season when steelhead are most likely attempting to migrate upstream. Adult passage at this site is likely much lower than the 72 percent suggested by the quantitative analysis.

Moffett drop structure and denil fishway, looking upstream.

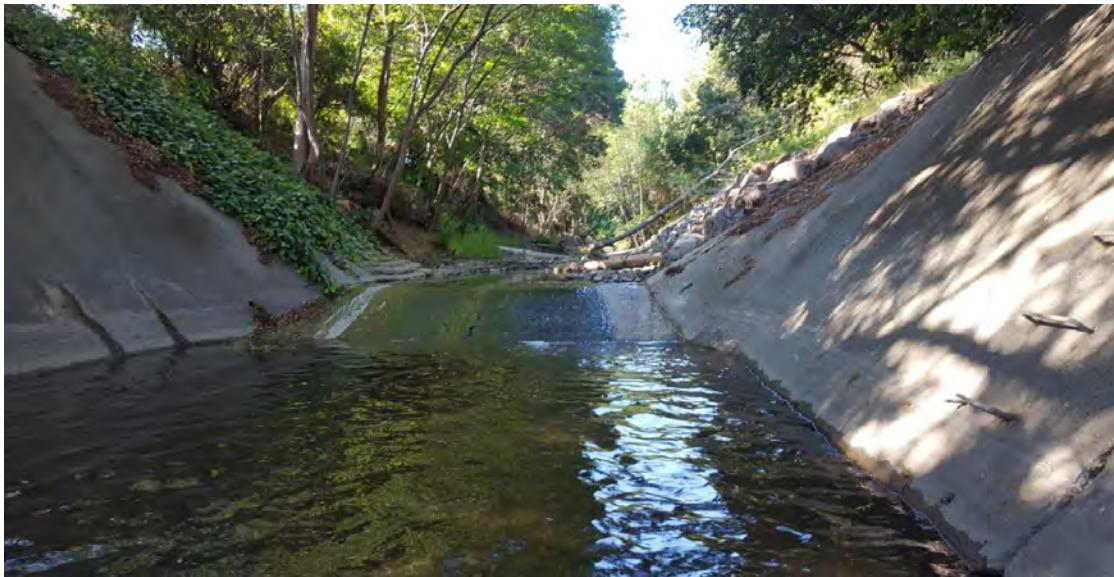
PAD ID: 713642

Looking upstream to drop structure

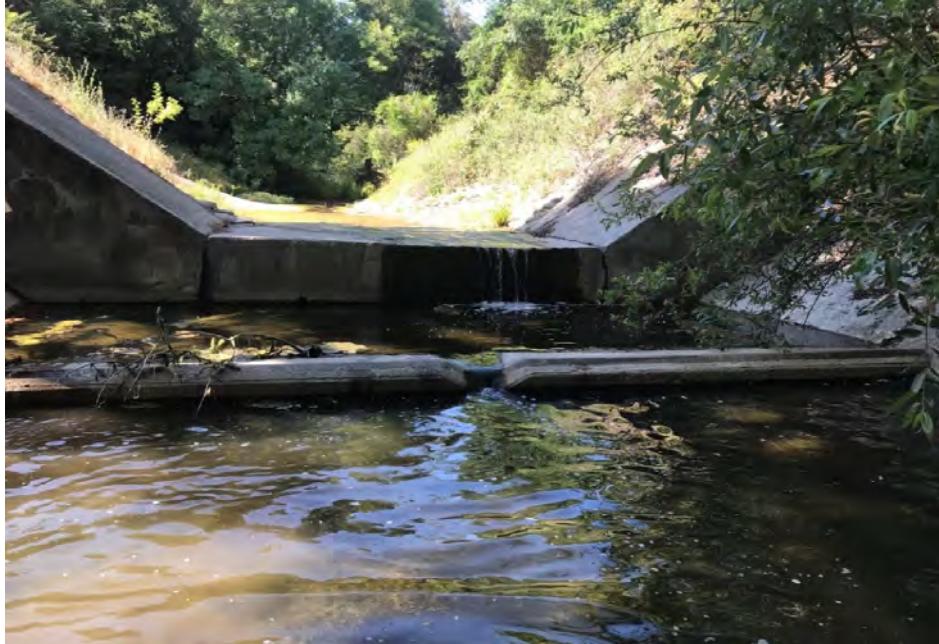
PAD ID: 713643

Looking upstream at the drop structure with pool and weir

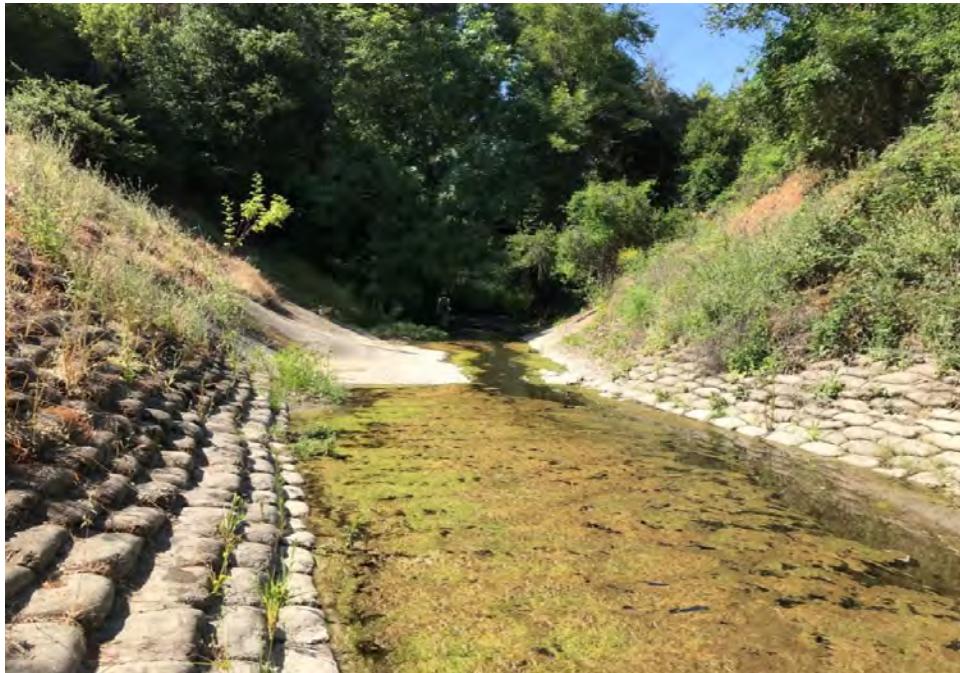
Looking upstream and concrete and sacrete channel above drop structure

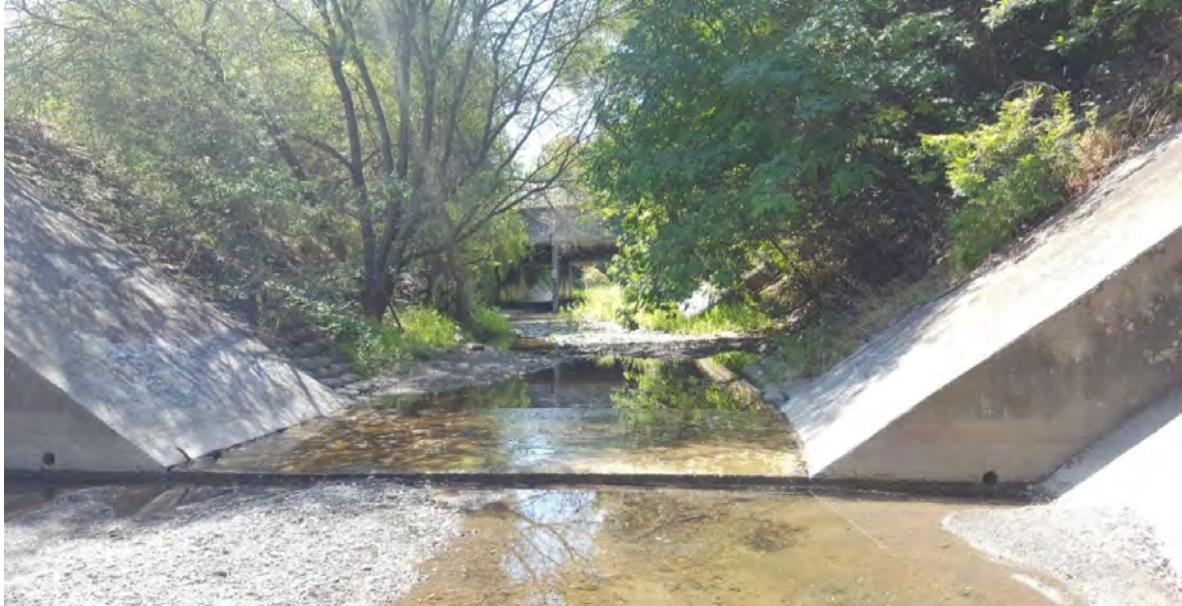
PAD ID: 713645

Looking upstream to drop structure

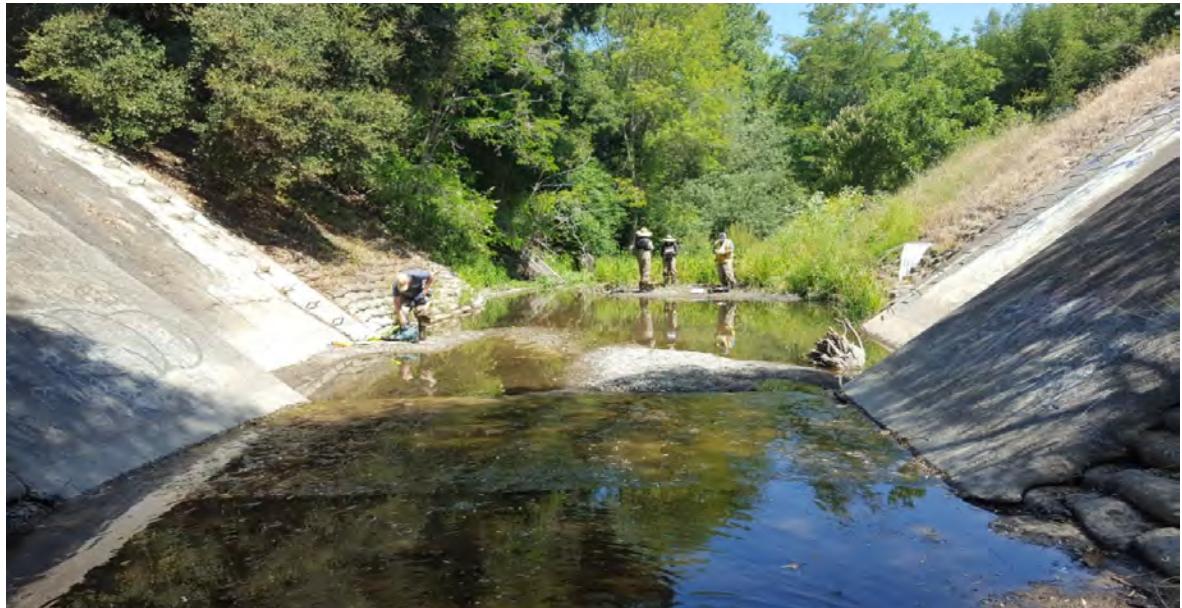
Looking downstream from above drop structure and concrete channel bed

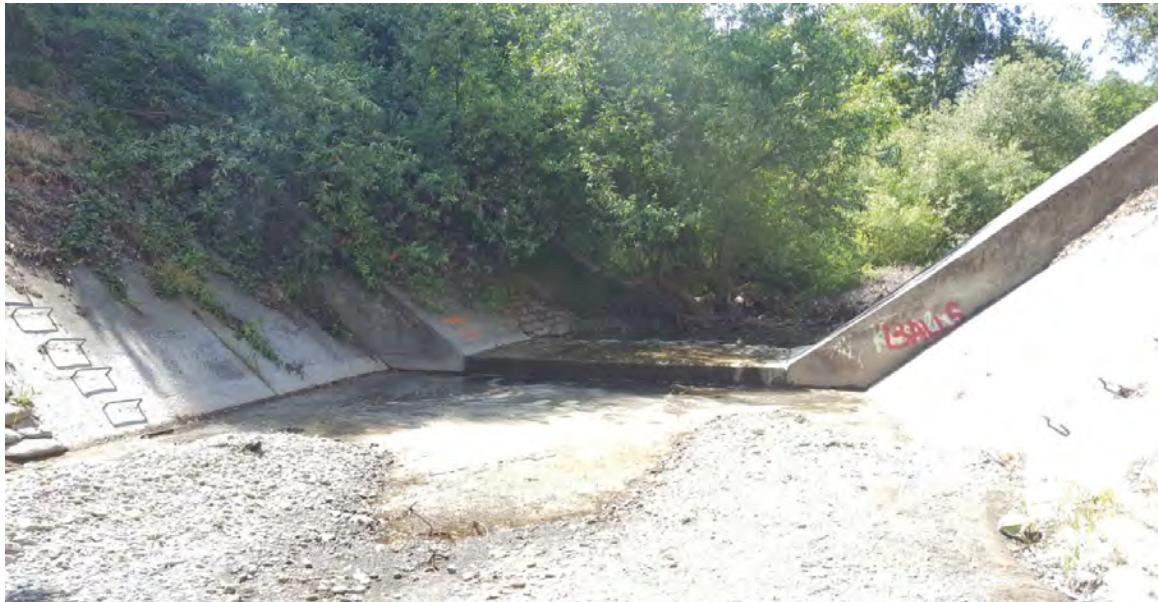
PAD ID: 713646

Looking upstream to drop structure

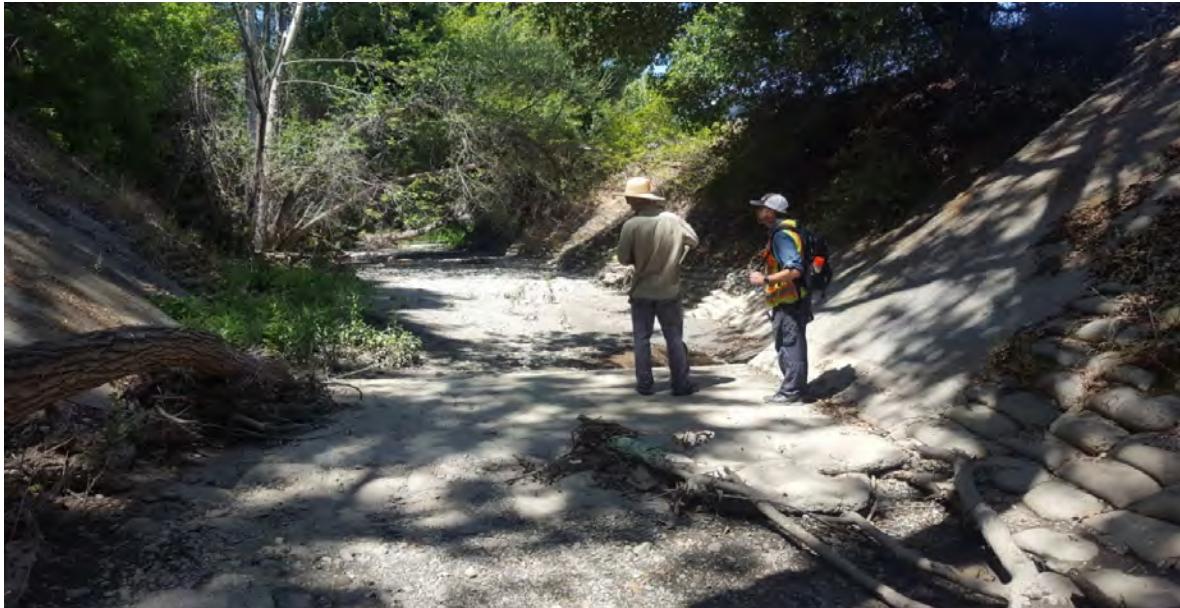
Looking downstream from above drop structure

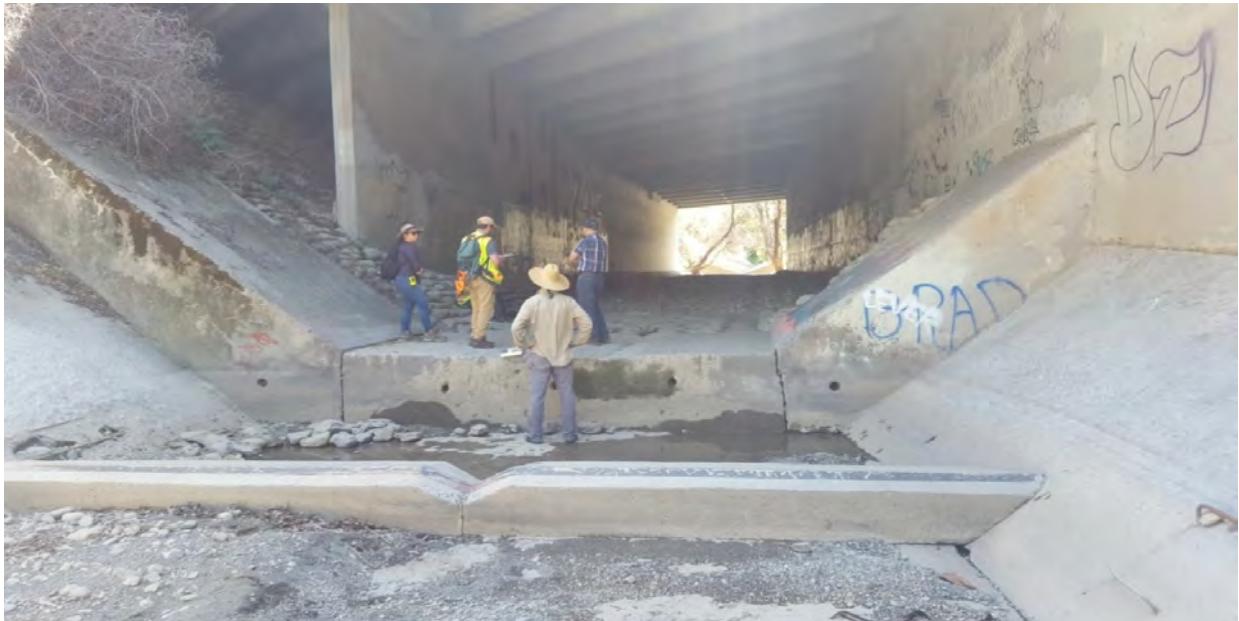
PAD ID: 713648

Looking upstream to drop structure and bridge, with v-weir in foreground

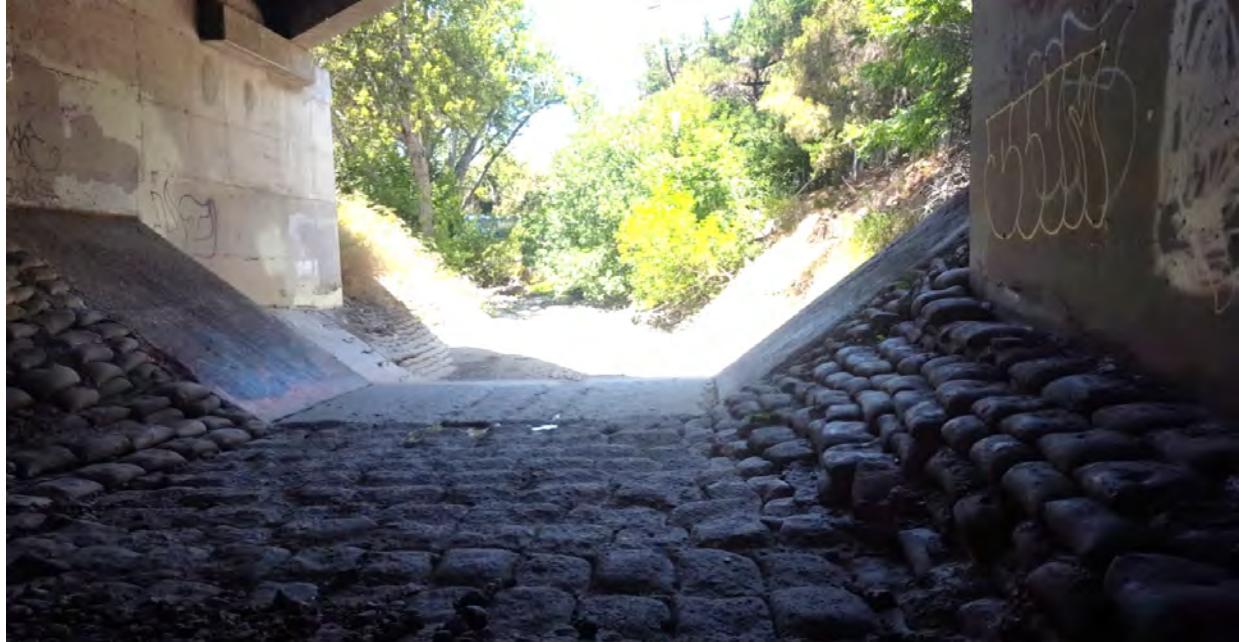
Looking downstream to drop structure from within culvert with sacrete invert

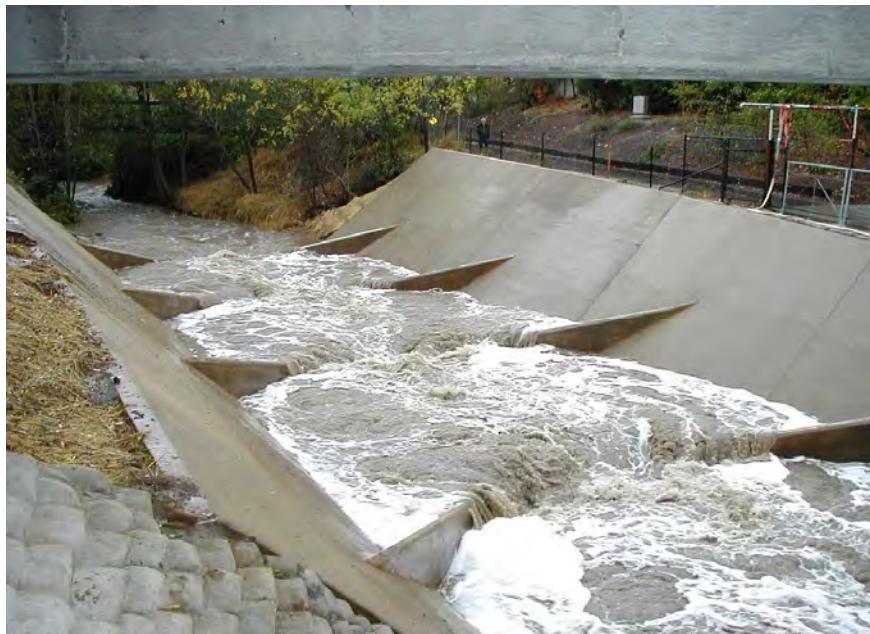
PAD ID: 713647

Looking upstream at fishway with entrance weir in foreground, and water surface drops increasing from upstream to downstream as a result of the low tailwater

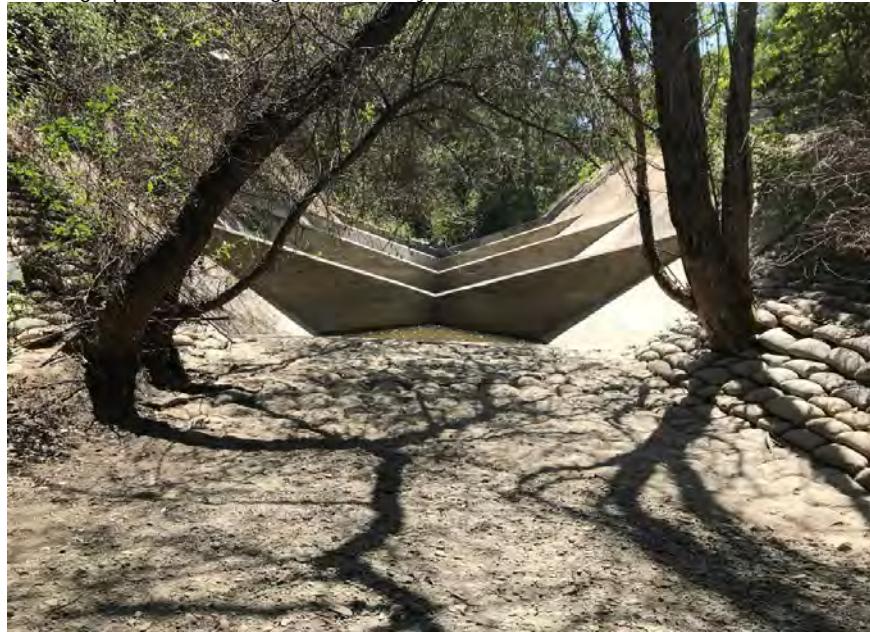
Looking upstream through the fishway from concrete/sacrete tailwater control

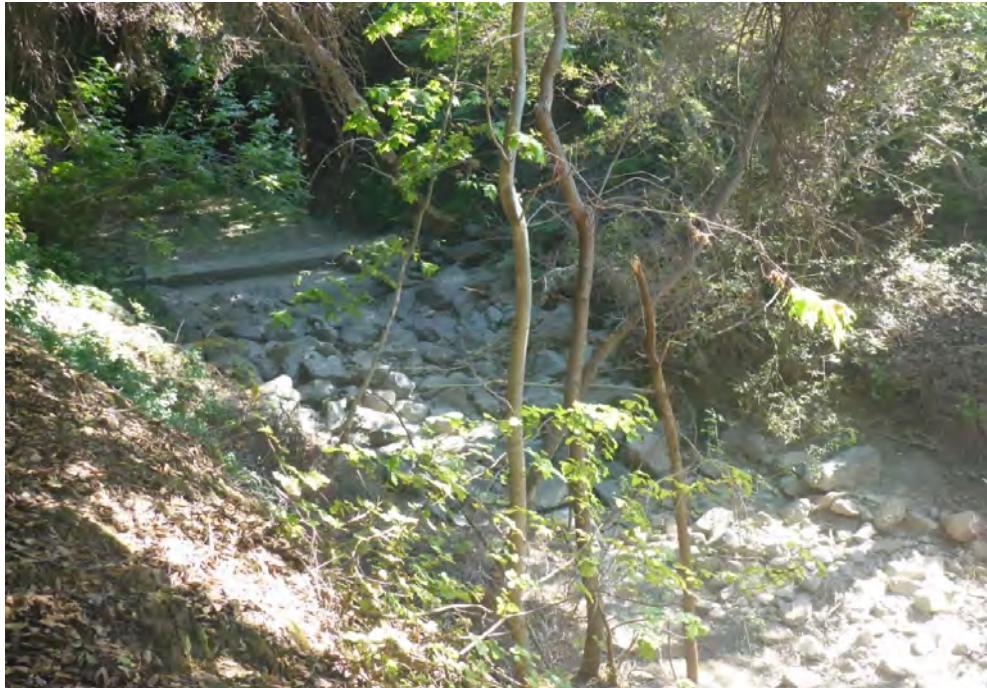
PAD ID: 713650

The drop structure becomes backwatered at approximately 30 cfs. At very low flows the concrete apron below the drop provides insufficient pool depth for leaping and swimming. The upstream end of the boulder chute creates excess velocities for adults and juveniles. The analysis likely under estimates passage conditions for adults given flow diversity in the boulder chute at high flows.

Concrete grade control with boulder chute below, looking upstream

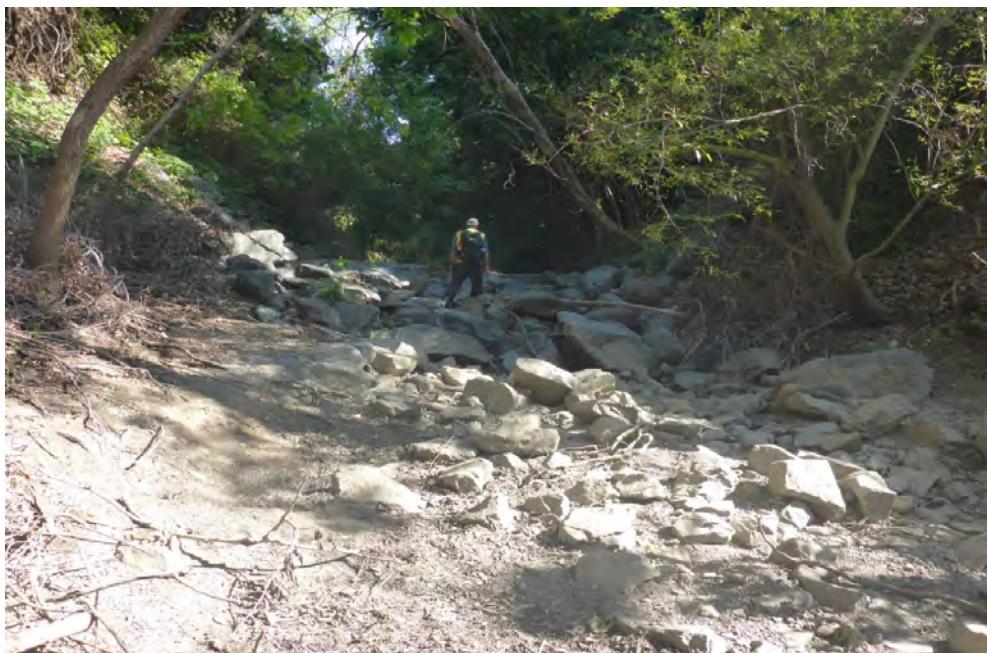
Boulder chute looking upstream

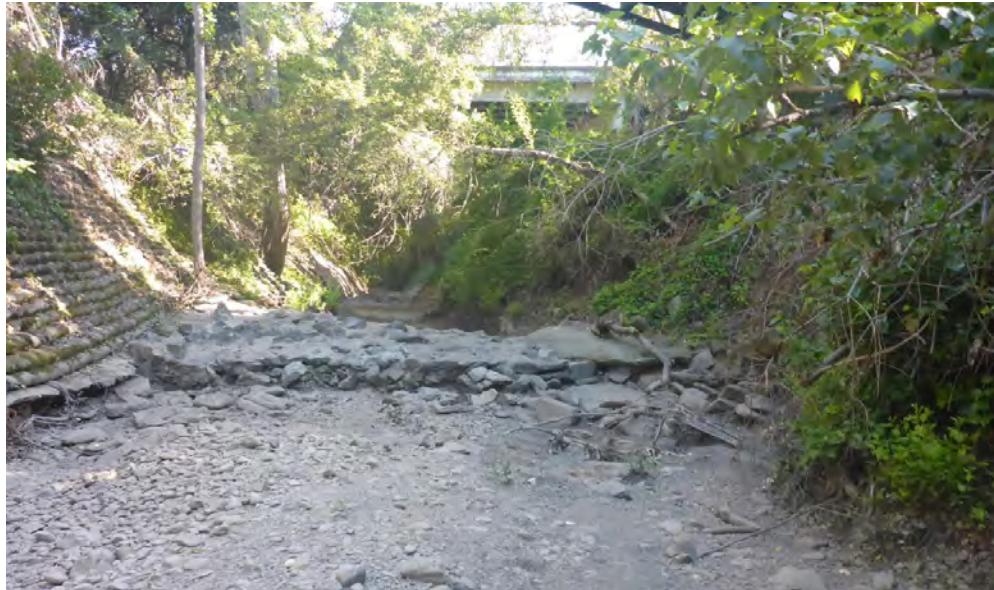
The downstream face of the grouted rock structure is backwatered and the top of grouted rock has a sloping face, so no leap is required. Instead, fish are assumed to attempt to swim over it. The analysis found the depth over the grouted rock is too shallow at low and moderate flows, and became too fast for juveniles at only 4 cfs.

Grouted boulder drop structure looking upstream

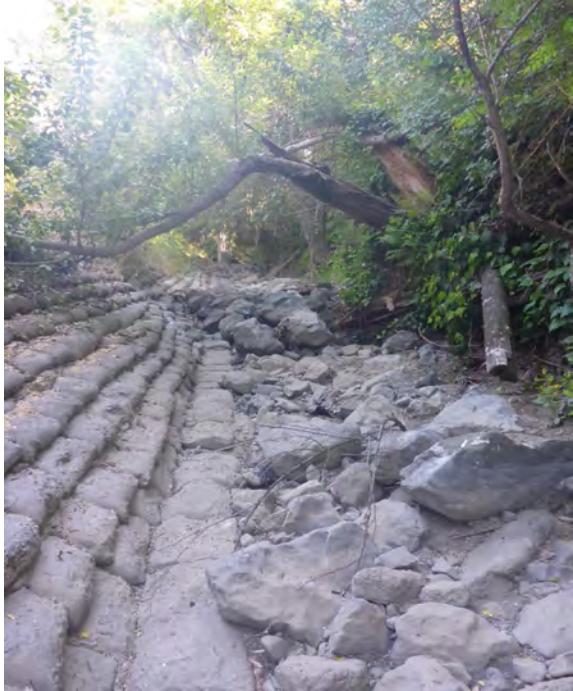
Looking upstream at boulder jam

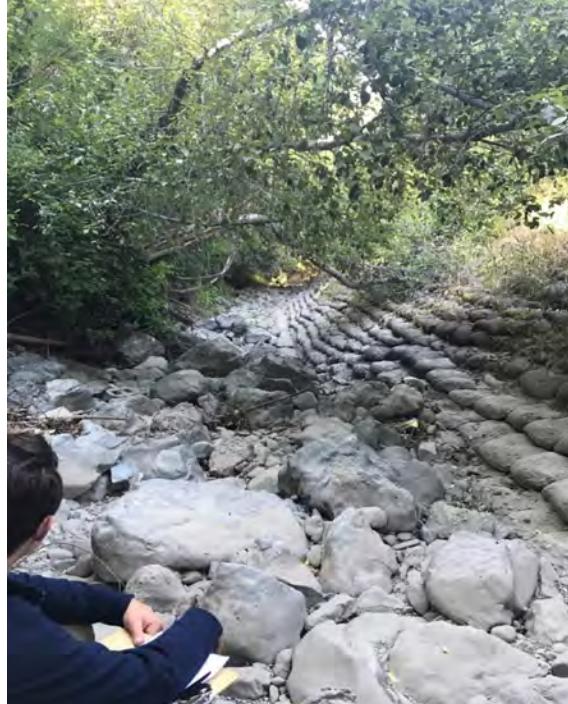
Looking downstream from top of boulder jam

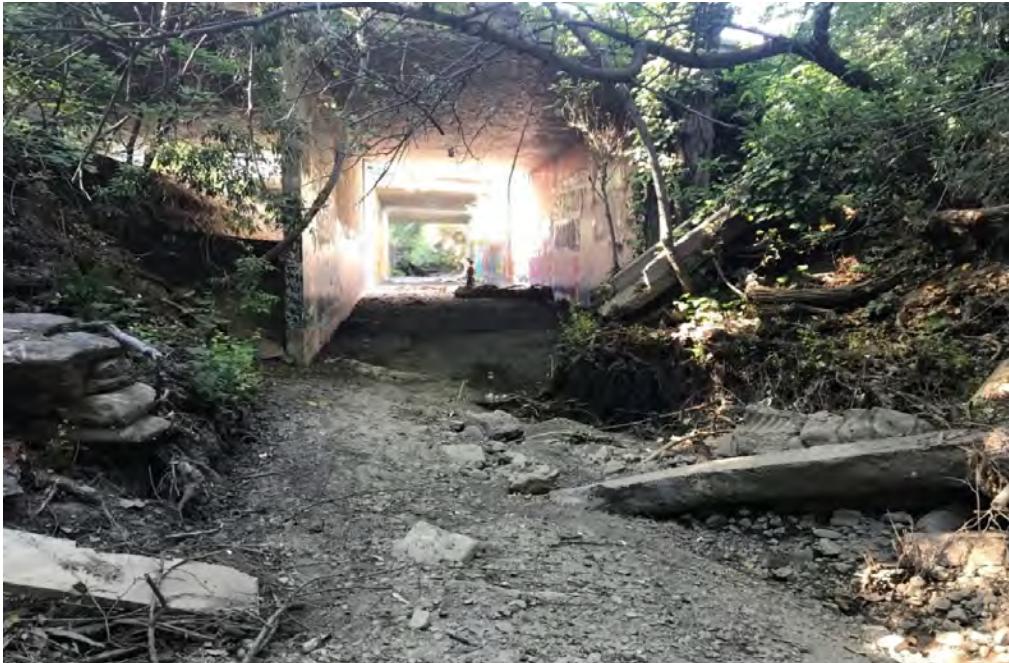
PAD ID: 713651

Culvert inlet looking downstream

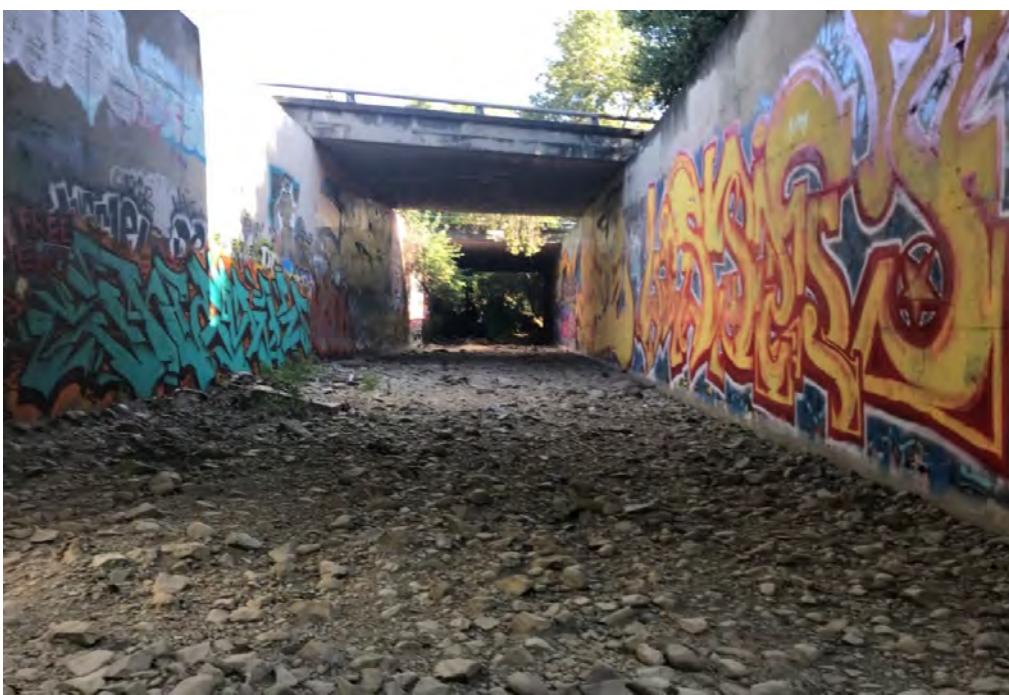
Mid culvert looking upstream

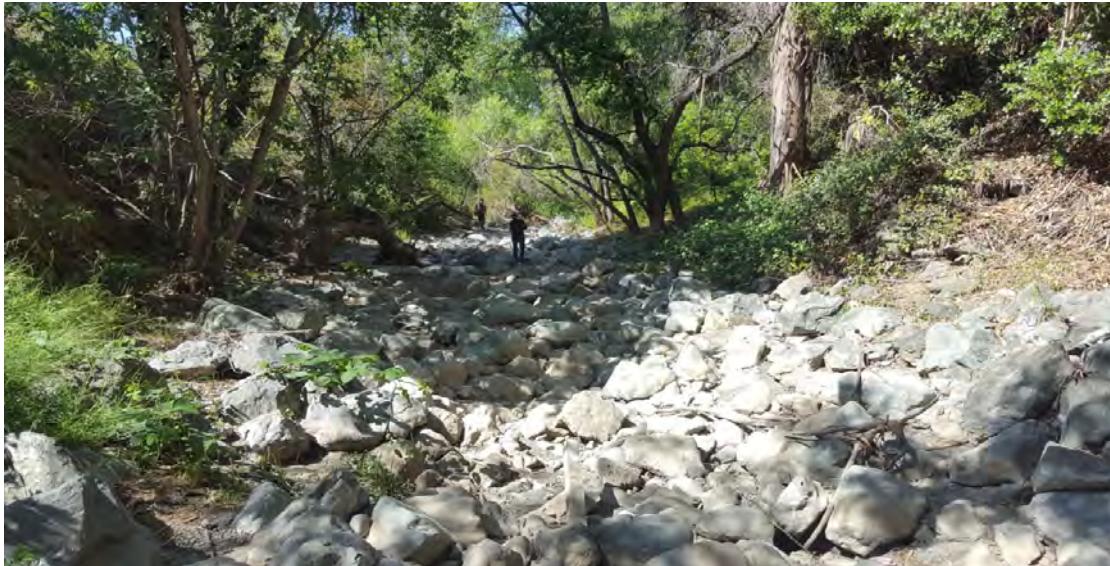
PAD ID: 733959

Looking downstream at boulder lined channel

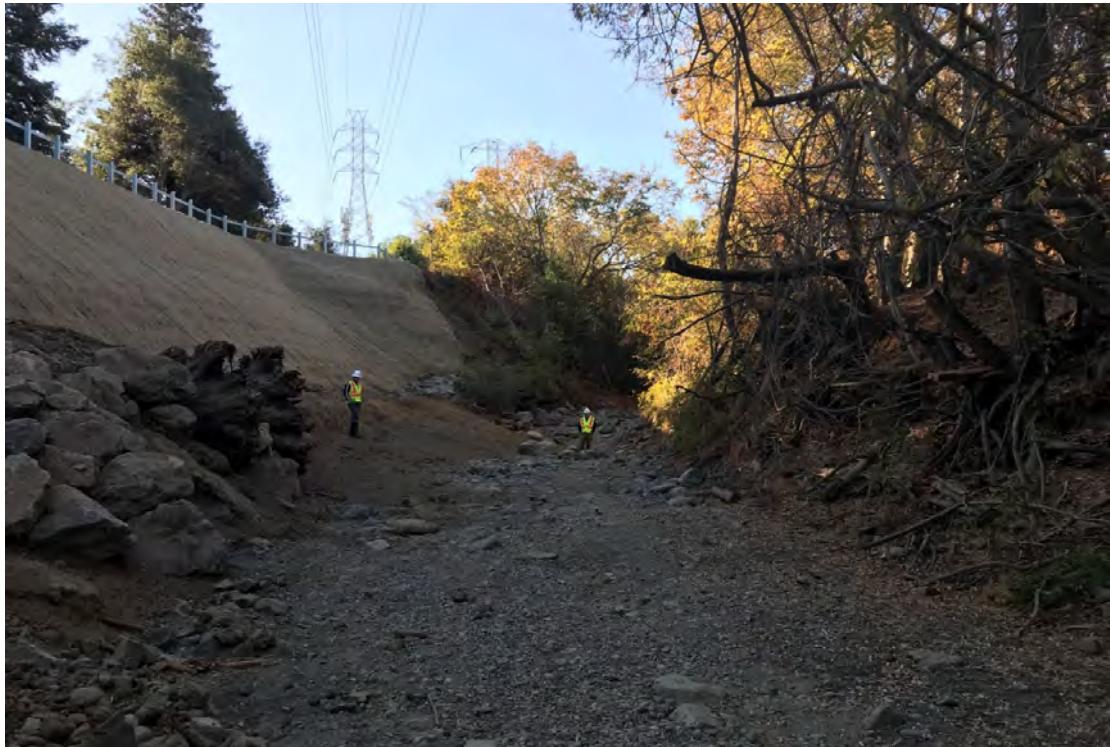
Looking upstream at downstream end of boulder channel and 2018 bank stabilization project

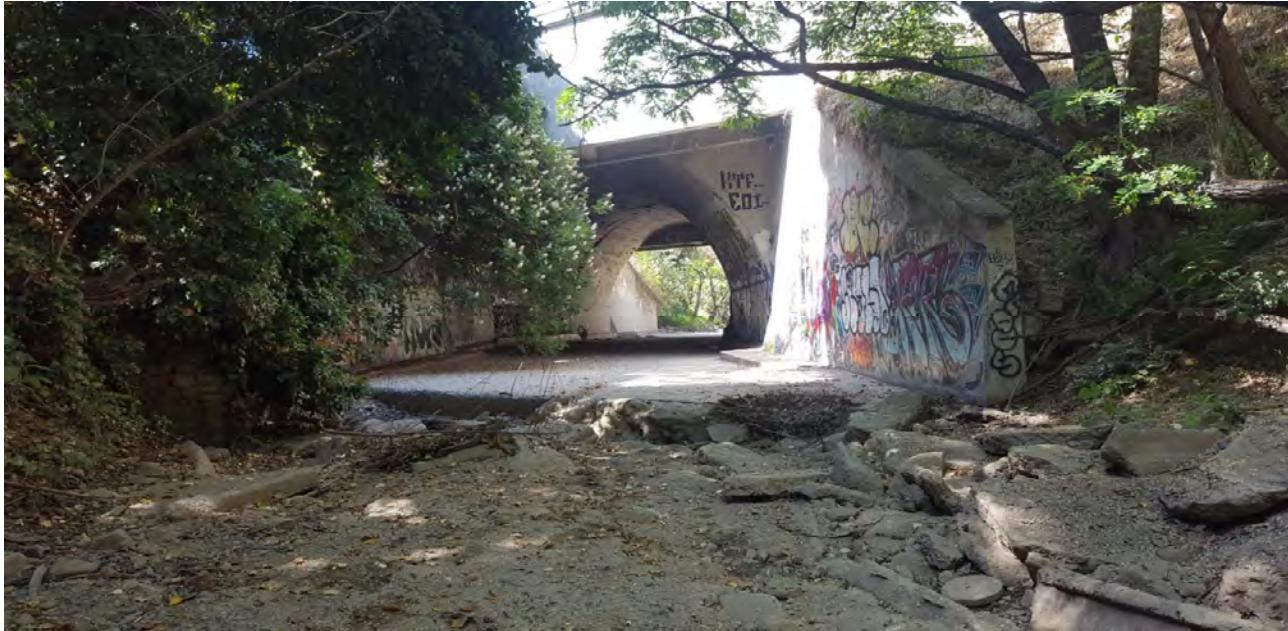
PAD ID: 713652

Looking downstream at culvert inlet

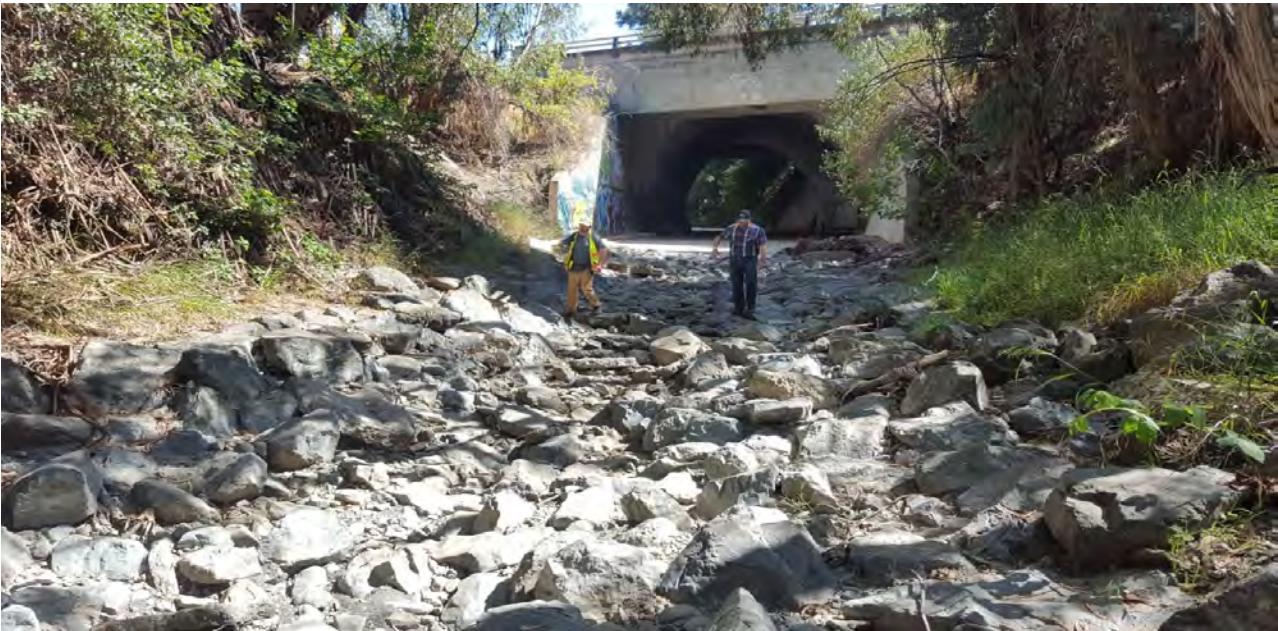
Looking upstream at culvert outlet with boulder channel (site 16) downstream of apron

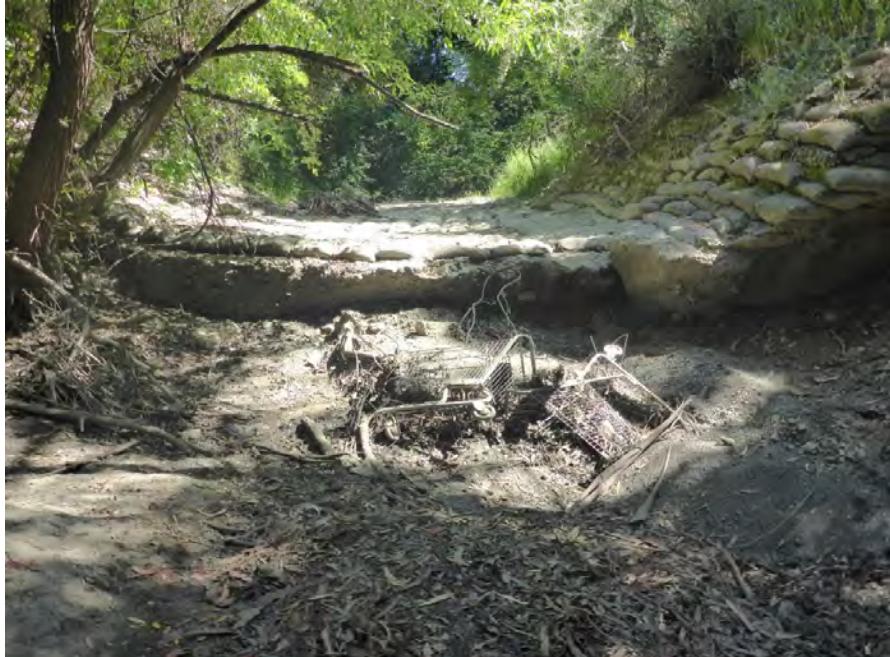
Looking upstream at drop structure/drainage outfall protection

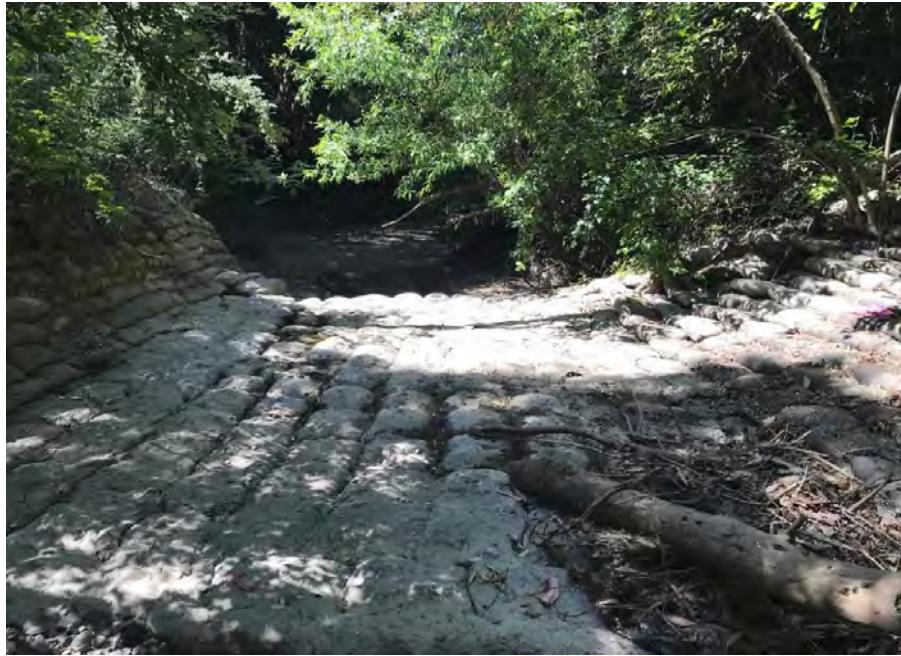
Looking downstream at drop structure/drainage outfall protection

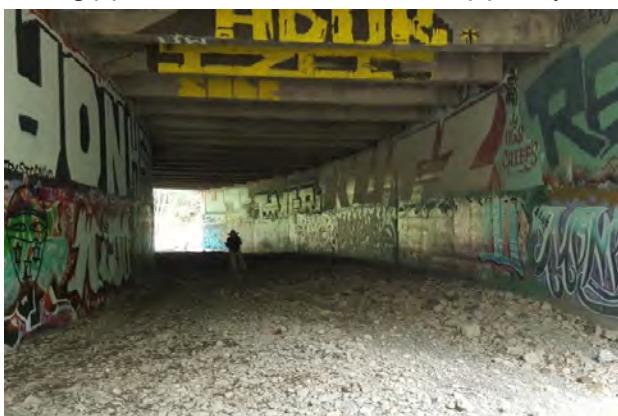
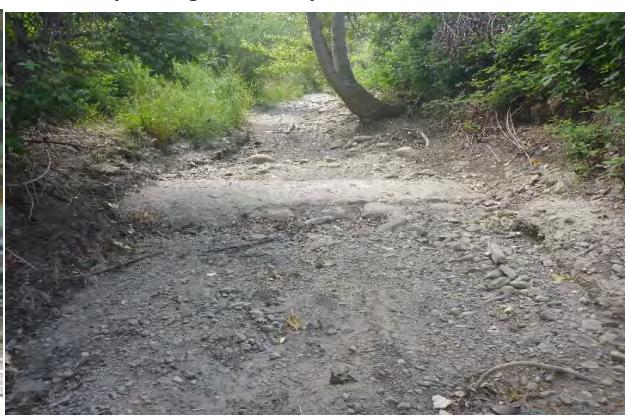
Looking (a) downstream within culvert and (b) at exposed concrete spanning channel upstream of culvert

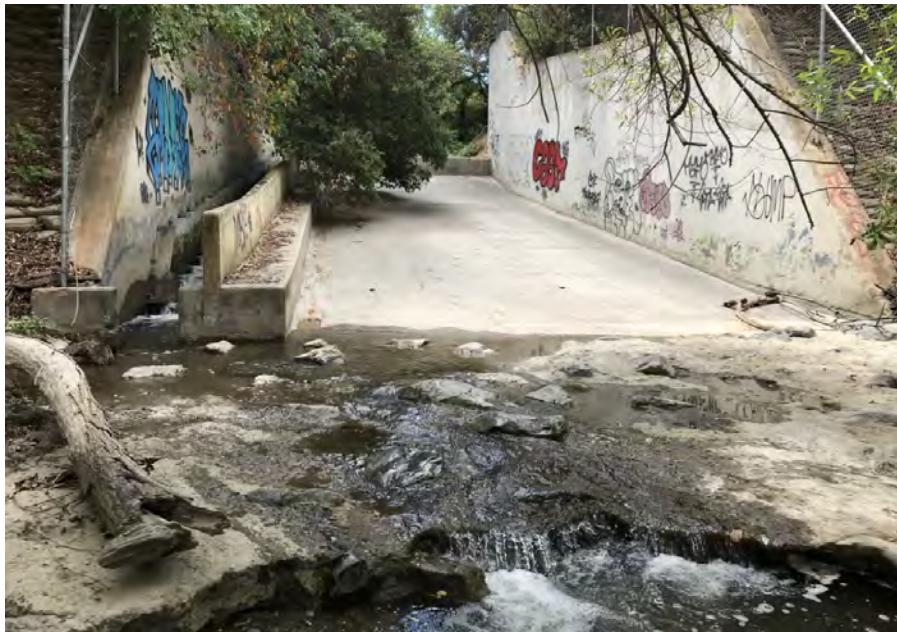
PAD ID: 707056

Grouted rock apron and fishway both create juvenile velocity barriers at all flows. Grouted rock apron creates depth barrier and poor entrance conditions at low to moderate flows for adults.

Looking upstream at Denil fish ladder entrance on left and grouted rock apron

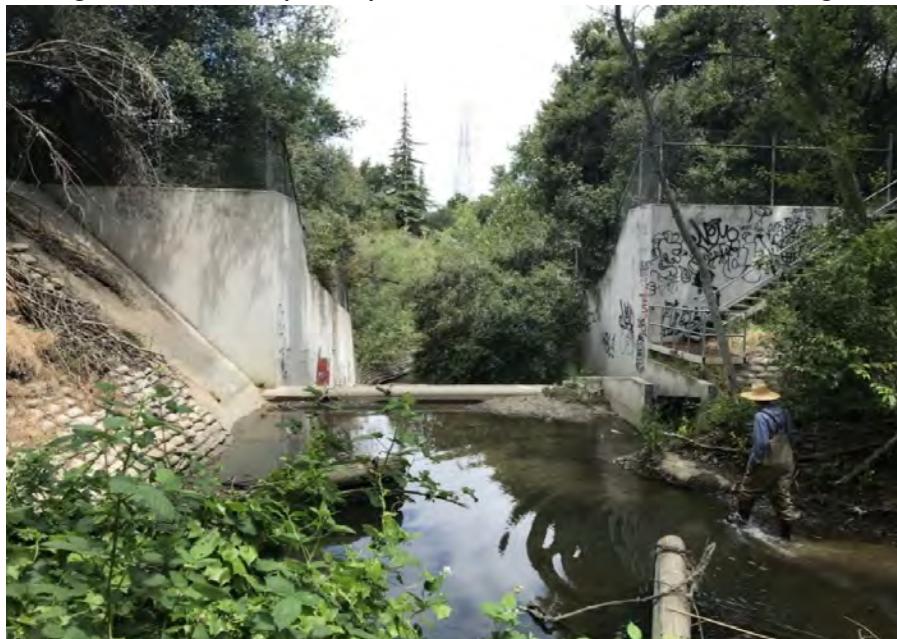
Looking downstream at top of drop structure with Denil fish ladder exit on right
