MEMORANDUM

SUBJECT: Stevens Creek Fish Passage
Remediation

STEVENS CREEK FISH PASSAGE ANALYSIS

CONCEPTUAL APPROACHES TO REMEDY FISH PASSAGE IMPEDIMENTS IN STEVENS CREEK

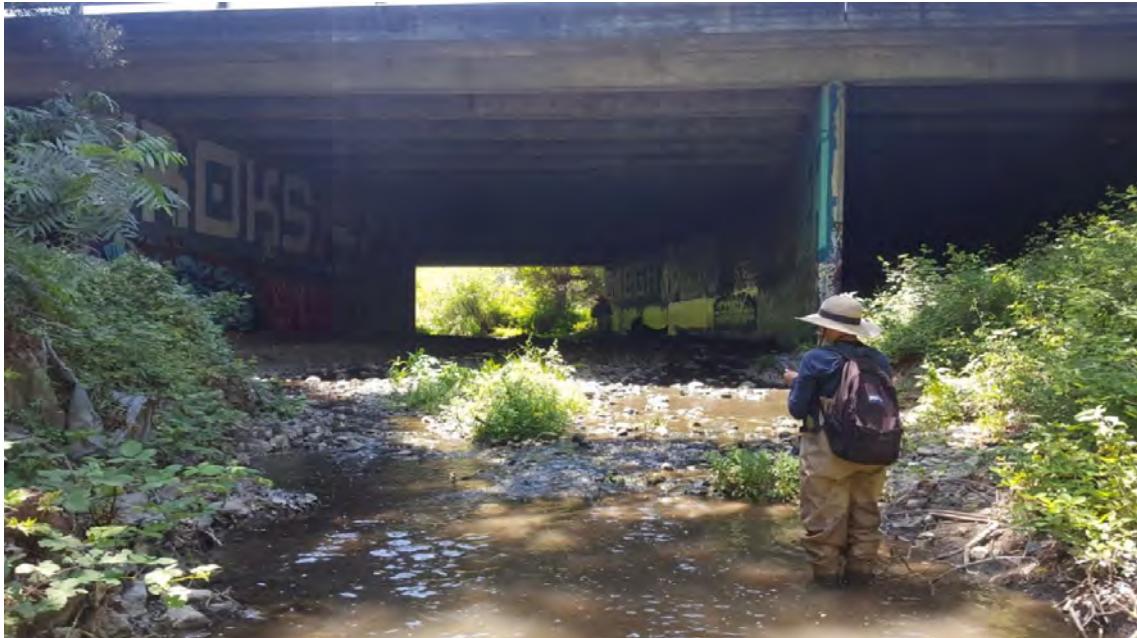
PAD ID: 733951

The channel is over-widened under the bridge, resulting in a depth barrier for adults and juveniles up to moderate flows. The analysis found velocity barriers for juveniles within the riffle near the outlet due to lack of roughness.

Bridge outlet looking upstream

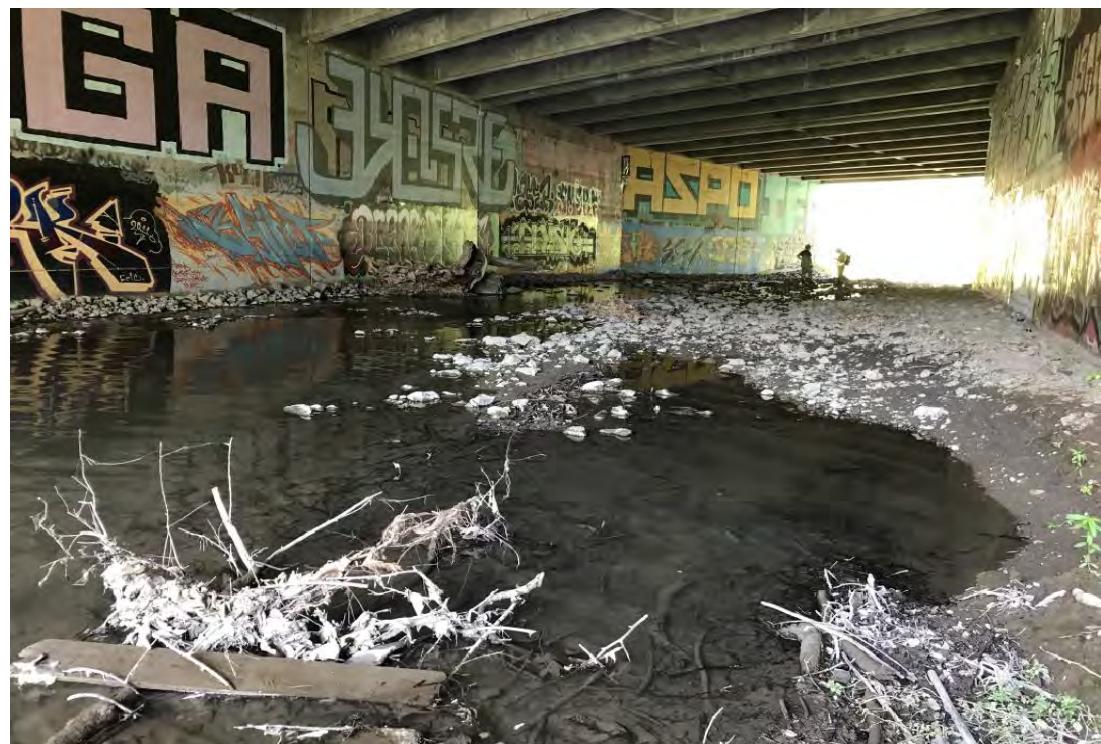
Inside bridge, looking downstream.

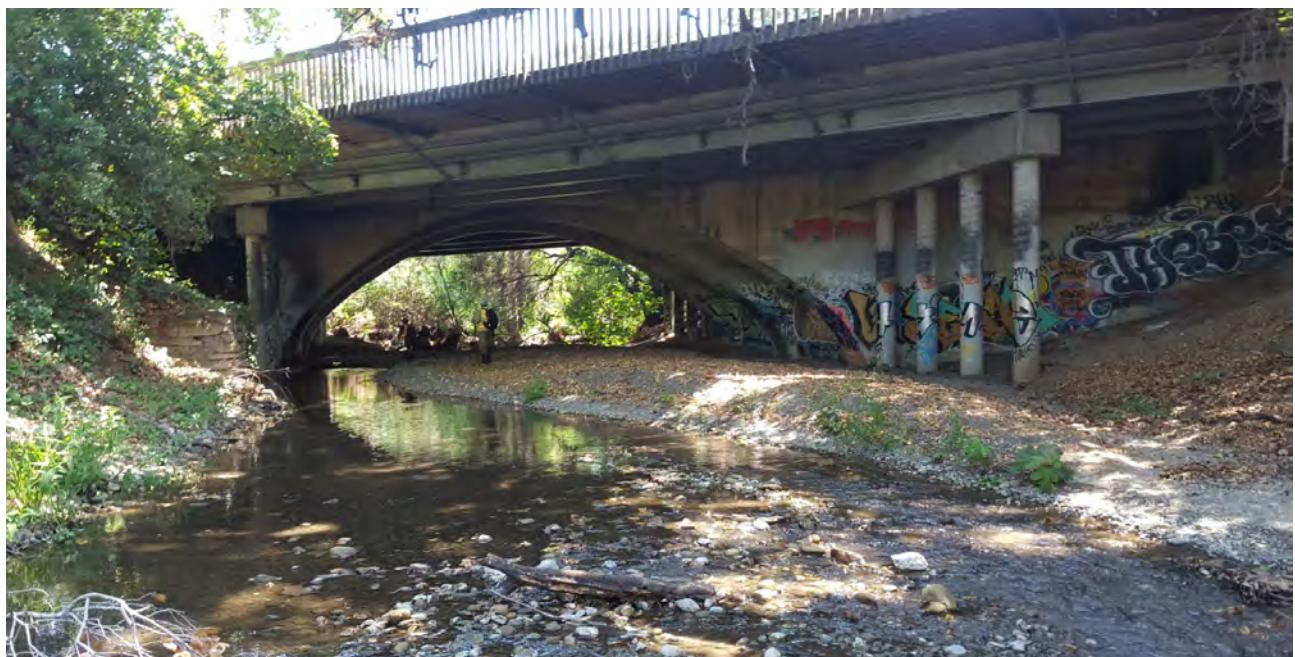
Culvert outlet facing upstream

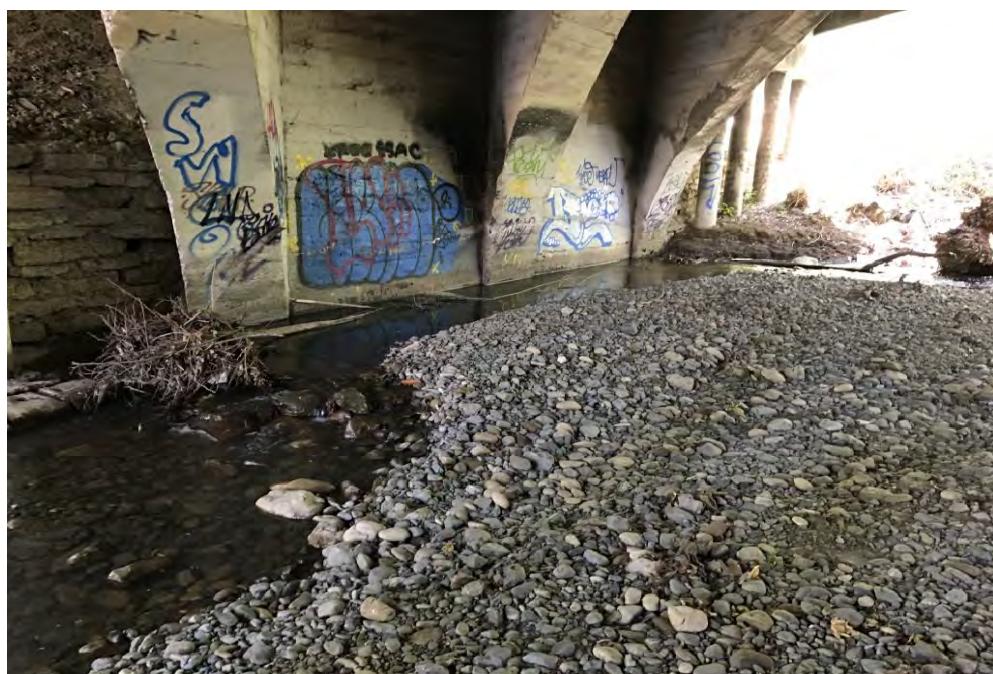
Inside culvert, facing upstream

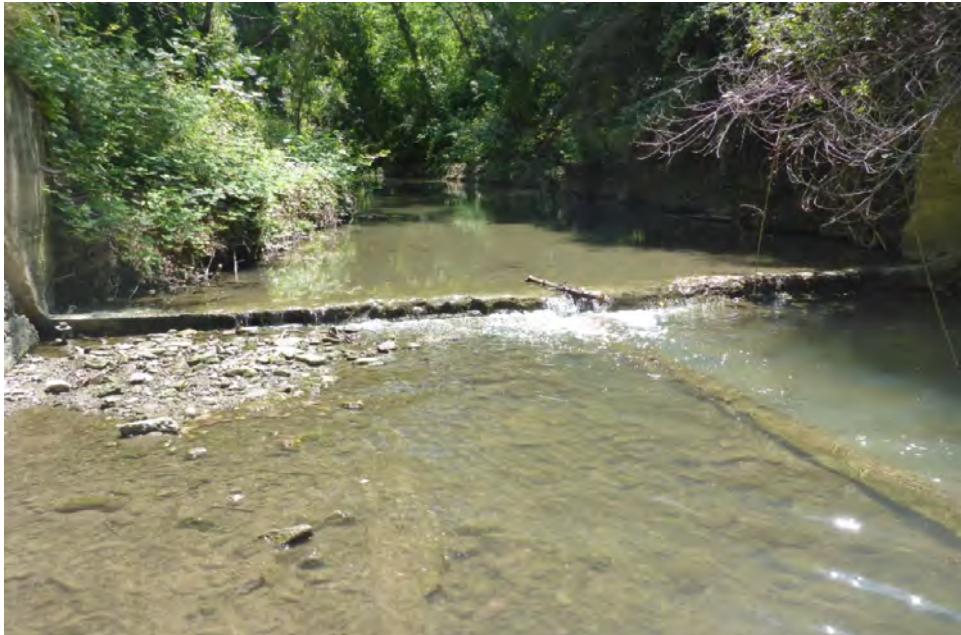
PAD ID: 713656

Drop structure looking upstream.

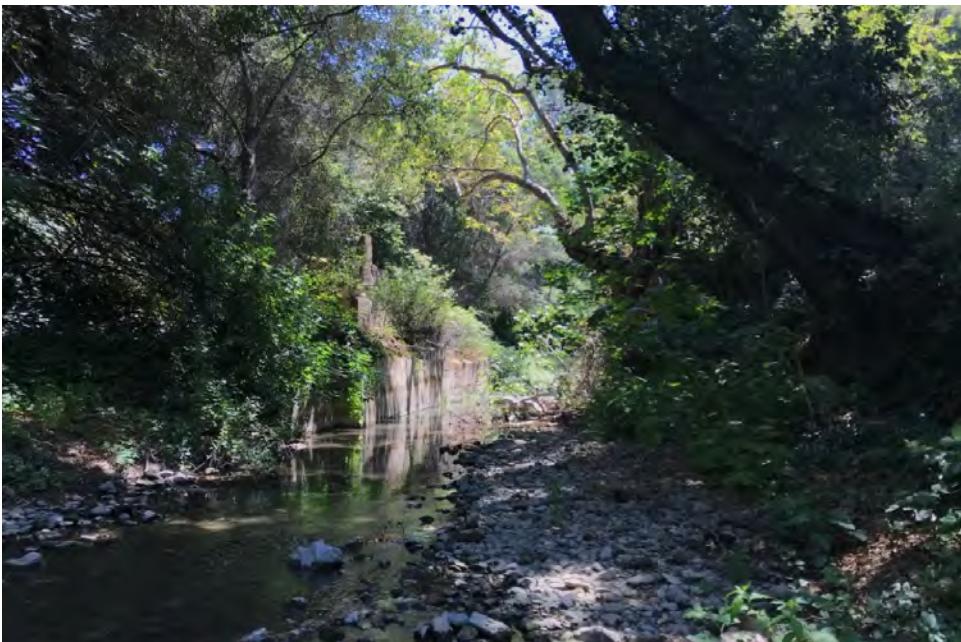
Tailwater control and drop structure pool, looking upstream.

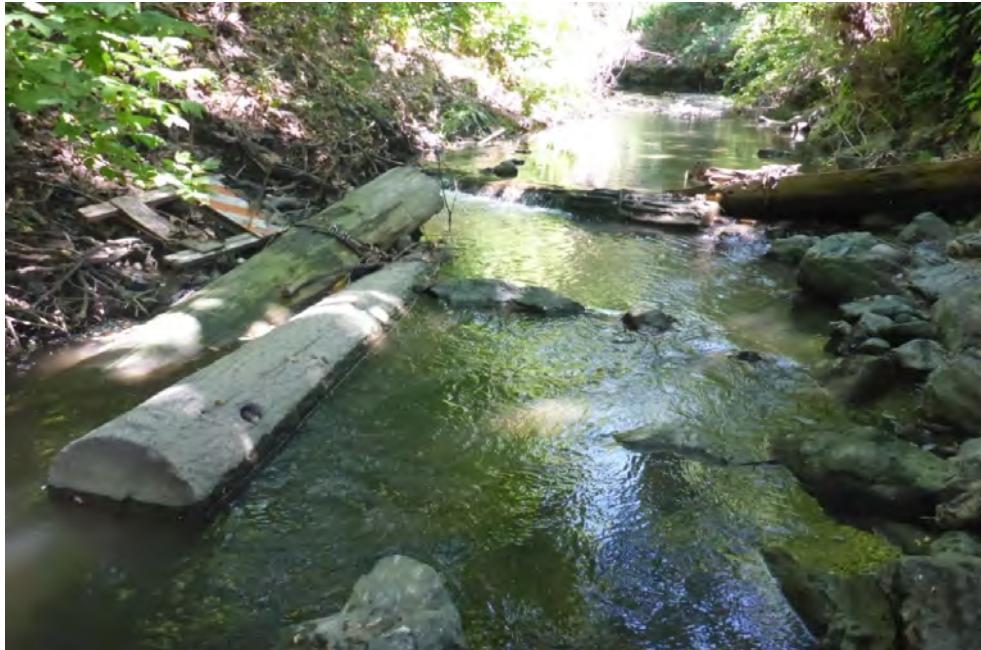
Concrete and wooden log structures, looking upstream.

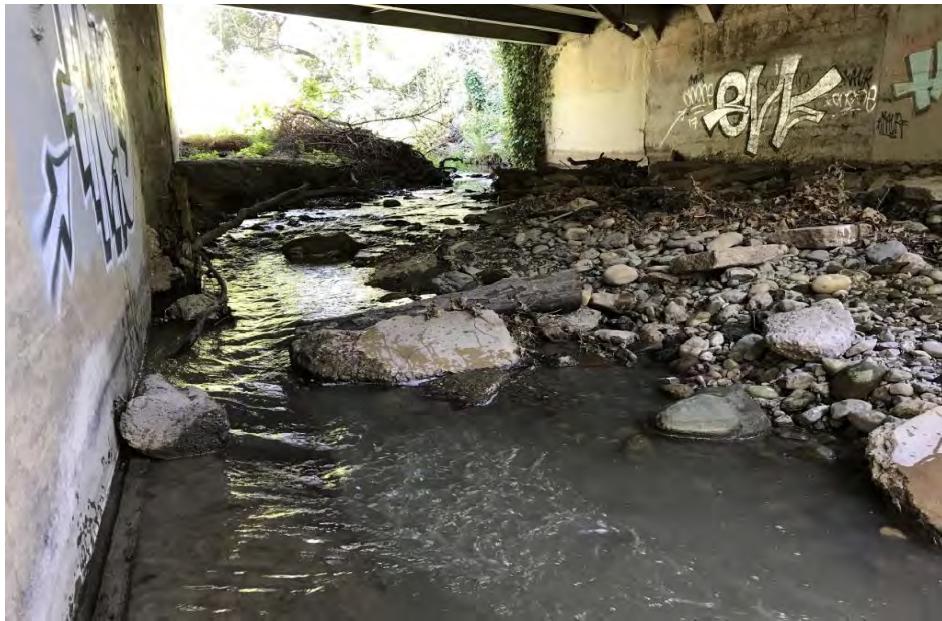
PAD ID: 713658

Looking upstream from crossing outlet

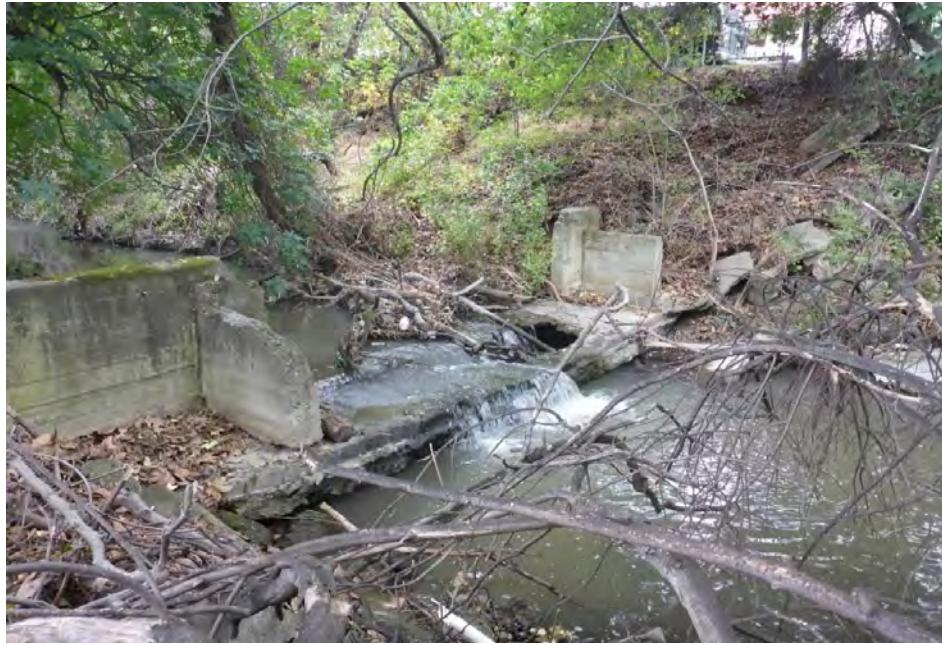
Abandoned flashboard dam. Structure partially failed and sagging in center. Hole in concrete apron with exposed rebar. Debris deposited upstream of hole.

Structure has already partially failed and currently serves no purpose. Hole in concrete apron and exposed rebar further exacerbates passage conditions due to fallback potential and risk of fish injury. Removal of this structure will likely increase drop at downstream end of sacrete channel at next site upstream.

Drop structure looking upstream from right bank

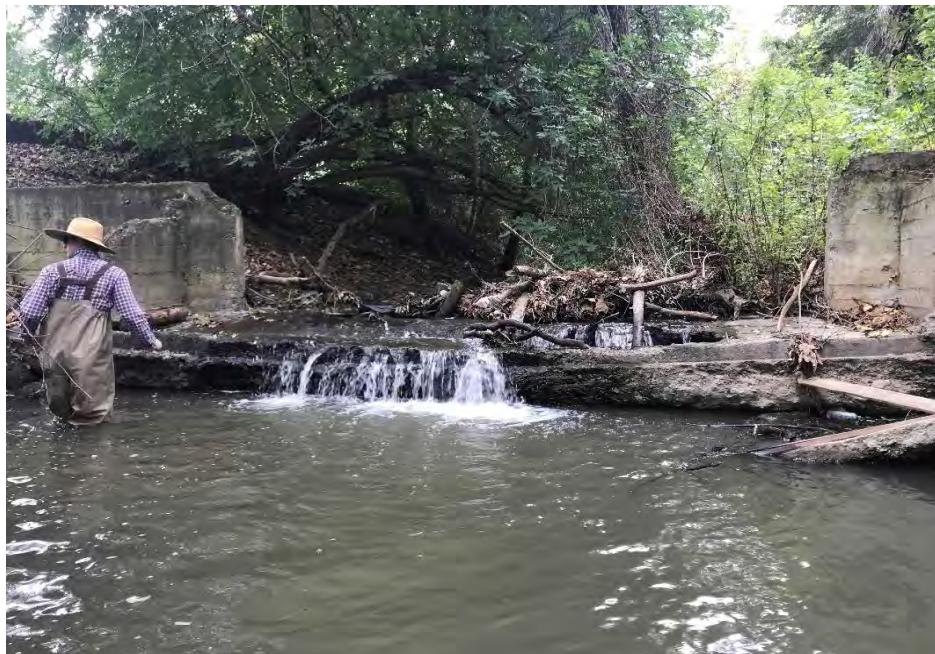
Drop structure looking upstream from scour pool

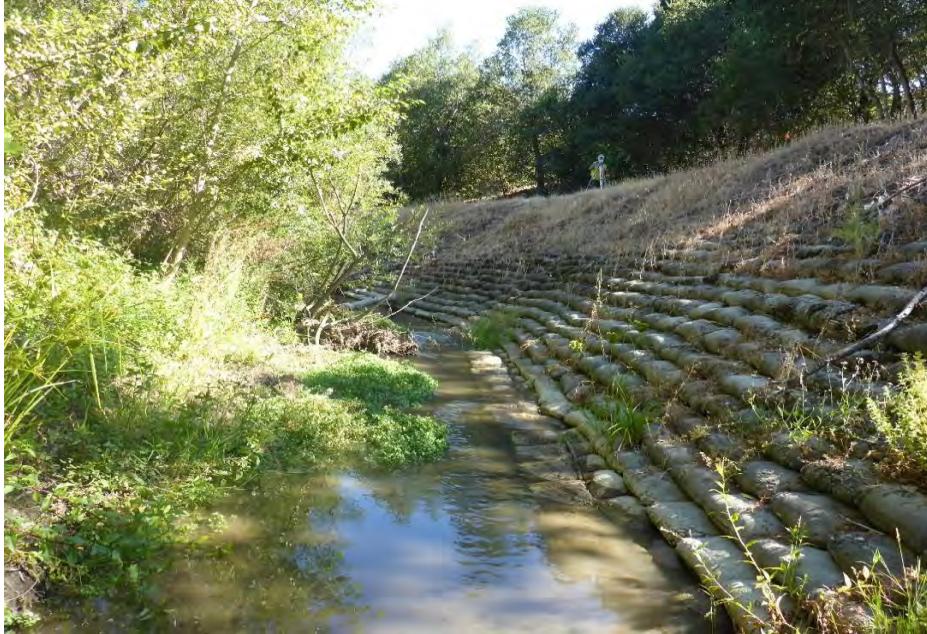
Mid-channel reach looking upstream

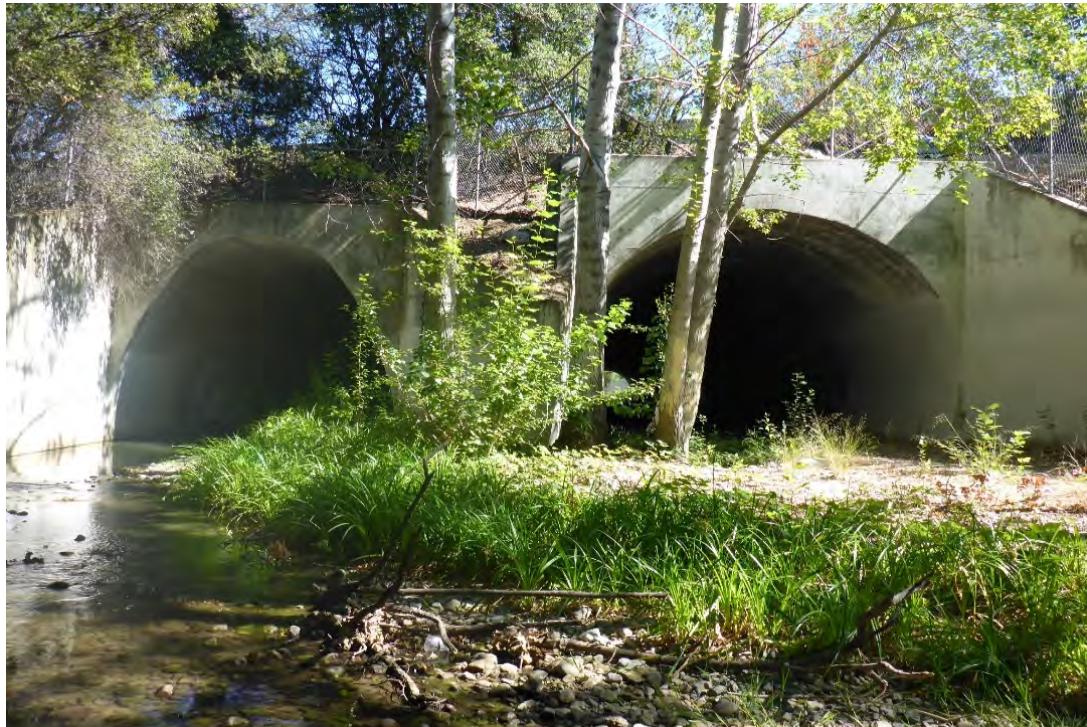
PAD ID: 713660

Juvenile fish likely able to pass this culvert at nearly all fish passage flows due to velocity diversity. A low flow channel along the right side of the culvert helps concentrate flows to provide adequate depth. This passage analysis fails to account for the areas of low velocity close to the bed of the channel.

Culvert inlets looking downstream, primary passage culvert on left

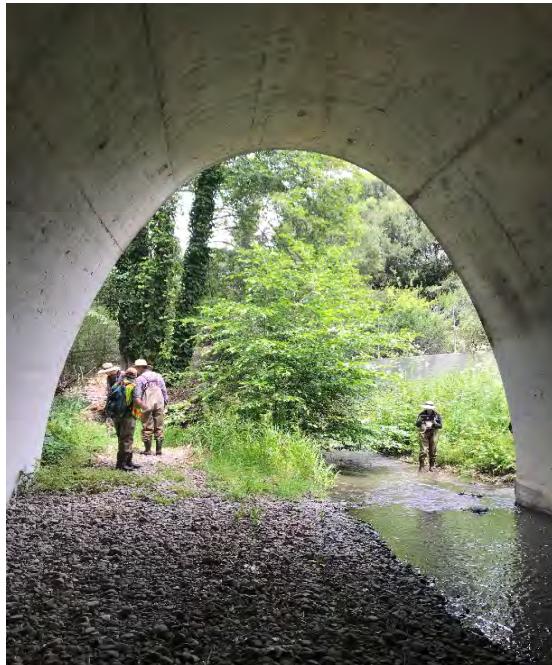
Primary passage culvert's outlet, looking downstream. Note low-flow channel shape provides suitable depth.

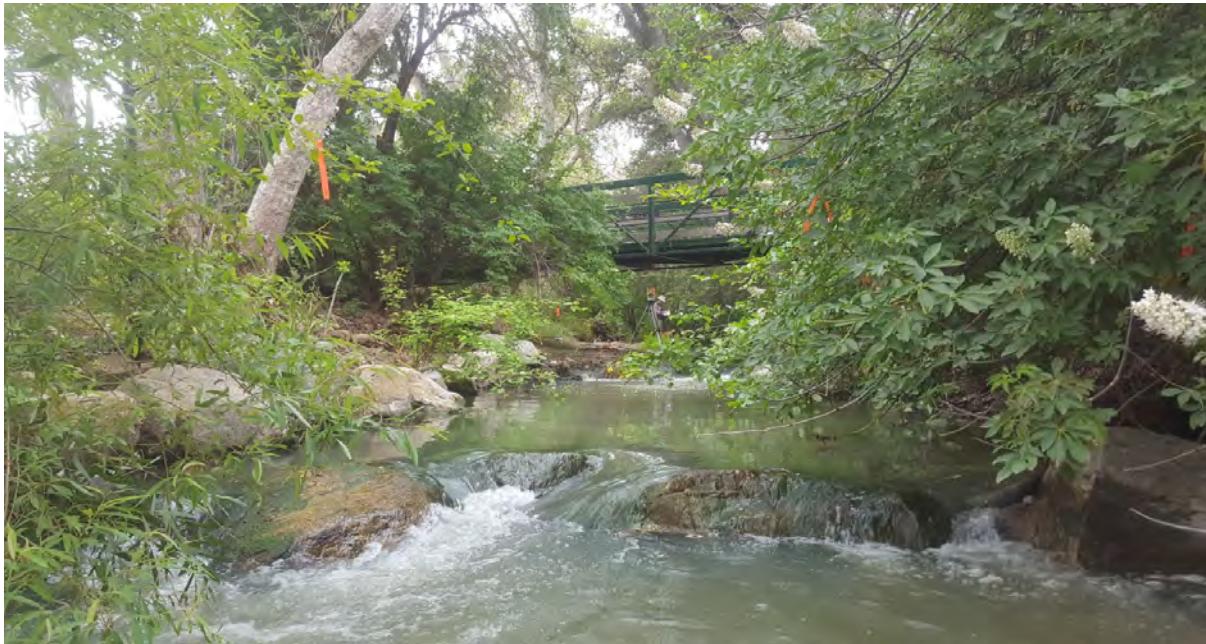
Looking upstream from downstream of lower weir

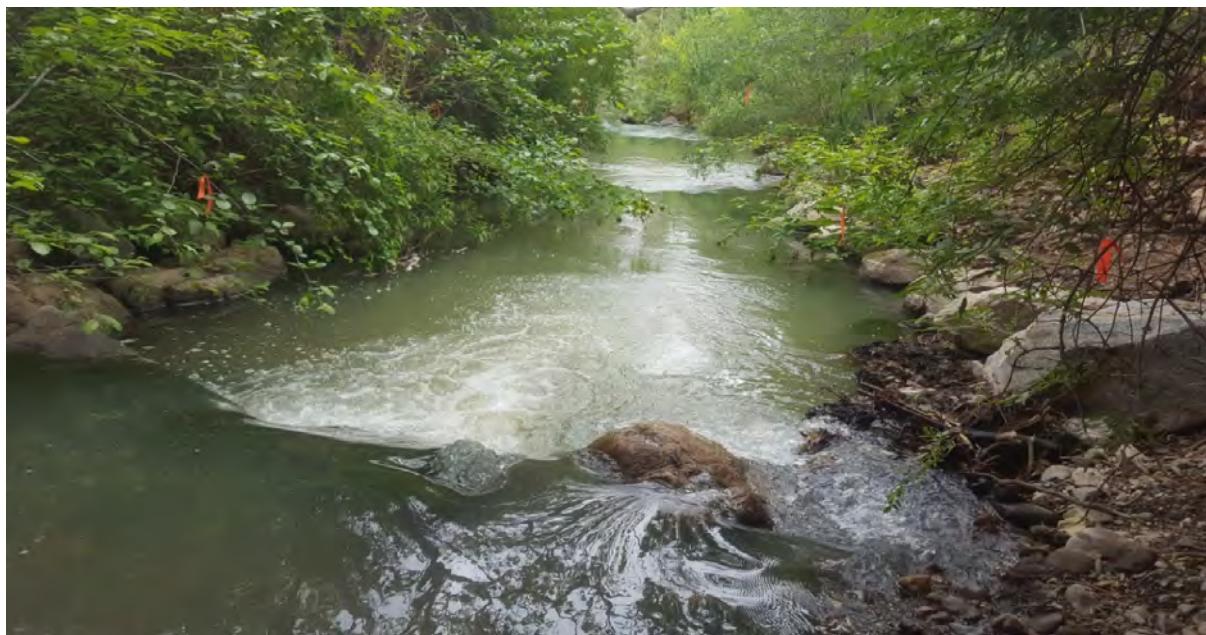
Looking downstream from upstream of upper weir

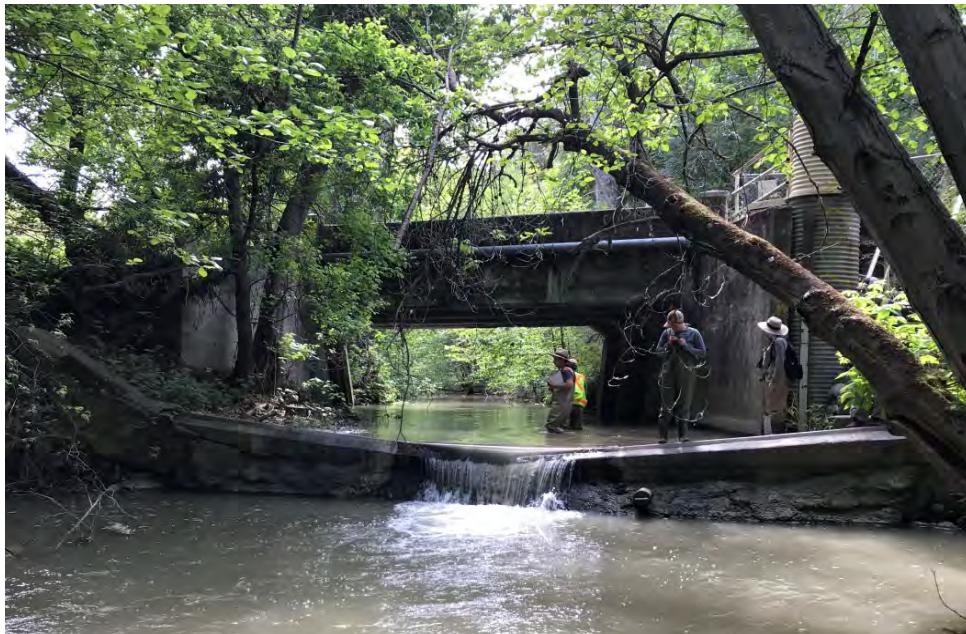
PAD ID: 713667

Looking upstream to gaging weir

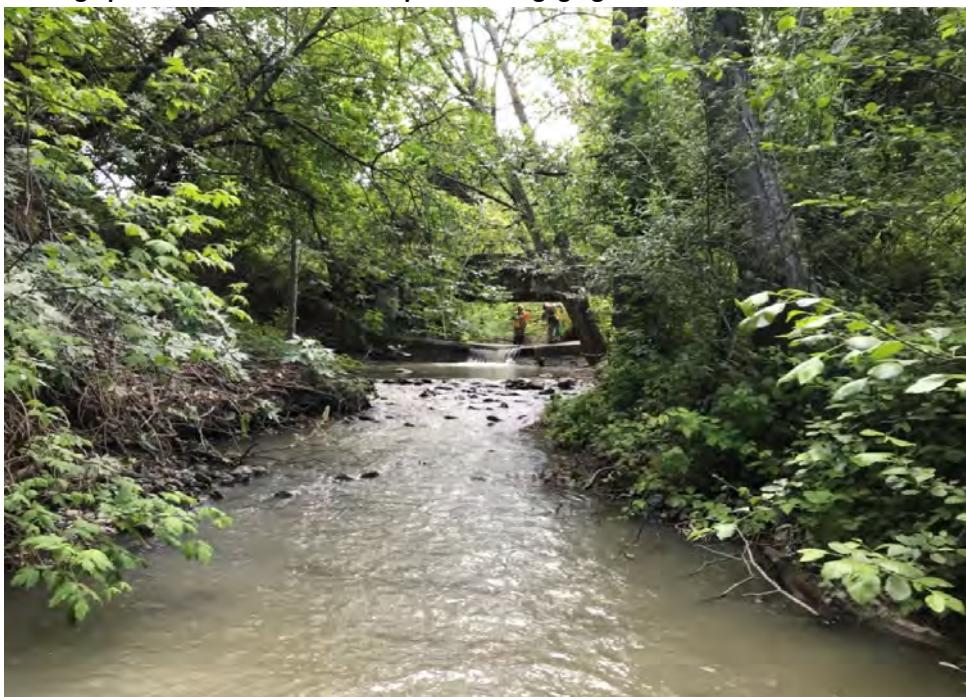
Looking upstream at riffle control of pool below gaging weir

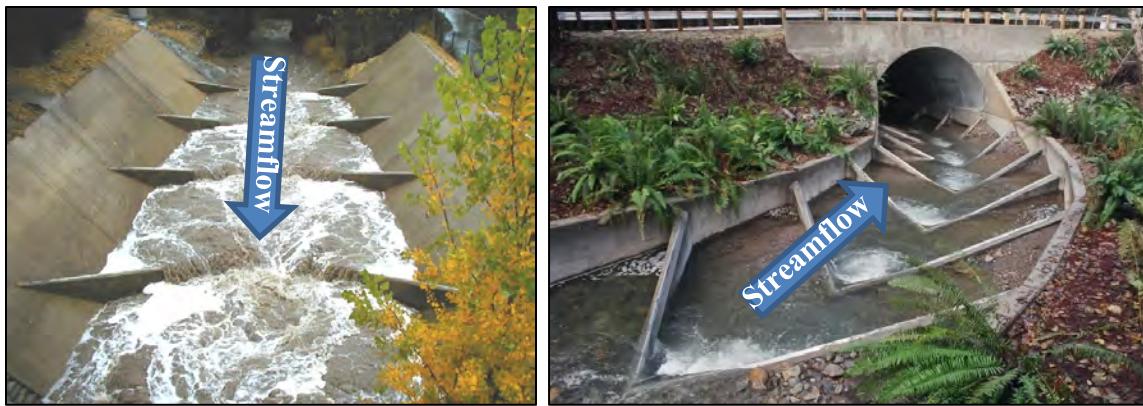
Figure 2-5 Vortex Pool-and-Chute Fishway on Stevens Creek at Gage SF35 (left image) and in Del Norte County, California (right image)
